Mines Safety Bulletin No. 173

Subject: Inspection and maintenance of handrails

Date: 26 March 2020

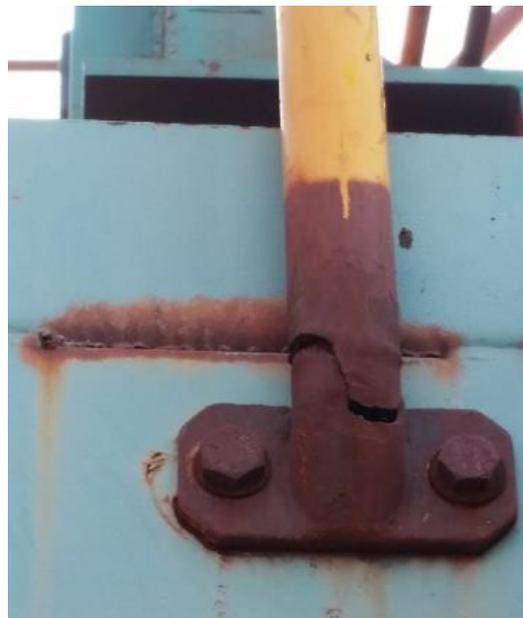
Handrail post failure after inappropriate repair. The corrosion was removed and the area painted without strengthening.

- Repairs should be undertaken as soon as corrosion appears or damage is notified.
- Repairs must be specified by a qualified person and parts replaced in accordance with the OEM's specifications and based on the site conditions.

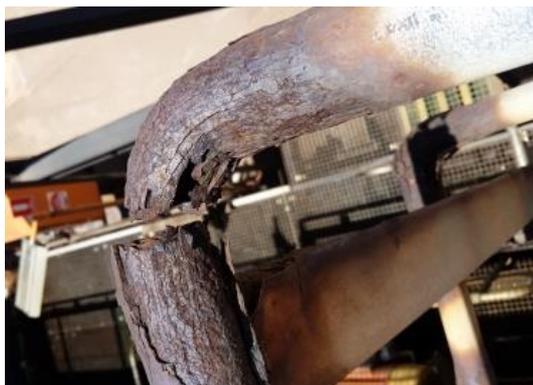
Delayed maintenance led to handrail failure.

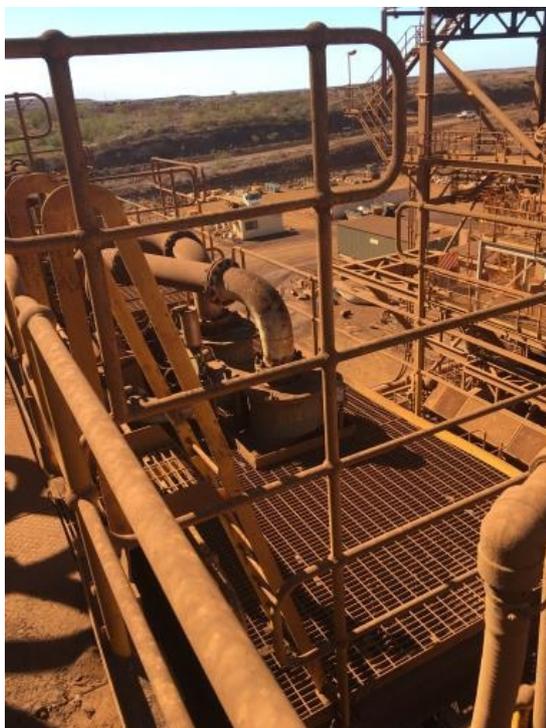
Workers are exposed to additional risks when handrails are modified locally and/or are increased in height. These modifications create a misleading sense of safety and expose workers to increased risks of falling from heights.

Handrails with six rails not in accordance with manufacturer's specifications of two rails.

- The following should always be referred to a competent person for appropriate action:
 - rust or damage to the post or rails
 - handrails with more than two rails
