Significant Incident Report No. 146

Hazard posed by cyclone draw in RC drilling

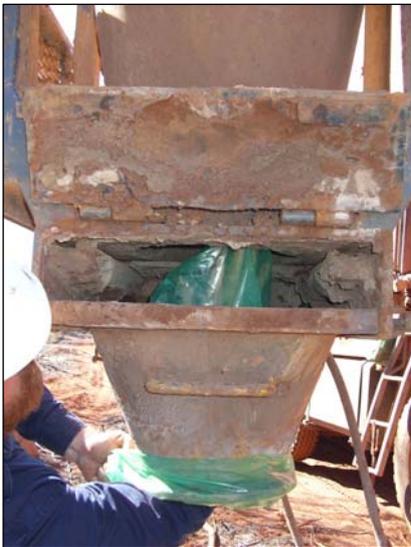
The sliding draw, beneath the cyclone, is a potential pinch point. With the sample splitter in place, this potential pinch point cannot be accessed.

With the splitter off, the length of the cone beneath the cyclone was such that it was possible for a person to reach up inside the cone and place their hand in a potential pinch point — the path traversed by the sliding steel plate of the draw.

The original adaptor cone is shown in photograph 1.

Photograph 1: Sample bag attached to original cone

The control measure adopted was to engineer out the hazard by:

- making it much more difficult to access the potential pinch point; and
- adding hydraulic interlocks to prevent operation of the draw under certain conditions

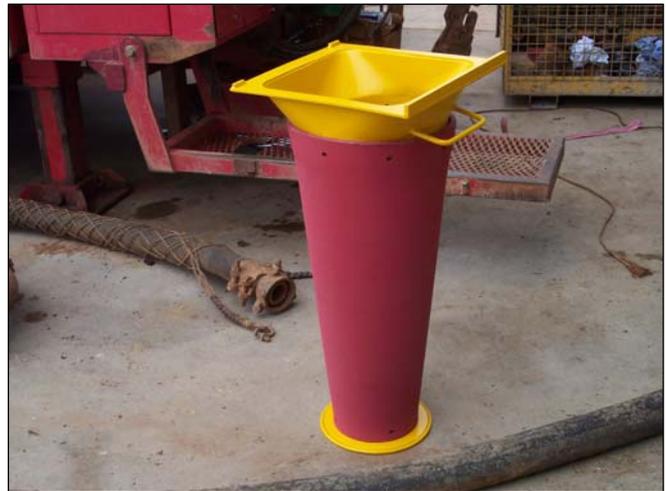
A new cone was fabricated that is much longer than the original cone, as shown in photograph 2.

Photograph 2: New cone, which is much longer than the original cone

In addition, two hydraulic interlocks were installed to prevent inadvertent operation of the draw.
