## Significant Incident Report No. 205

**Subject:** Worker injured by moving parts on automatic rotary sample collector

**Date:** 19 August 2014

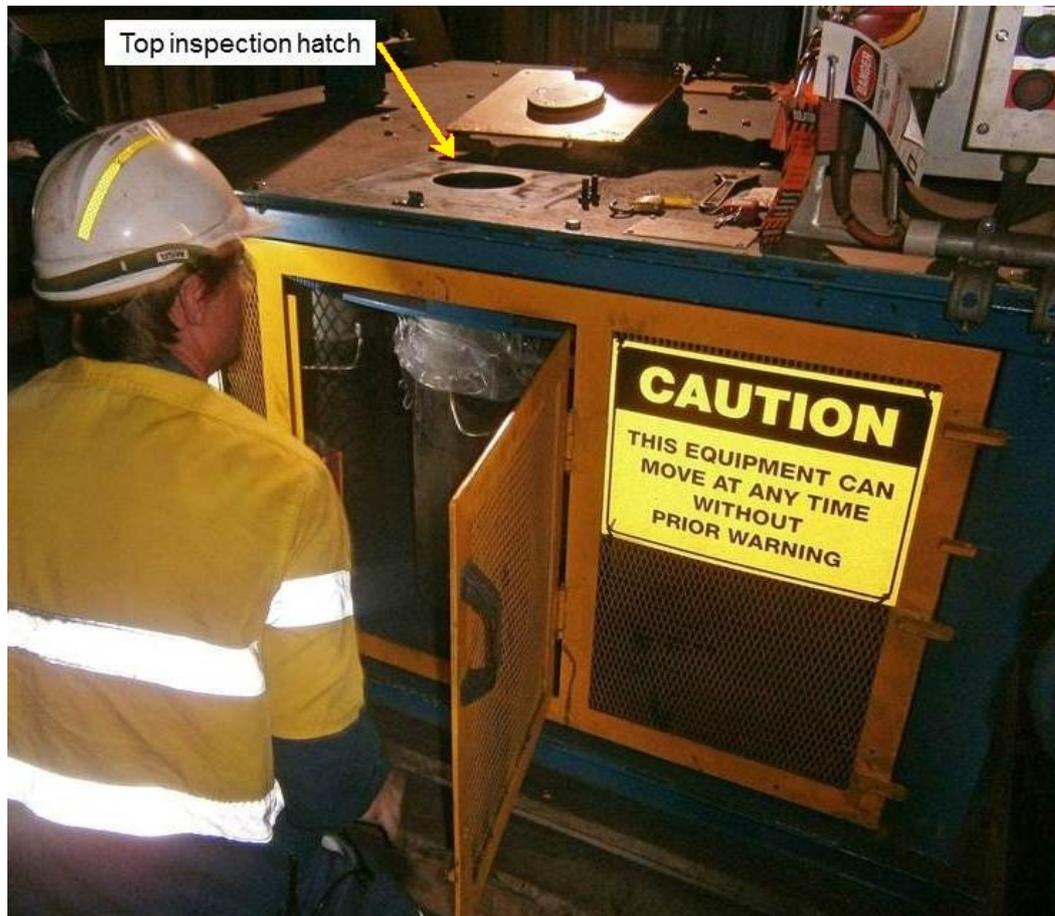
A worker operating a 12-canister automatic rotary sample collector in an outload facility identified that the bag inside one of the sample canisters was not in the correct position. The worker opened the top inspection hatch and put his left arm into the canister to adjust the bag. At this point the sampler automatically rotated one increment. The worker activated the emergency stop button using his right hand when he heard the sampler start. However, his left arm was trapped between the fixed frame of the sampler and the moving canister, and he received crush injuries.

Example of 12-canister automatic rotary sample collector showing the top inspection hatch

- Although there was an automatic isolating switch on the door to the canister recess, the top inspection hatch was not similarly protected. This inspection hatch (guard) was not locked as required in the manufacturer's instructions.
- The worker was new to this plant and was not under direct supervision at the time of the incident.
- The worker had not been assessed as competent before being assigned to operate the sampler.

- all reasonably foreseeable hazards associated with the plant are identified and, so far as is practicable, workers are not exposed to those hazards
- manufacturer's instructions for the safe use of plant are available and understood by those using them
- workers are adequately supervised to enable them to perform their work safely
- workers are assessed as competent before operating plant.
