Significant Incident Report No. 213

Subject: Maintenance worker pinned by bulldozer belly plate - fatal accident

Date: 11 February 2015

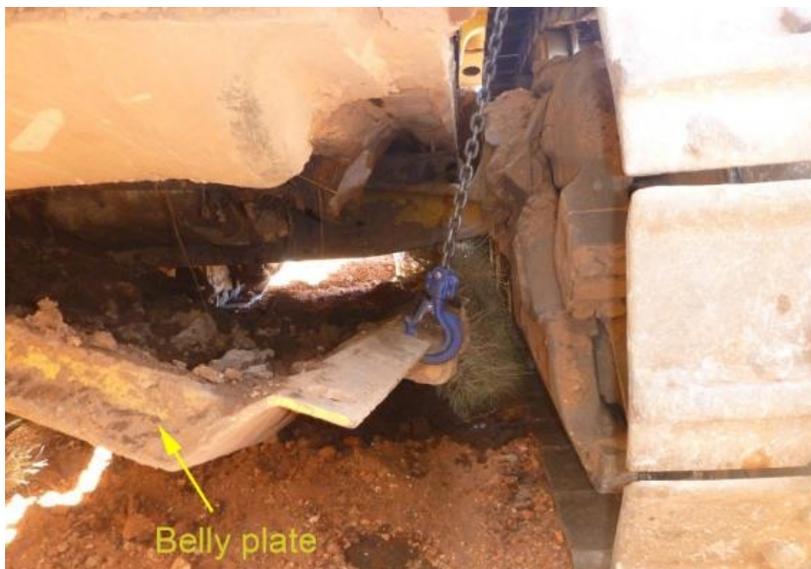
Before removal of the belly plate's fastening bolts, a "come-a-long" device (hand-operated ratchet lever hoist) had been attached to the flange on the right-hand (non-hinged) side of the plate. The worker then lay on the ground beneath the belly plate to access the fastening bolts on the left-hand side. When the fastening bolts were removed, that side of the belly plate fell and pinned the worker to the ground. The plate and accumulated material weighed more than 400 kilograms and the worker was fatally injured.

The underneath of the bulldozer showing the belly plate. Note: The come-a-long device has been moved from its position at the time of the accident.

- A stored energy hazard was left uncontrolled as no support was installed between the ground and the belly plate.
- The worker was beneath the belly plate when it fell.

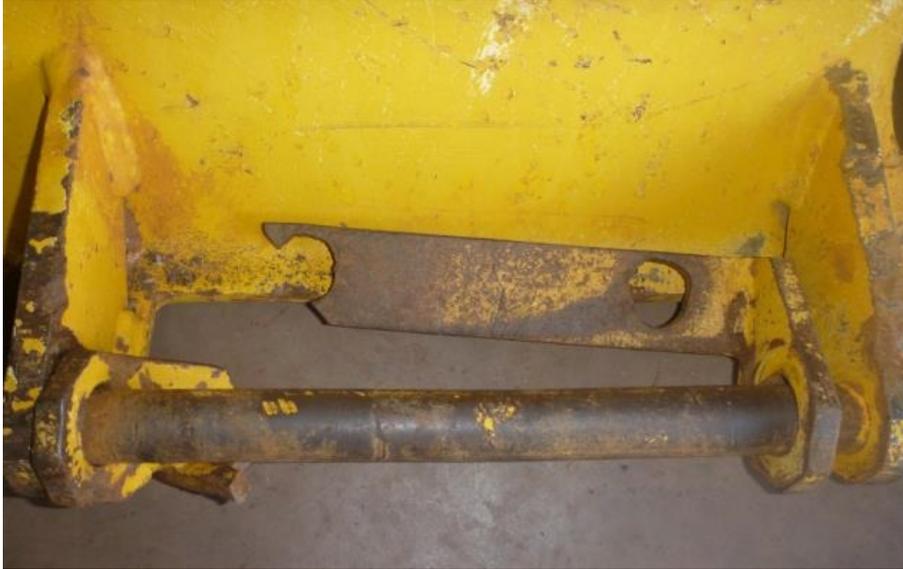
- The belly plate was not attached in accordance with the specifications of the original equipment manufacturer (OEM) — the hinge was not attached to the frame of the bulldozer and was later found to have pre-existing damage.

Damaged hinge on left-hand side of belly plate shown after cleaning.

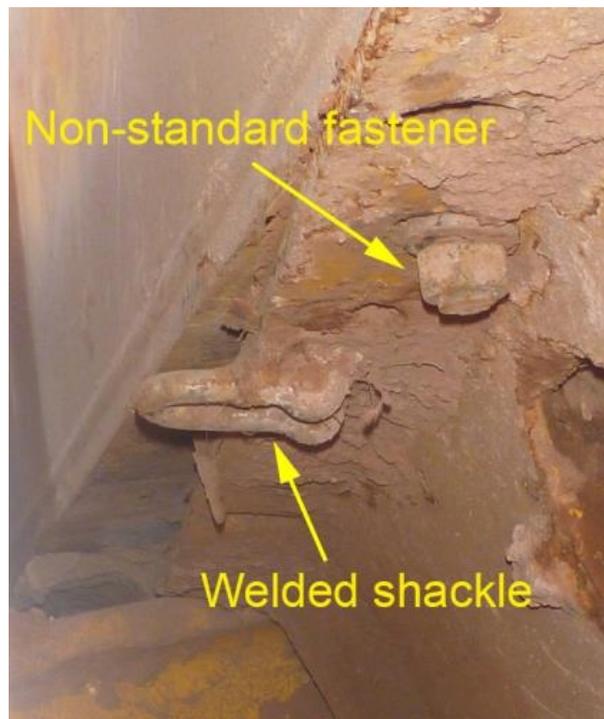
- The belly plate had non-OEM modifications, including a shackle welded to its flange and non-standard fasteners.

View from below showing non-OEM modifications to the right-hand side of the belly plate.
