Significant Incident Report No. 215

Subject: Overloaded stemming truck rolls over

Date: 11 May 2015

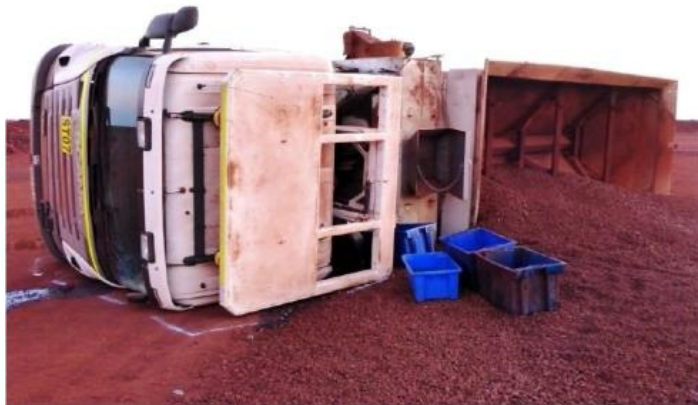
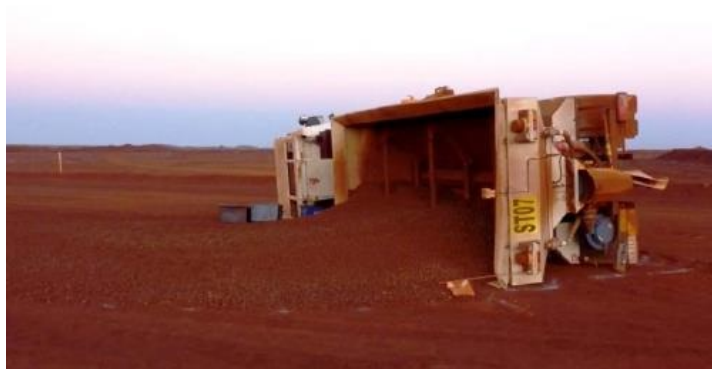
A loaded stemming truck was being driven at low speed through a right hand turn to enter a drill pattern. As the stemming truck turned, it rolled onto its left hand side, resulting in the load of stemming spilling out and also injuring the passenger. The emergency response team was mobilised to provide medical assistance and secure the scene.

At the time of the rollover, the loaded truck's mass was actually 4.5 tonnes overloaded despite being 2.1 tonnes less than the estimated GVM.

Front and rear views of rolled stemming truck

- The GVM estimated by the supplier was 6.66 tonnes greater than the design GVM calculated by engineering consultants after the incident.
- The stemming truck had been overloaded as the GVM provided was incorrect.

- Full operating manuals, drawings and engineering sign-off were not provided by the supplier of the modified stemming truck.
- The truck, which was hired, was not subjected to the same approvals process as purchased vehicles.

- Ensure equipment, whether hired or purchased, is supplied with the correct safe working loads.
- Ensure competent persons approve any modifications.
