## Significant Incident Report No. 228

**Subject:** Worker seriously injured when sprayed by anhydrous ammonia after failure of flexible rubber hose

**Date:** 09 October 2015

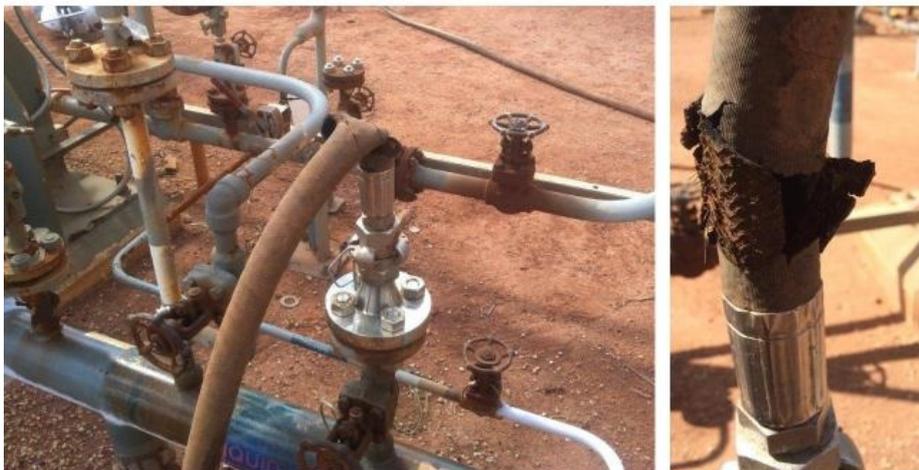
As part of a routine purging operation, the process worker connected a flexible rubber hose via a coupling to a purge connection point. The purge hose was charged with nitrogen and the valve was being opened slowly, allowing nitrogen to flow into the system, when the hose ruptured above the connection point.

Flexible rubber hose and assembly connected to anhydrous ammonia purge point. Close up (right) shows rupture in hose above connection point

- The purge hose failed as the valve was opened.
- The worker was next to the hose when it failed.

- It appears that the hose was not in a serviceable condition, with factors including:
  - lack of information about its recommended use, either visible on the hose or provided by the site

- repeated bending of the hose to less than its minimum design radius during routine use, damaging the steel braiding and inner rubber lining
  - loss of structural integrity can be difficult to identify from visual examination.

- When selecting flexible hoses, consider their specific application and whether they comply with the appropriate Australian standard. Take into account factors such as:

- pressure, temperature, type of fluid, gas or chemical being conveyed
  - any special hose requirements (e.g. abrasion-resistant, fire-resistant, anti-static, cryogenic service, minimum bend radius).

- Implement a management system that defines:
  - an appropriate inspection, testing and maintenance regime, based on a risk assessment, manufacturer specifications, supplier recommendations and applicable Australian standards and previous experience

- how each hose type will be inspected and tested (e.g. competent person using appropriate testing equipment), and marked or tagged accordingly
  - how each hose type will be stored, based on manufacturer recommendations.

- Implement a training program so that workers understand:
  - the risks associated with using flexible rubber hoses under pressure
  - how to do a pre-task inspection on a flexible hose to confirm that it is fit for purpose before being used

- the actions to take when a hose is found not to meet the requisite standards for the task.

*Note: Workers are not in a position to identify internal degradation of the hose, hence the need for periodic testing by a competent person.*

- Hoses deemed to be at the end of their life should be rendered unserviceable and discarded to prevent further use.

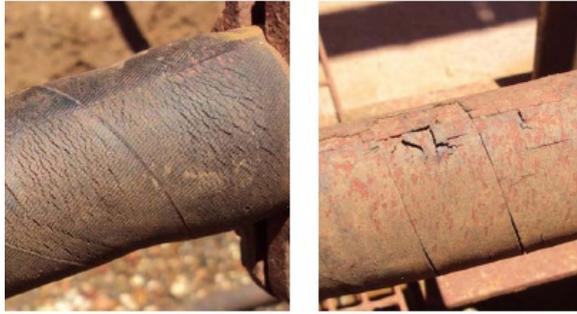
Flexible rubber hoses showing external damage. Only testing by a competent person will reveal whether the internal integrity of the hose has been compromised
