Incident Alert

Ammonium nitrate emulsion tanker trailer explosion

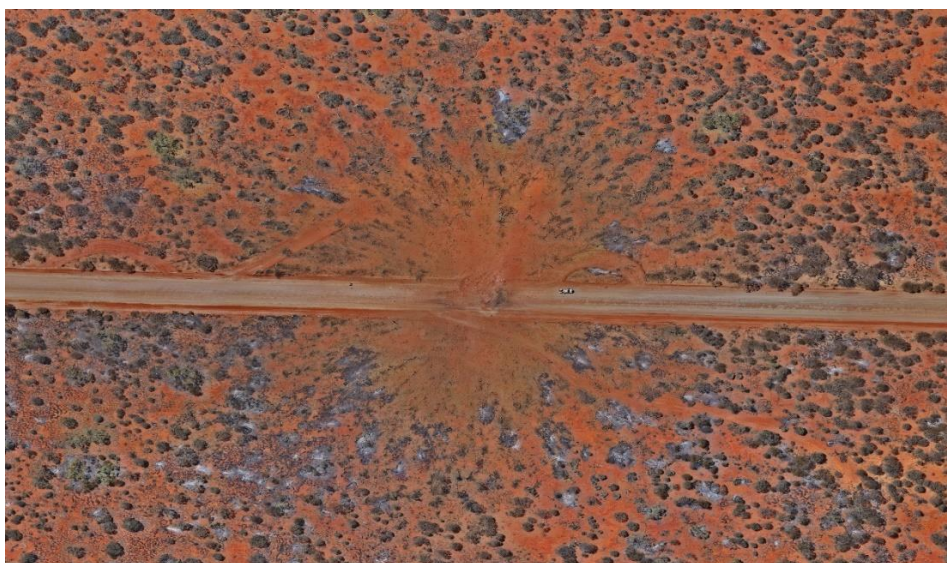
At 11:33 am, the tanker exploded. The explosion caused several spot fires around the site. No one was injured.

Drone image capturing aftermath of explosion. Photo courtesy of Gold Fields, Gruyere Joint Venture.

- The trailer was completely destroyed.
- A crater, approximately 15 metres by 17 metres wide and one metre deep was formed.
- Shrapnel was located around the blast location with an approximately 25 kilograms piece located approximately 800 metres from the epicentre.

- Shrubs and trees to approximately four metres high were snapped at ground level to a distance of approximately 40 metres and branches 75 millimetres thick were snapped to a distance of approximately 150 metres from the blast site.

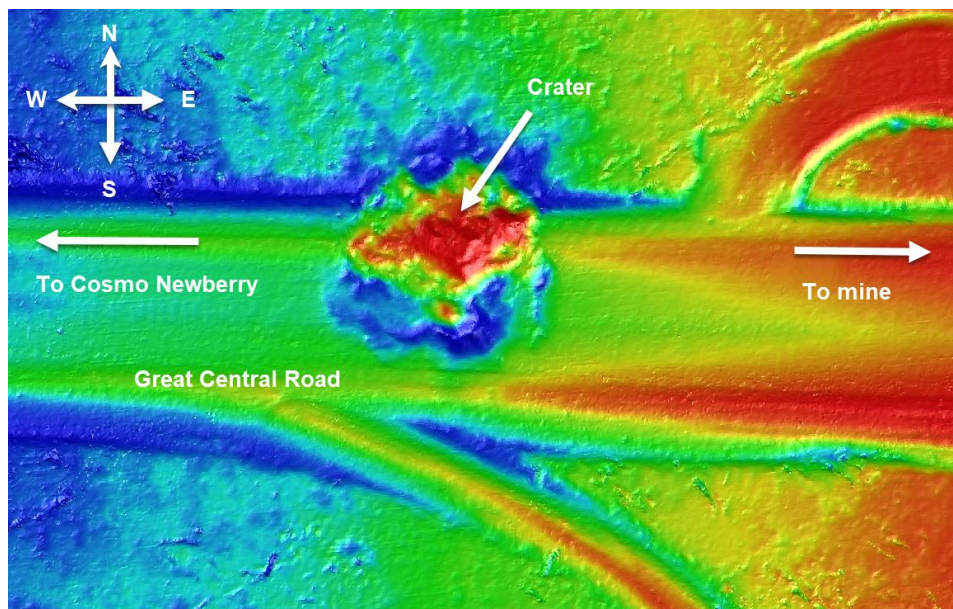
Survey image of crater. Photo courtesy of Gold Fields, Gruyere Joint Venture.

The department's Dangerous Goods Officers attended the incident location and have taken samples for further analysis. The department is attempting to identify the cause of the fire, the triggering event that caused the detonation and any other factor that contributed to the explosion. The department is also reviewing the handling of the incident prior to the explosion for any potential improvements.

All operators involved with the storage, handling and transport of all types of explosives are encouraged to review their procedures and practices to ensure that there is a clear understanding of the steps necessary to prevent fires and how to respond if a significant fire occurs.
