Mines Safety Bulletin No. 143

Subject: Use of an excavator bucket as a lifting point

Date: 12 May 2017

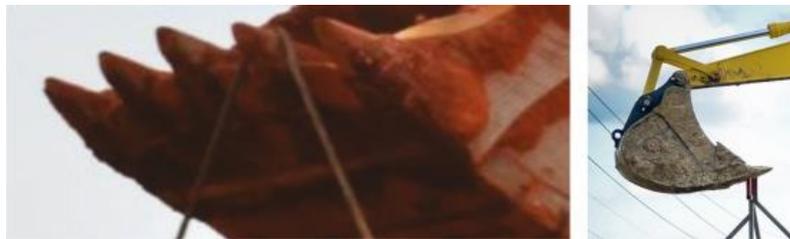
A bucket tooth loaded with a wire rope sling (left) and a soft sling (right).

- Use only designated lifting points on the bucket unless the GET assembly is assessed and rated as a lifting point by a competent person.

- Adequately and regularly inspect slings for damage in accordance with manufacturer's recommendations and relevant Australian standards.

Note: Consider use of protective sleeves on slings if a GET assembly is to be used as a lifting point.

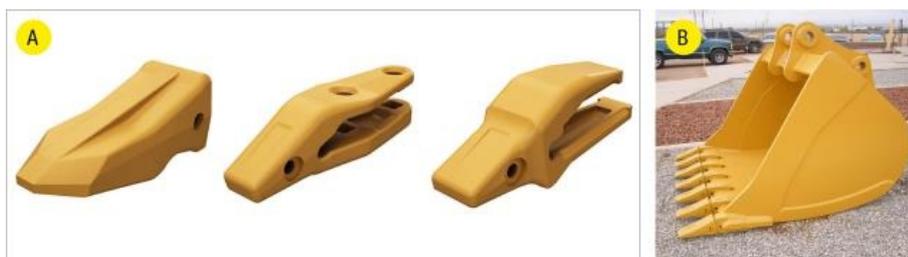
An excavator GET or bucket tooth is typically attached to the body of the excavator bucket with an adaptor piece. The adaptor piece is welded or pinned to the bucket body and the bucket tooth tip is commonly attached to the adaptor using connecting pin(s).

Bucket tooth tips and adaptors are typically made from hardened material for wear resistance. Depending on the fabrication technique (casting or forged), this material may be brittle and suddenly fail, especially if shock loading occurs (e.g. lifting).

A. Examples of a bucket tooth tip (left) and adaptor pieces. B. A fully assembled bucket.
