Mines Safety Bulletin No. 175

Subject: Integrity of equaliser cables on vehicle hoists

Date: 25 May 2020

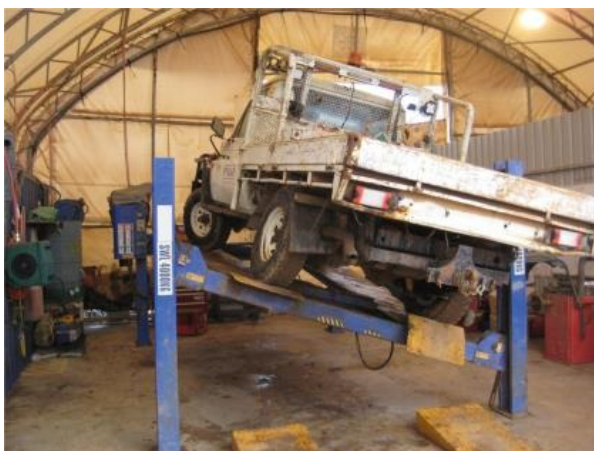
The Department has received numerous reports of failed and damaged equaliser cables on vehicle hoists, including those types with two or four posts.

The equaliser cables are typically made using steel wire rope and are used to keep the hoist level during raising and lowering. Over time, equaliser cables can stretch, fray, corrode, crack or break and therefore should be regarded as a wearing component.

(L) Example showing a four-post hoist with failed equaliser cable. (R) Example of a failed equaliser cable.

- Appoint competent person(s) to conduct vehicle hoist selection, inspection, maintenance and testing as per manufacturer recommendations and the requirements of AS/NZS 2550.9 *Cranes - Safe use; part 9: Vehicle hoists*.

- Ensure the entire length of the equaliser cable is inspected and maintained, including the ends, around sheaves and behind guards and guides. Where it is not possible to inspect the cable in situ, arrangements should be made to remove the cable at regular intervals based on the OEM's schedule for the conditions encountered on site.

- Ensure steel wire ropes used as equaliser cables are inspected and maintained in accordance with AS 2759 *Steel wire rope – Use, operation and maintenance* or BS 6570 – *Code of practice for the selection, care and maintenance of steel wire ropes* as appropriate.

- If the integrity of the cable is in doubt, either replace the cable or refrain from using the relevant hoist functions.
- Ensure equaliser cables installed on vehicle hoists comply with manufacturer recommendations. The cable manufacturer's certificate is to be recorded in the vehicle hoist equipment file.
