# Mines Safety

## Significant Incident Report No. 135

### Aluminium drill rod failure

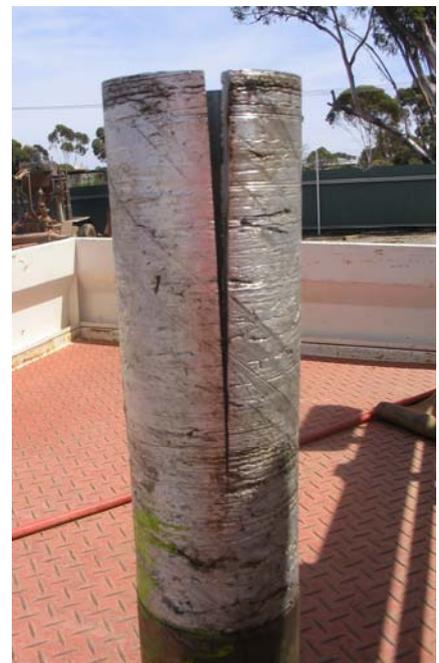
A reverse circulation (RC) drill rig was drilling at a depth of about 94 m when the head drill rod failed. The failure was a long split that rapidly formed from between the pin end tool joint, about 0.5 m from the end of the drill rod, to about 2 m from the same end of the drill rod.

Based on available evidence, the likely cause was a fault induced by the manufacturing process and associated with contamination of the raw aluminium billet material as it was extruded through dies to form raw aluminium pipe. A lubricant is required in the process and, in some instances, there can be contamination towards one end of the raw pipe. This can produce a flaw that may result in a seam, possibly not be visible to the naked eye.

Another risk factor is concerned with the method of joining the tool end joint to the aluminium drill rod. In this incident, the split failure appeared to begin at the end of the internal threaded section of the aluminium drill rod where the steel insert was screwed into it.

An appropriate hazard or risk assessment must be undertaken and completed by all parties concerned, including the manufacturer of the drill rods. Principal employers and employers must ensure that they are satisfied that manufacturers can demonstrate compliance with the relevant regulations, and that appropriate procedures and systems of instruction, training, competency assessment and supervision are established and maintained to ensure safe selection, use, inspection, maintenance and discard criteria for all drill rods, not only the aluminium rods that failed in this instance.
