Significant Incident Report No. 222

Subject: Worker seriously injured by falling jib attachment on integrated tool carrier (IT)

Date: 12 June 2015

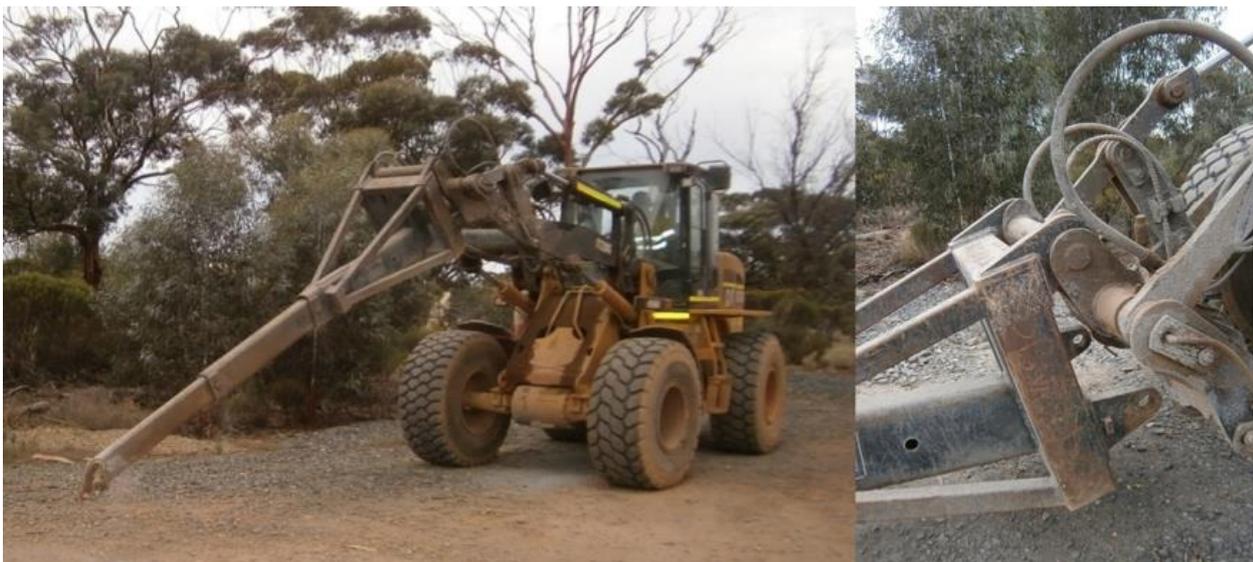
The offsider was beneath the jib when the jib attachment detached from the IT and fell. His injuries included fractured vertebrae, broken ribs and a punctured lung.

Left: IT with jib angled down. Right: Jib attachment with locking pins not engaged.

- The offsider was positioned beneath the raised jib.
- It appears that the IT was being operated while the jib attachment locking pins were not fully engaged.

- The design and configuration of the IT and jib attachment did not allow for visual confirmation of engagement of the locking pins. There was also no mechanical or electronic indicator fitted to confirm that the hydraulic pins were fully engaged.
- The IT with a jib attached was not fit-for-purpose.
- The operator had not been trained and assessed as competent to operate the IT with the jib attached.

- conducting risk assessments before performing any task
- using fit-for-purpose equipment for a task
- ensuring jib attachments (including quick hitch components) for IT carriers are periodically inspected and maintained by competent persons
- ensuring significant damage to jib attachments is assessed by a competent person and, when necessary, the jib is repaired, inspected and tested by competent persons or replaced
- ensuring workers are competent to safely operate the equipment and attachments
- ensuring the correct operation of attachments on ITs, including the positive engagement of locking pins, before the equipment is used
- ensuring areas that could be in the line-of-fire from suspended loads are clearly identified and workers do not enter such areas.
