Significant Incident Report No. 230

Subject: Dump truck roll-over - fatal accident

Date: 18 November 2015

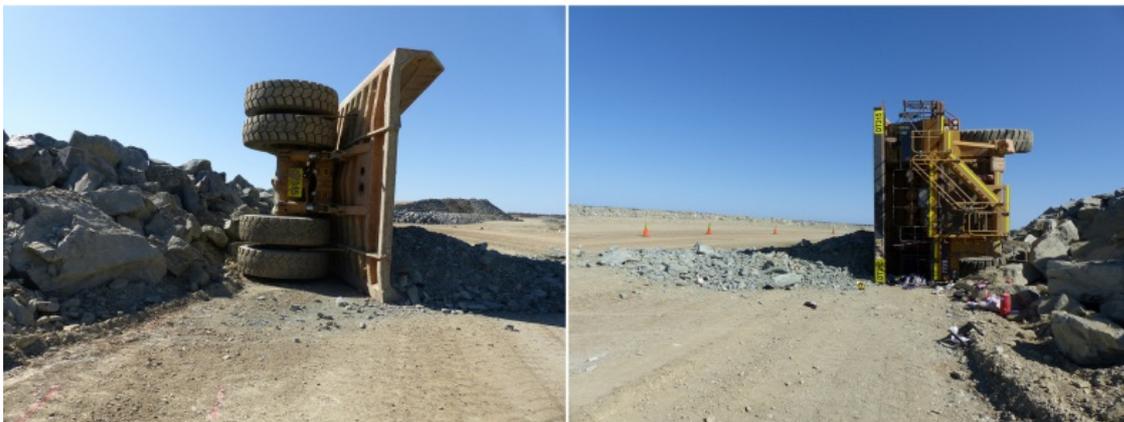
Tyre marks indicate that the truck's front and rear left tyres mounted the windrow, and the dump truck rolled onto its right side. There is no evidence of braking before or at the time the truck mounted the windrow.

Rear and front views of the dump truck

- The dump truck mounted the hard rock windrow, changing its centre of gravity and causing it to roll over.

- each vehicle used at the mine to be fitted with seat belts and seat belt anchorage points that conform with the Australian Design Rules
- if any seat position is added to a vehicle used at the mine, the seat to be fitted with a seat belt and seat belt anchorage point that conforms with the Australian Design Rules
- if a seat is a suspension seat, the seat belt anchorage to be attached to the seat assembly and the seat belt fitted with the appropriate retractor.

Regulation 4.16(3) requires people driving or travelling in a vehicle where a seat belt is fitted for that seat position to properly adjust and securely fasten that belt.

Workers should be instructed, through training and inductions, regarding the importance of using the seatbelts provided in vehicles to reduce the impact of potential collisions.
