## Significant Incident Report No. 284

**Subject:** Service mechanic sustained serious hand injuries when struck by radiator fan blades on a generator.

**Date:** 22 February 2021

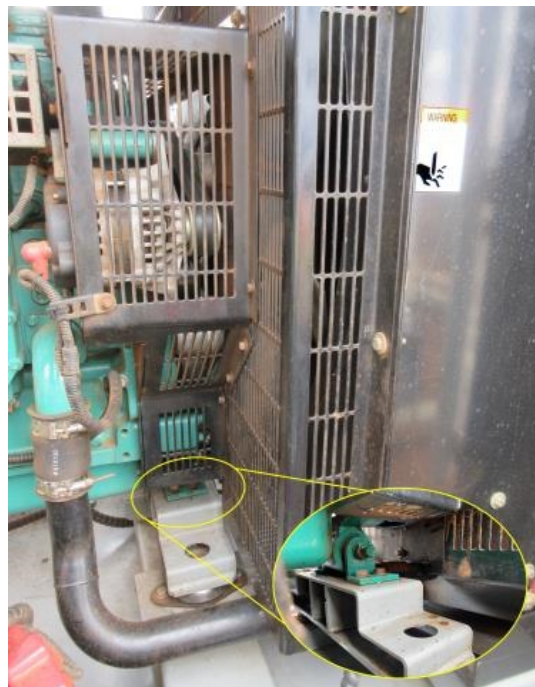
When the service mechanic leaned into the generator enclosure with a rag in his hand, it appears the rag and his hand were drawn into the rotating radiator fan blades causing serious injuries to his thumb, index and middle fingers.

Main photo and inset showing gap in the underside of the guarding as possible access point.

The service mechanic's hand contacted the rotating radiator fan blades while working near the underside of the fan guarding with the machine running.

- The service mechanic was cleaning up inside the generator enclosure with the engine running.
- There was a gap in the underside of the guarding around the radiator fan.
- It is possible for a loose rag to be drawn into the fan blades thereby pulling a hand in through the gap in the guarding to contact the moving blades.
- Risk assessments conducted by duty holders had not identified the risk of entanglement posed by the gap in the fan guarding.
- The work procedure for servicing and inspecting the generator was not clear in terms of job sequence and isolation requirements.
- Monitoring processes were not undertaken to confirm that standards/safe work procedures were followed (e.g. audit, task observations, site inspections).

- Duty holders must ensure that guarding and other access controls prevent inadvertent contact to moving machine parts. Inadvertent contact can mean unintended contact in the course of performing work activities, and is not only due to a slip or trip event.

- Implement and enforce suitable isolation procedures for maintenance, servicing and cleaning of generators. The procedures must include de-energising plant and the lock, tag and try/test method.
