## Significant Incident Report No. 244

**Subject:** Failed gantry bridge crushes boilermaker working in thickener tank – fatal accident

**Date:** 03 August 2016

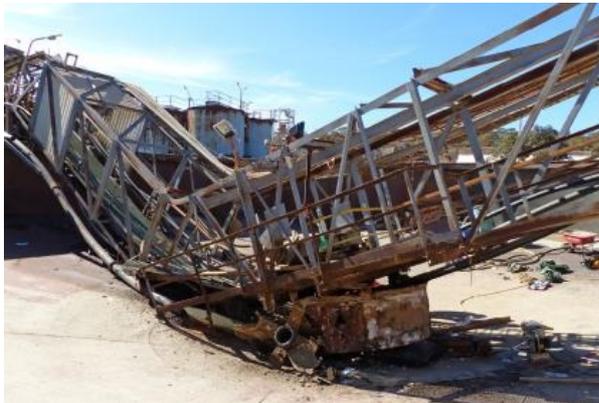
Left. Gantry bridge that failed and collapsed onto the thickener floor. Right. Corroded structural steel angle.

- The gantry bridge had deteriorated substantially due to corrosion and was no longer self-supporting.
- The rake shaft, which was now providing primary support, failed while being cut.

- Using a risk-based approach to determine the timing of inspections and monitoring, a competent person should periodically assess all plant and structures on site to confirm structural integrity or advise of remedial measures.

- A competent person, with an understanding of job weights and load paths at all stages of the work, plans any job involving the cutting or removal of structural components.
- Maintain the structure, and its components, in a safe and stable condition at all work stages.
- Use temporary bracing, guy ropes, shoring or combinations of these for stability where necessary.
