Department of Mines, Industry Regulation and Safety

Wheal Ellen Mine Shafts and Open Pits Geotechnical Assessment and Remediation Methodology (DMIRS750620) Geotechnical Report

September 2020

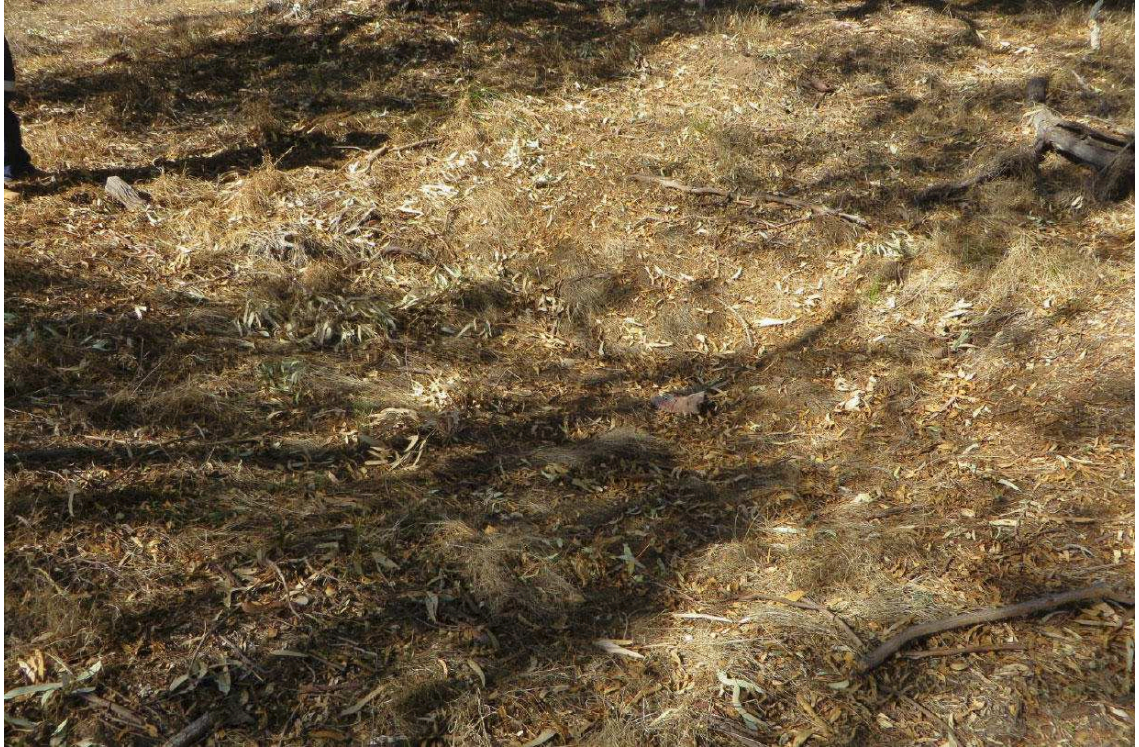
Image 9 Old Workings Pass: 2020 photo (DMIRS)

Both appear to have been backfilled and that fill subsided to form depressions. The Old Working Pass depression is shallow, not steep sided and well vegetated with grass. In comparison, the Old Workings Shaft has steeper un-vegetated sides indicating erosion and subsidence processes are continuing. Given the location of the shaft, surface water flows during heavy rainfall events are likely to be the primary trigger for instability.

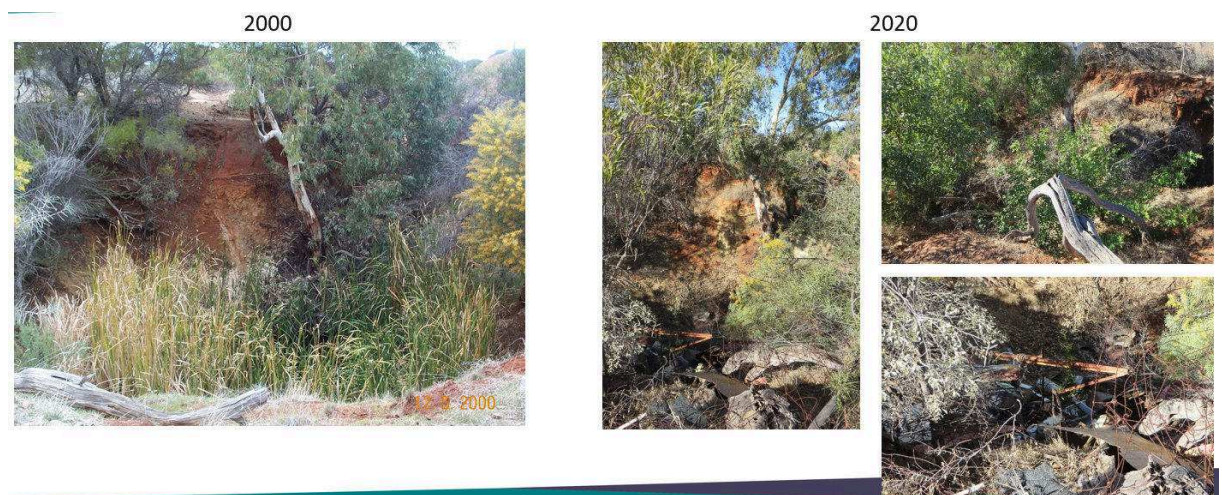
Image 17 S0113097: 2000 and 2020 comparison photos (DMIRS)

As shown in Image 14, feature S0113149 is thought to be associated with a pass which extended to the No. 1 level at 38 m. Feature S0113097 is thought to be associated with another pass immediately to the southwest.

The base of S0113149 is about 2.1 m higher than the water in the base of S0113097 which is obscuring its base. The slopes of the pit suggest it has been open cut but it is distinct from the pit associated with an unnamed pass to the immediate southwest.

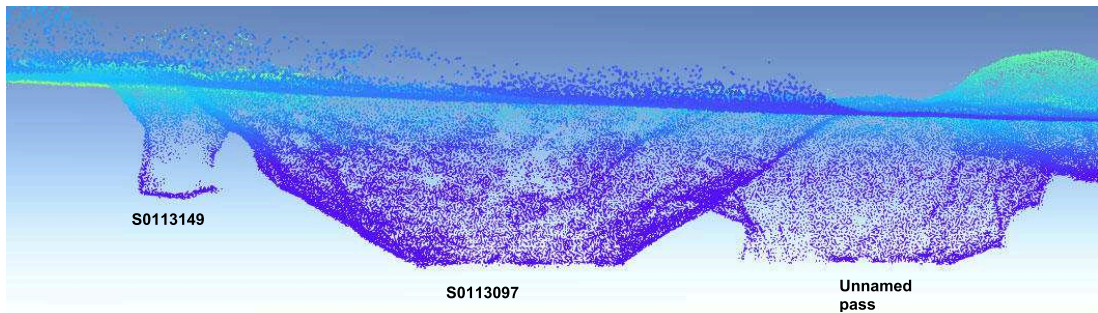
Image 18 S0113149 and S0113097: Point cloud elevation view

Although now part of the same pit, it is clear in the below point cloud image that feature S0113149 is separate and more likely a backfilled pass which has subsided.

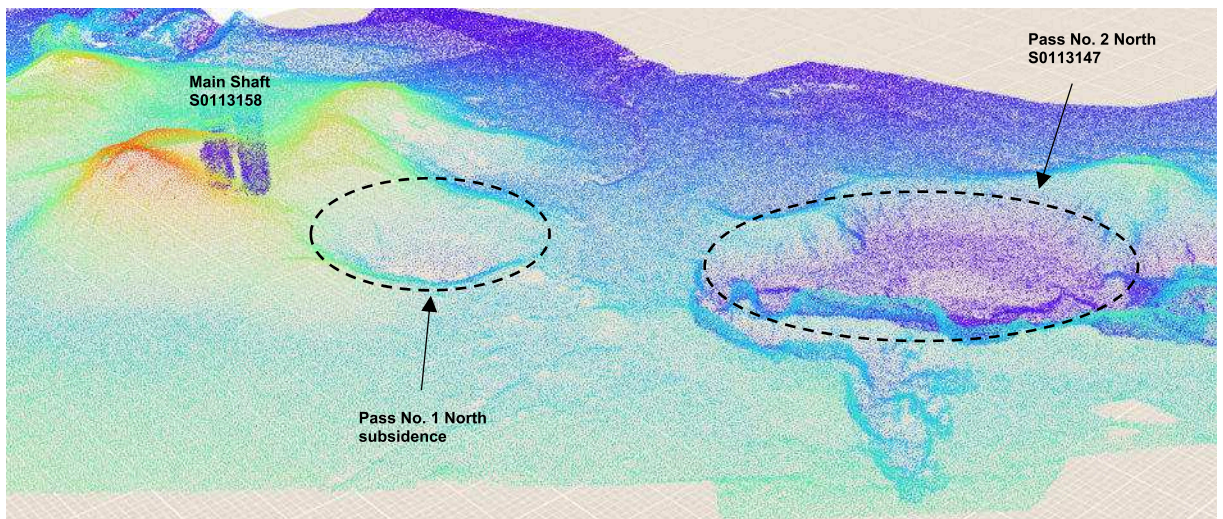
Image 19 S0113147 and Pass No. 1 North: Point cloud elevation view

Pass No. 2 North is the southwestern extension of the “barbell” shaped open cut. It extended to “old workings” at about 29 m depth with stoping below this as is the case of the adjacent workings. It is currently about 3 m deep, shallower than the adjacent pits to the northeast. This is because it has been filled with fines (soil). The original depth is expected to have been similar to the adjacent pit at about 6.7 m.

The interpreted relationship between Pass No. 1 North, Pass No. 2 North and the Main Shaft (S0113158) is shown in the below point cloud image.

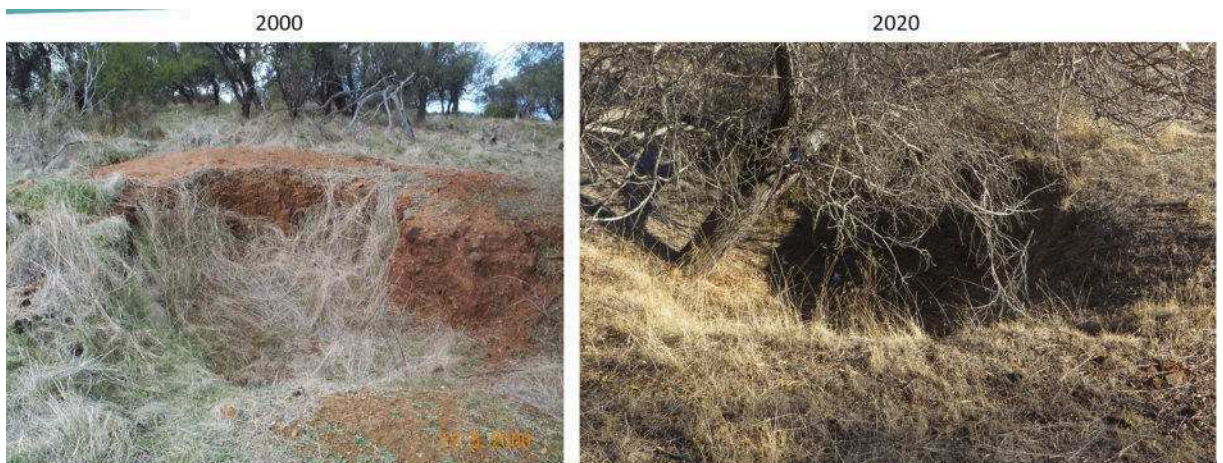
Image 25 S0113127: 2000 and 2020 comparison photos (DMIRS)

These features form part of a chain of bowl shaped depressions not exceeding 1.9 m depth. Neither feature contained ponded water although they are both expected to collect surface water runoff from the slope to the southeast during periods of rainfall.

Comparison of the below 2000 and 2020 images show little change in the past 20 years other than vegetation.

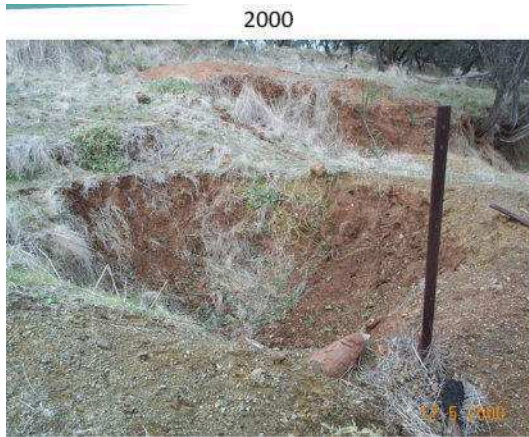
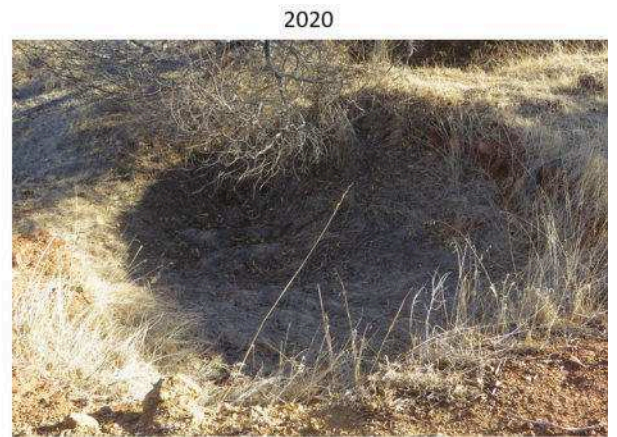
Image 26 S0113128: 2000 and 2020 comparison photos (DMIRS)

These features are not associated with any known shafts or passes and probably represent subsidence resulting from movement of soil into stopes below under the action of water flows.

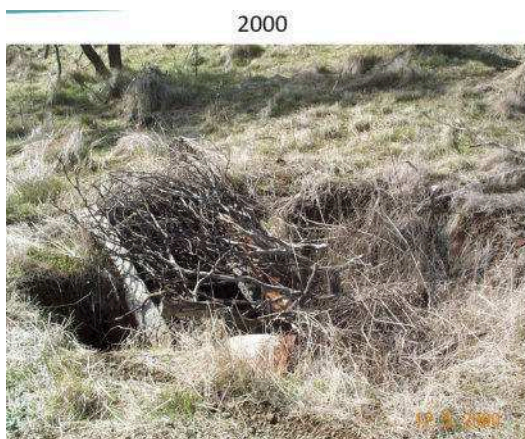
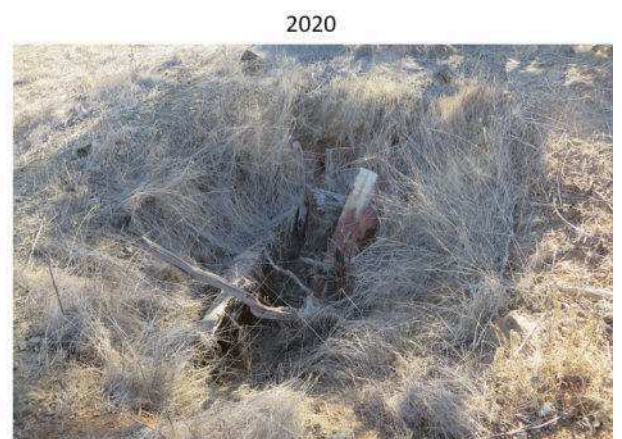
Image 27 S0113114: 2000 and 2020 comparison photos (DMIRS)

The feature did not contain ponded water although it is expected to collect surface water runoff from the slope to the southeast during periods of rainfall.

Comparison of the below 2000 and 2020 images show some removal of sticks, changes to vegetation and also a flattening of the pit sides since 2000. This is attributed to erosion from surface water during periods of heavy rain.

The origin of this feature is difficult to ascertain. Possibilities are a shaft or subsidence resulting from movement of soil into a stope below under the action of water flows.

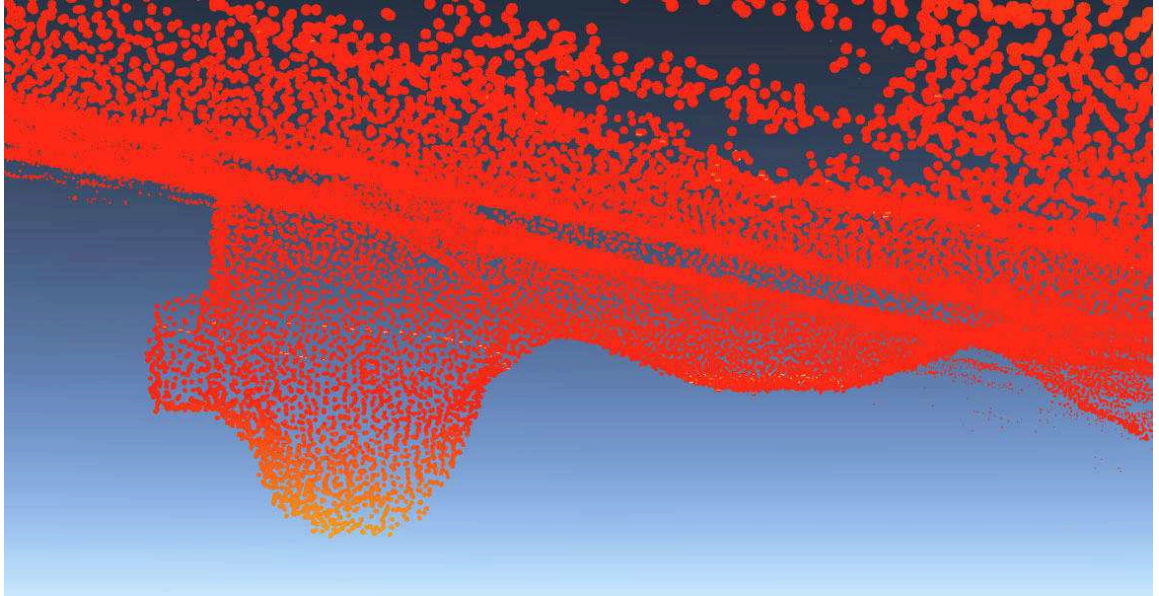
Image 28 S0113122 point cloud

The feature is about 3.6 m deep and did not contain ponded water although it is likely to collect surface water runoff from the adjacent slope during heavy rain.

The shape of the feature is similar to Pass No. 5 North with the western face noticeably steeper and the base sloping down to the northwest in the same direction as the lode dip. However, S0113122 is elongated along the lode sub-crop with a secondary and shallower depression on the southern end and a narrow undercut section on the northern end. This undercut section is visible in the 2000 photo as well as the below point cloud image.

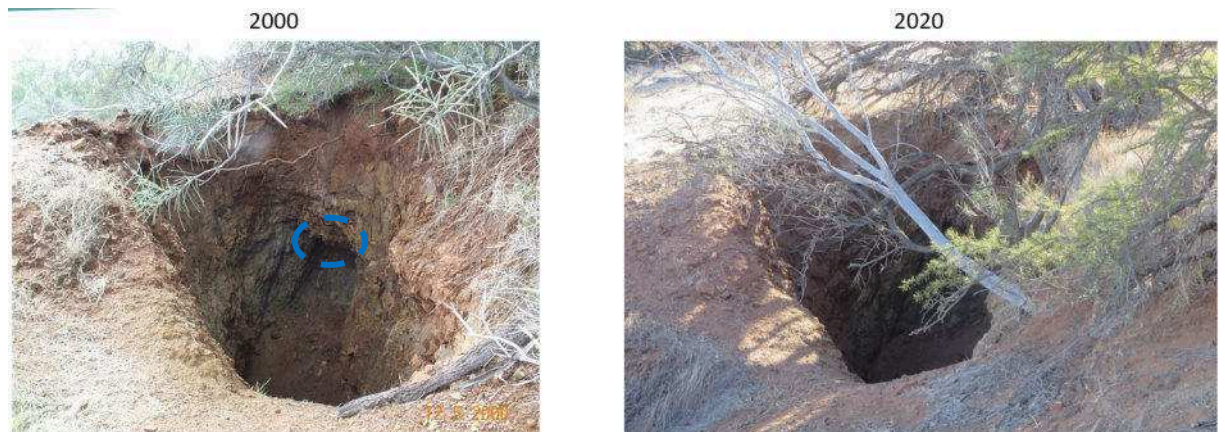
Image 29 S0113122: 2000 and 2020 comparison photos (DMIRS)

Comparison of 2000 and 2020 photos below show little change in the past 20 years. Some collapse of the undercut section has occurred with the loss of a group of swallow nests that are visible in the 2000 photo but not the 2020 photo.

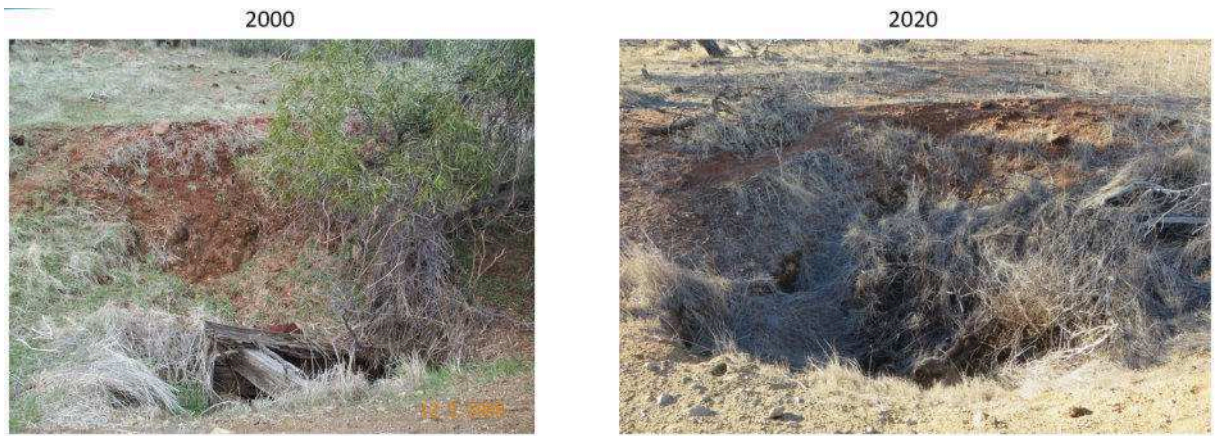
Image 31 S0113111: 2000 and 2020 comparison photos (DMIRS)

The feature is about 3.6 m deep and roughly circular in plan. It did not contain ponded water although it is expected to collect surface water runoff from the slope to the southeast during periods of rainfall.

Comparison of the below 2000 and 2020 images show removal of some timber, changes to vegetation and possible erosion of material from the base of the feature since 2000, deepening it although this may be from removal of the timber.

The likely origin is a subsidence feature resulting from movement of soil into a slope under the action of water flows.

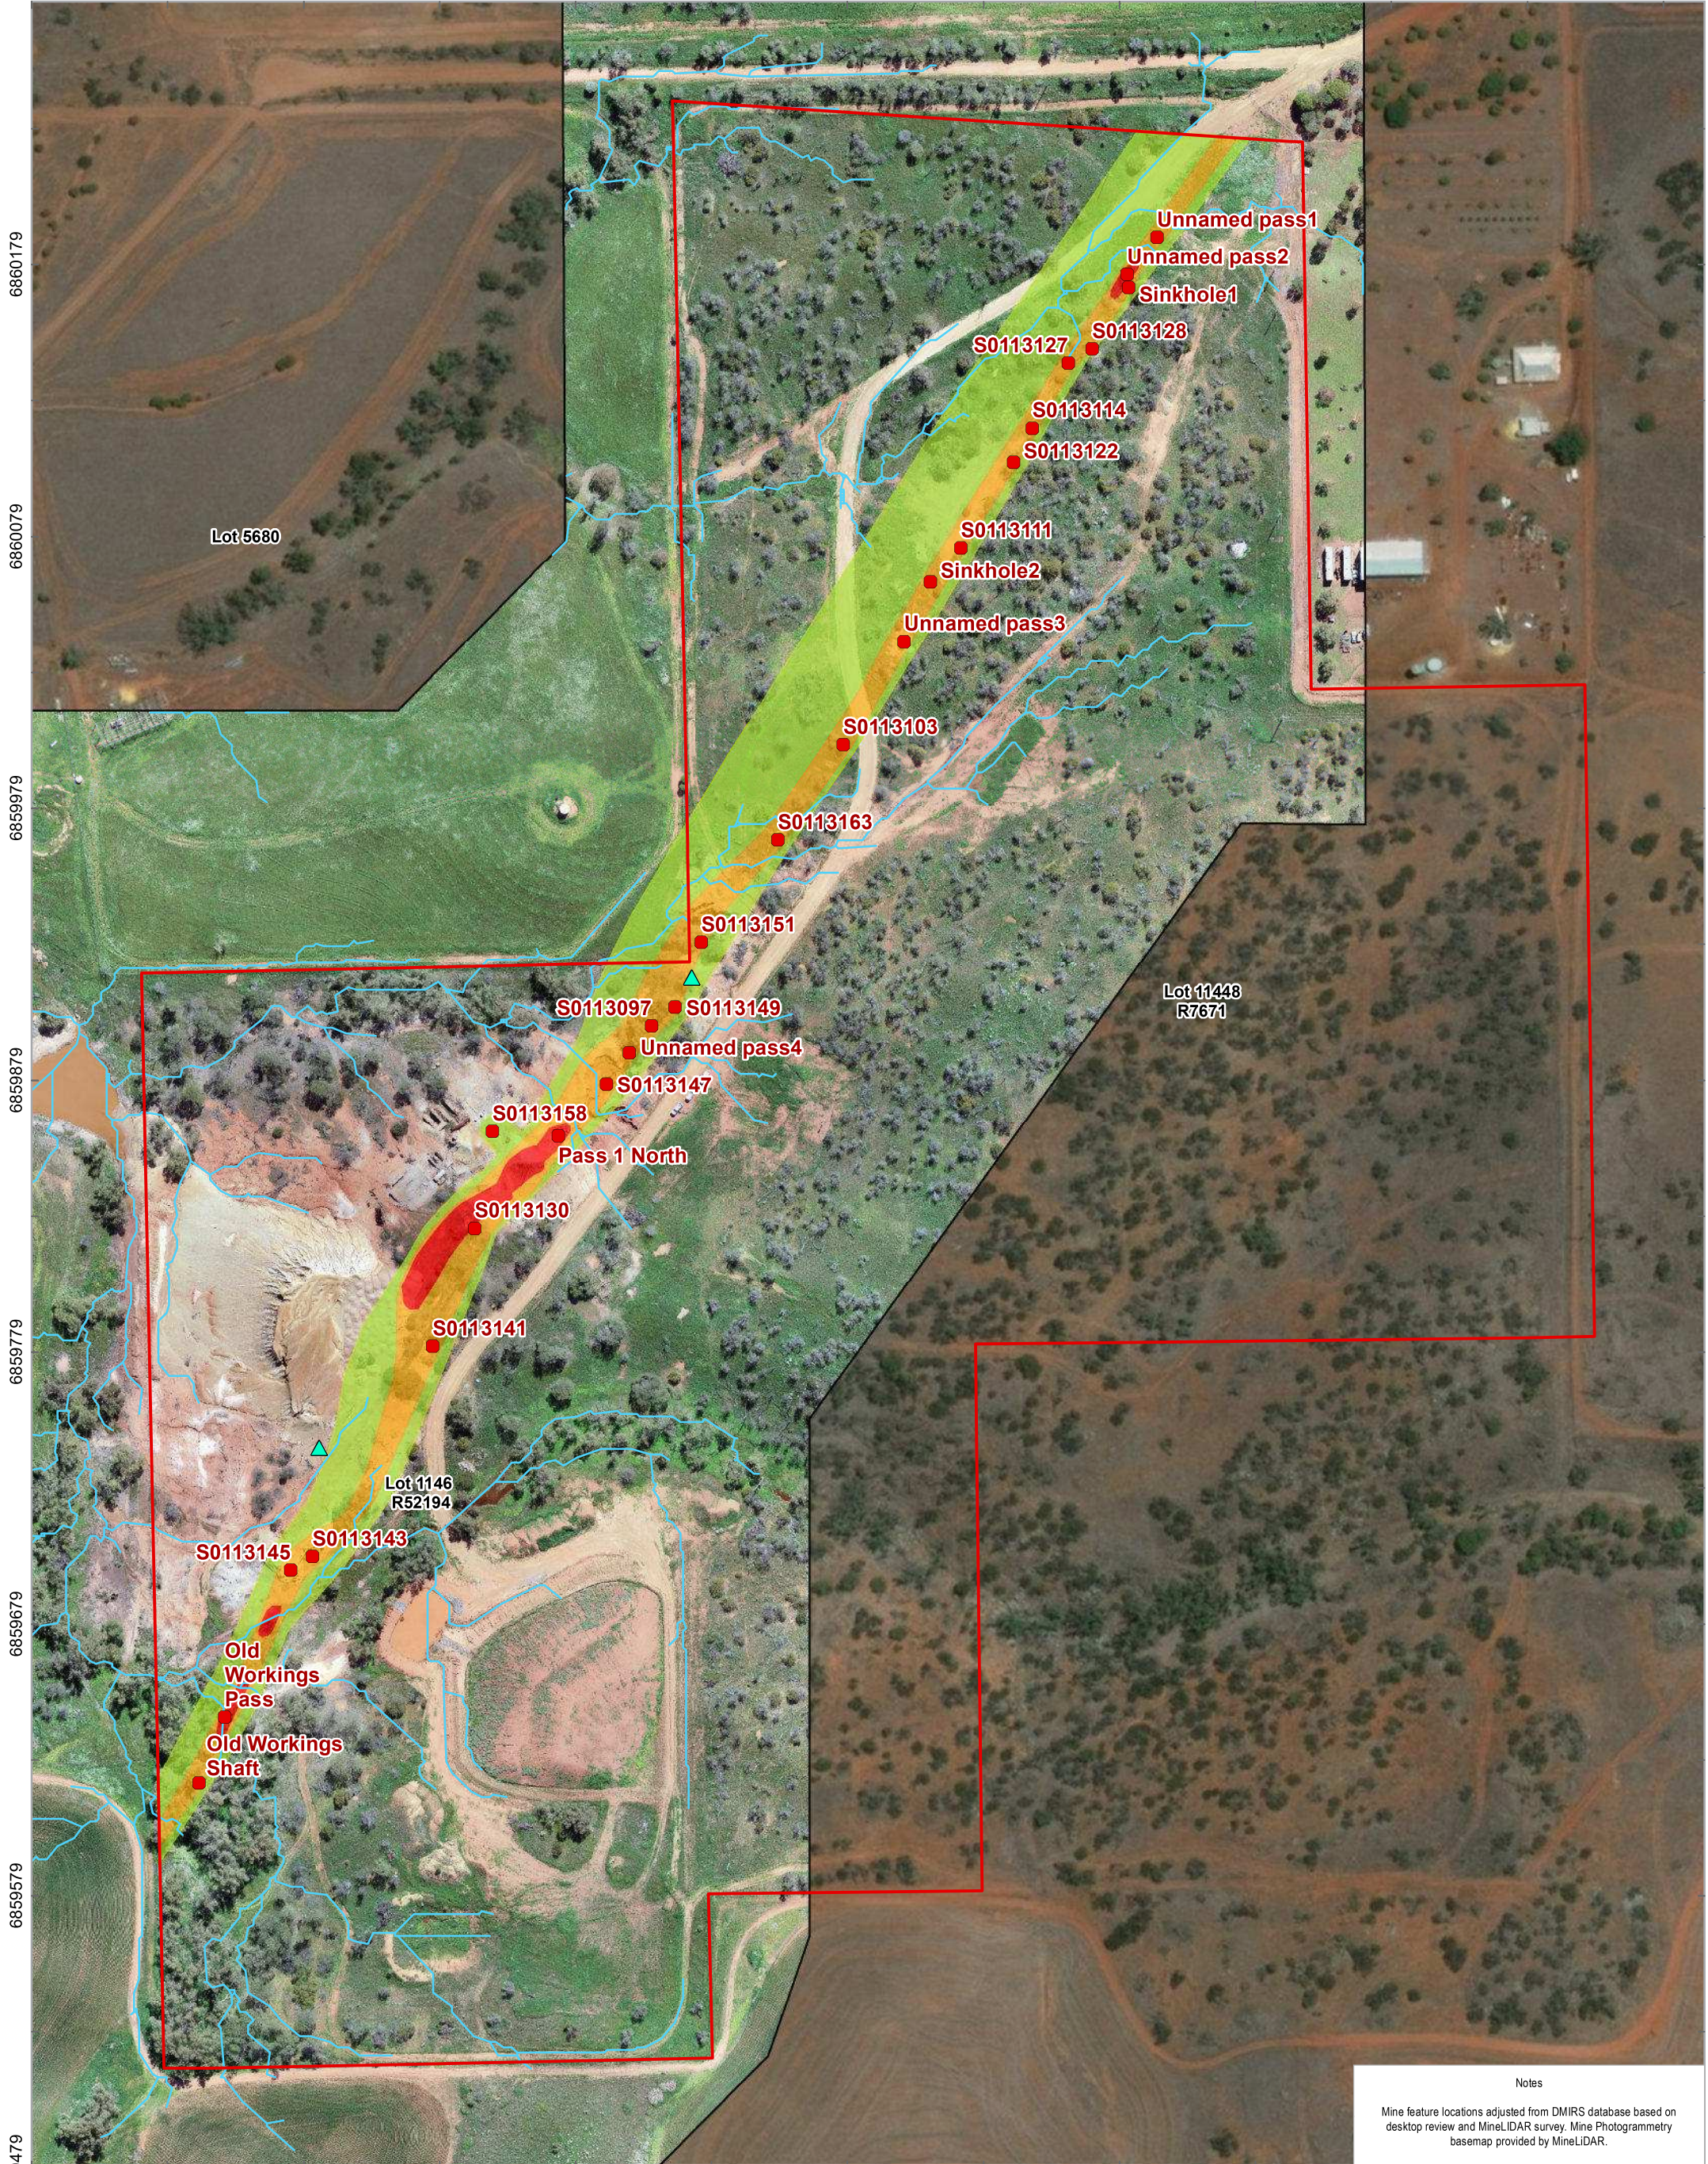
FIGURE 6

Potential Asbestos Containing Material (ACM) in the form of cemented sheeting was observed at two locations shown in Figure 6. The suspected ACM will need to be taken into consideration during remediation to manage risk to human health.

Zones of Low, Moderate and High sinkhole hazards are shown on Figure 6 in Appendix B.

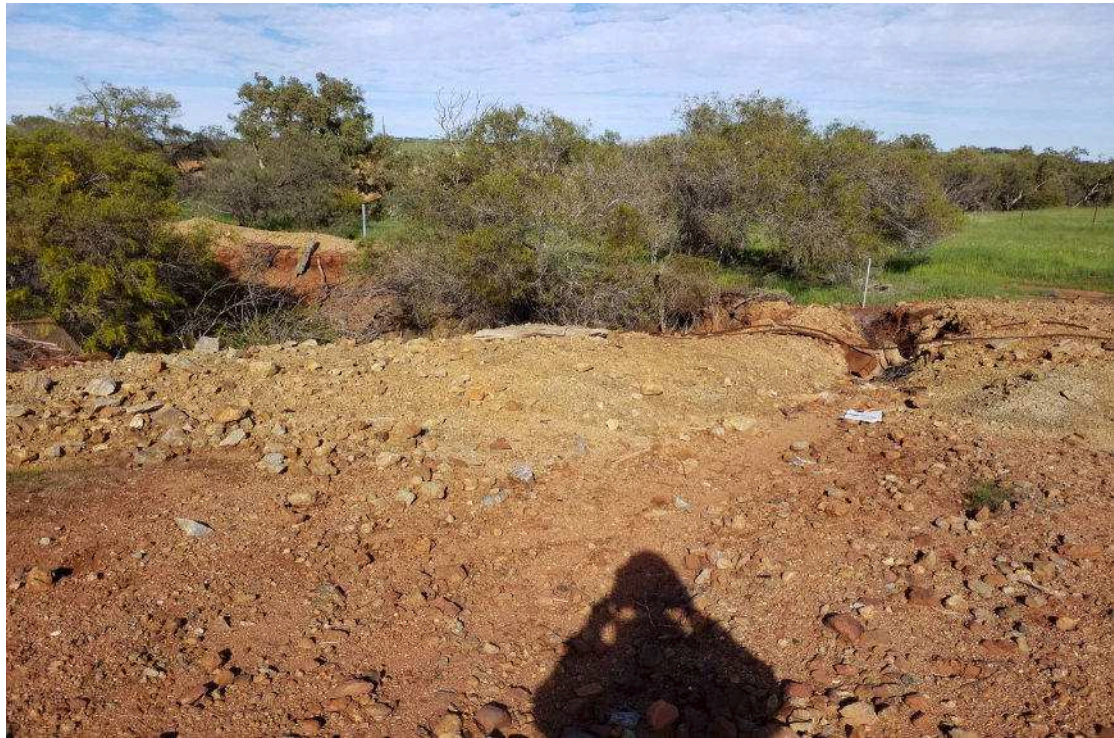
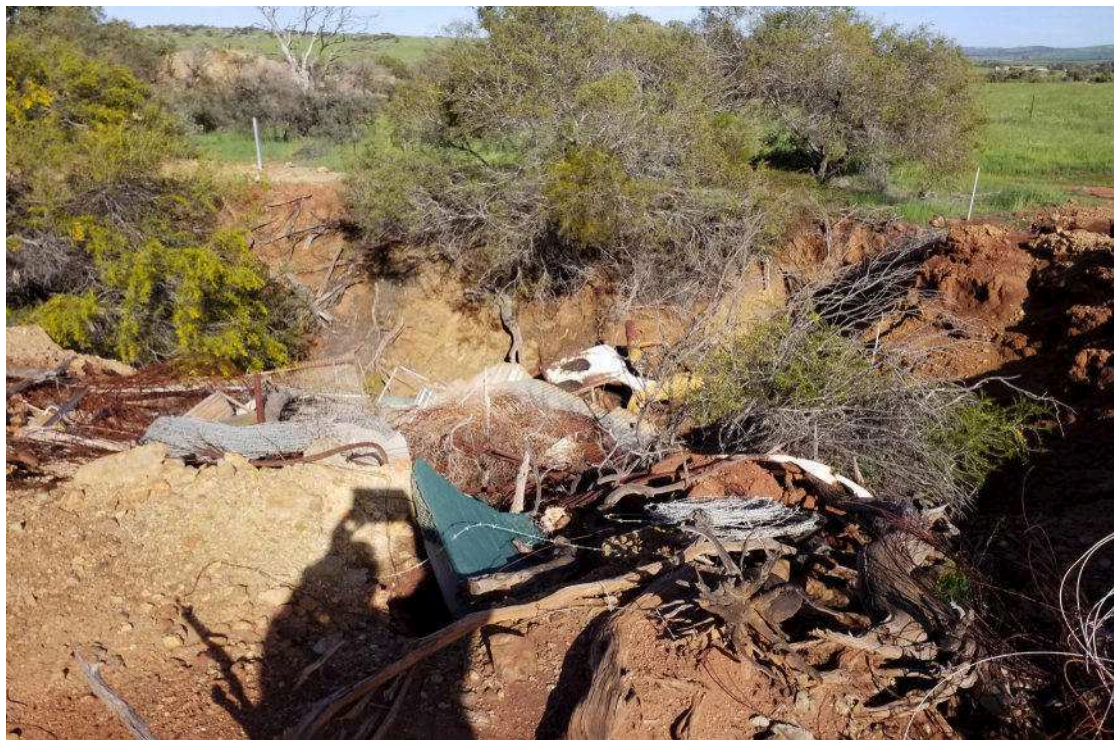
Plate 8: S0113151

Pass No. 3 North is only shown in one section (Ref. 10836) and is separate from the deeper unnamed pass at S0113151 as shown in Image 5. While Pass No. 3 North is shown to extend to about 24 m depth, the unnamed pass is shown to extend to the No. 1 level at 38 m depth and to have a surface open cut and stope above the No. 1 level.
