DEPARTMENT OF  
MINERALS AND ENERGY  
WESTERN AUSTRALIA

# MINESAFE

MINING OPERATIONS DIVISION

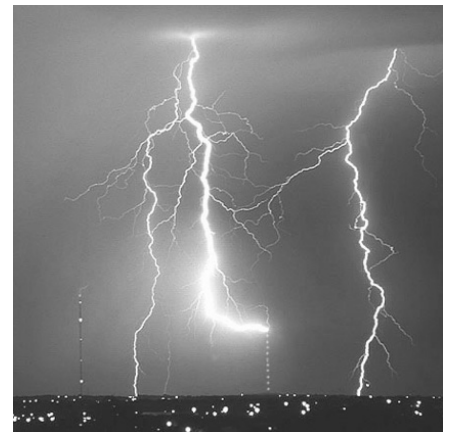
*Lightning strike! This time a communications tower, next time a drill mast?*

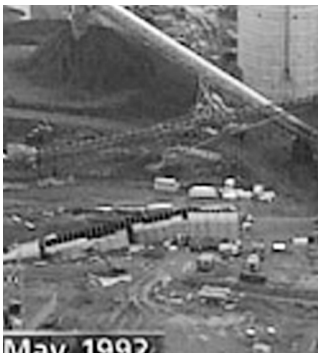
Mine surface infrastructure

The immediate cause of the disaster was a methane/coal dust explosion. The transport machinery of a mine, in particular the belt conveyors, create accumulations of fine coal dust in the 'roadways'. If this material mixes with air an explosive mixture is formed. For well over 120 years it has been part of coal mining knowledge that a localised methane explosion can 'lift' the coal dust into the mine atmosphere, which if ignited explodes with extreme violence. If dust accumulations are kept low and ground stone dust is provided to 'dilute' the coal dust, the hazard can be controlled. To use a common expression; "this is not rocket science", nonetheless a methane/coal dust explosion killed 26 people at Westray on May 9, 1992. It is also worldwide coal mining practice to drain as much
