INCIDENT INVESTIGATION REPORT

# Fuel tanker fire at Maddington 15 May 2009

Government of Western Australia  
Department of Mines and Petroleum  
Resources Safety

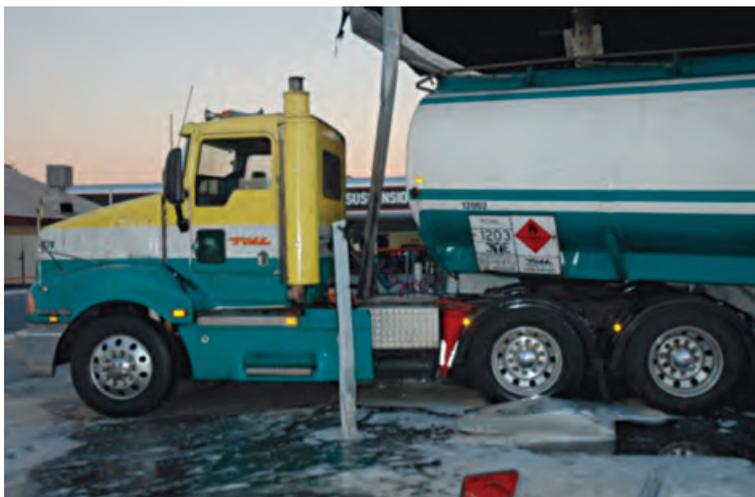
**Figure 8** Prime mover after the fire [photograph courtesy of FESA]

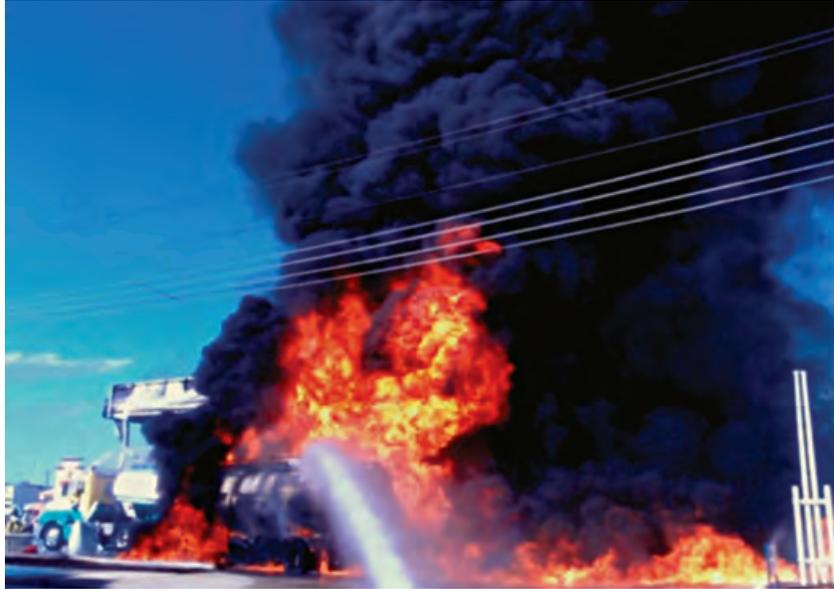
- Flames were observed at the emergency vent of compartment 4, which is on top of the compartment. The tanker is designed to respond to a fire in this way, which reduces the risk of tank failure.
- The rupture of tanker compartment 6 resulted in a fireball that travelled about 20 m laterally towards the service station shop and reached a height of about 60 m.
- The fire caused extensive damage to the fuel dispensers, service station canopy and shop building.
- The contents of the 9 kg LP Gas exchange cylinders inside a cylinder cage caught fire. The tanker was about 15 m from the cage.
- Most of the tanker's aluminium discharge pipes were damaged or melted in the fire.
- Four of the tanker's six outlet valves were on the ground.

**Figure 14** Tanker on fire [photograph courtesy of FESA]

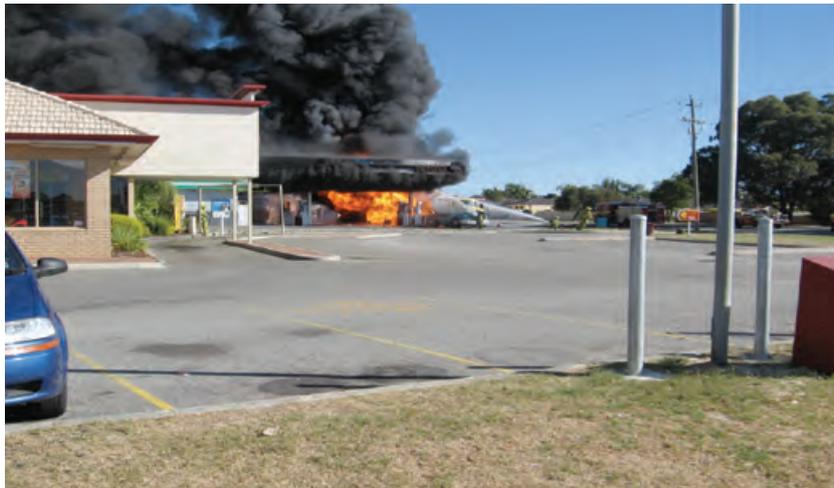
**Figure 15** Spread of fire from the tanker to service station canopy and building [photograph courtesy of Department of Environment and Conservation]

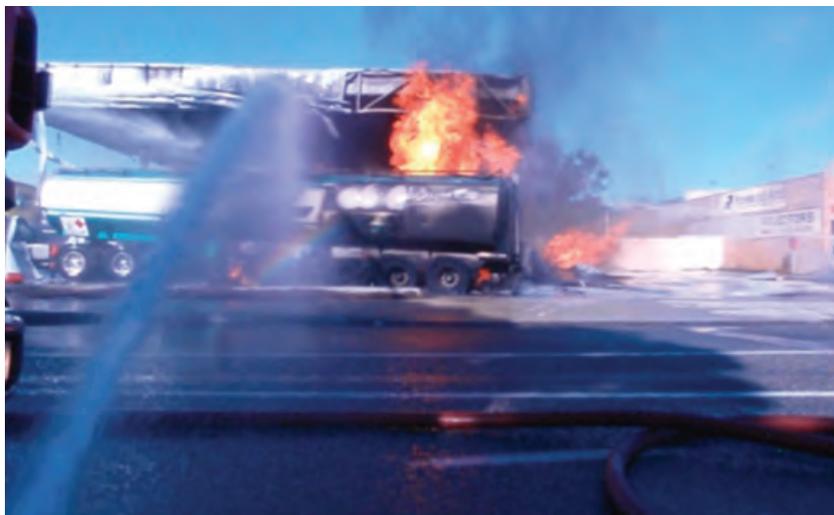
**Figure 16** Fire on top of compartments 5 and 6, and burning LP Gas cylinders in cage in the background [photograph courtesy of FESA]

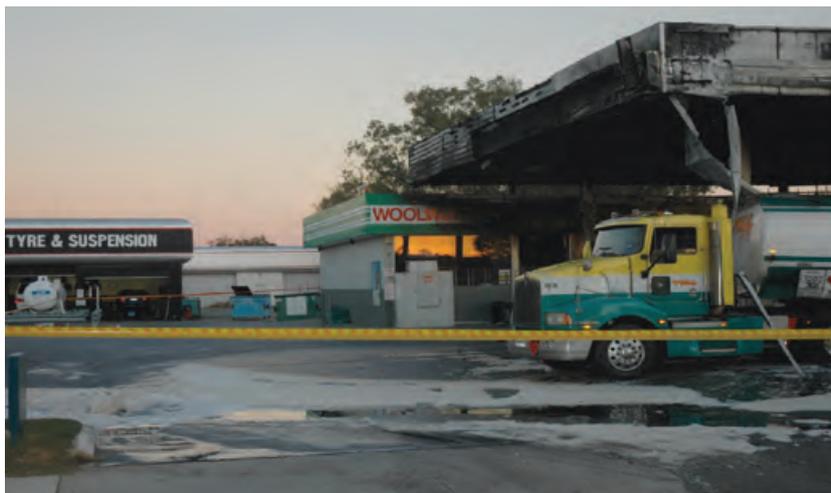
**Figure 18** Tanker vehicle after the fire was extinguished. The aboveground bulk LP Gas tank is visible on the left of the photograph [photograph courtesy of FESA]

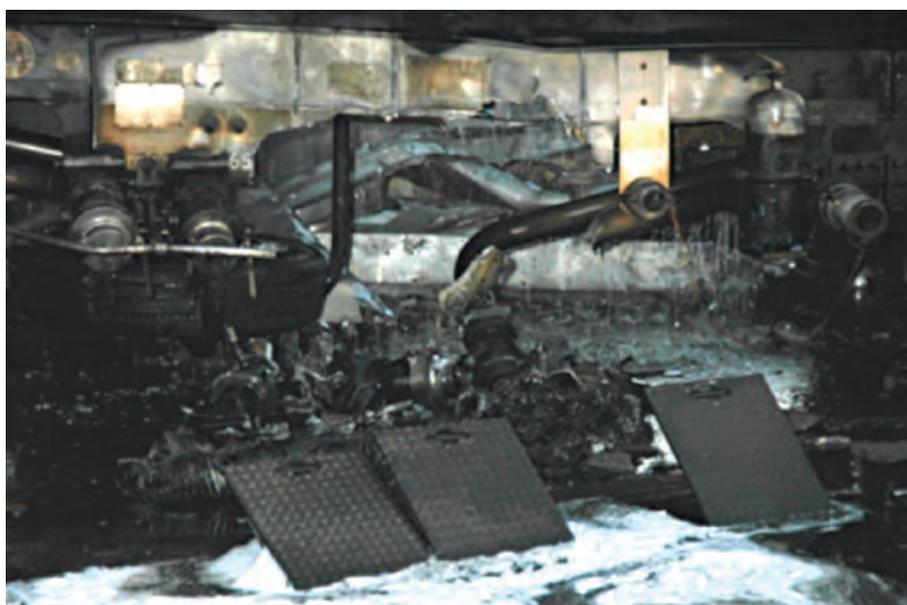
**Figure 19** Fill point area after the fire was extinguished with metal covers in the open position [photograph courtesy of FESA]

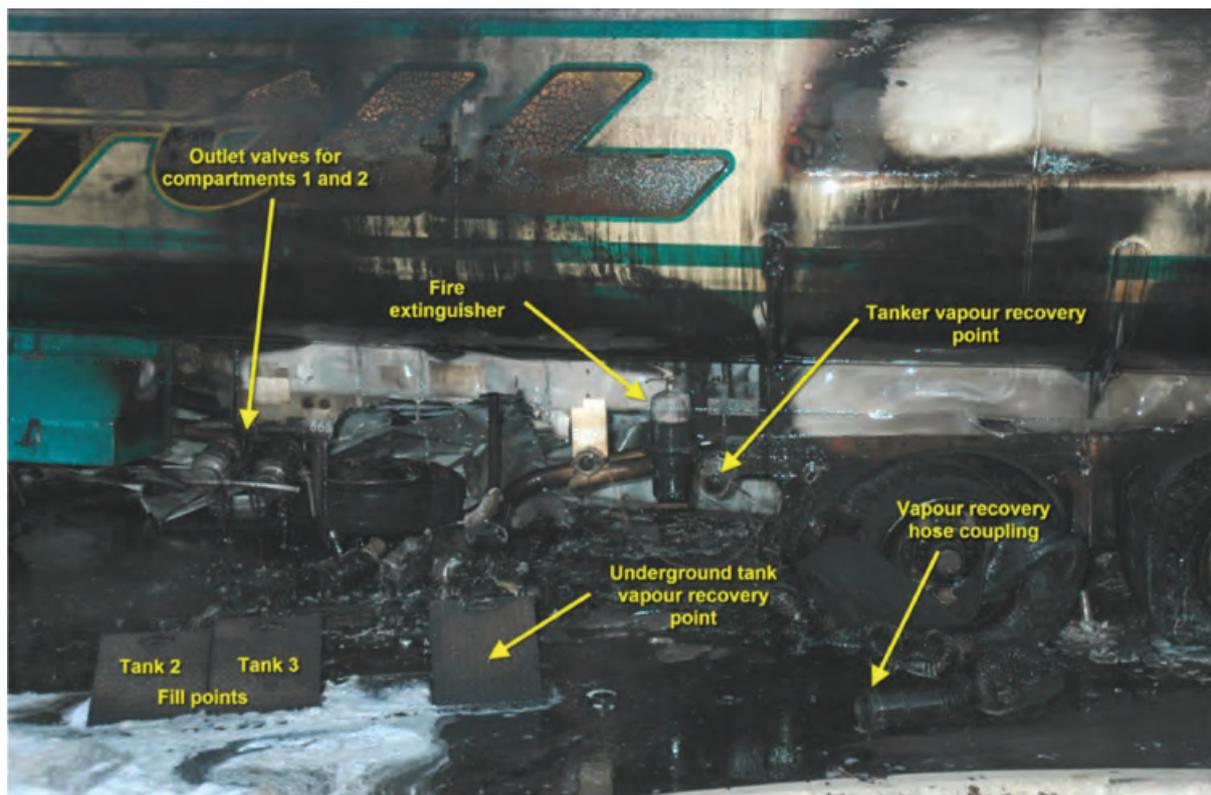
**Figure 20** *Underground tank fill point area and tanker equipment after the fire was extinguished [photograph courtesy of FESA]*

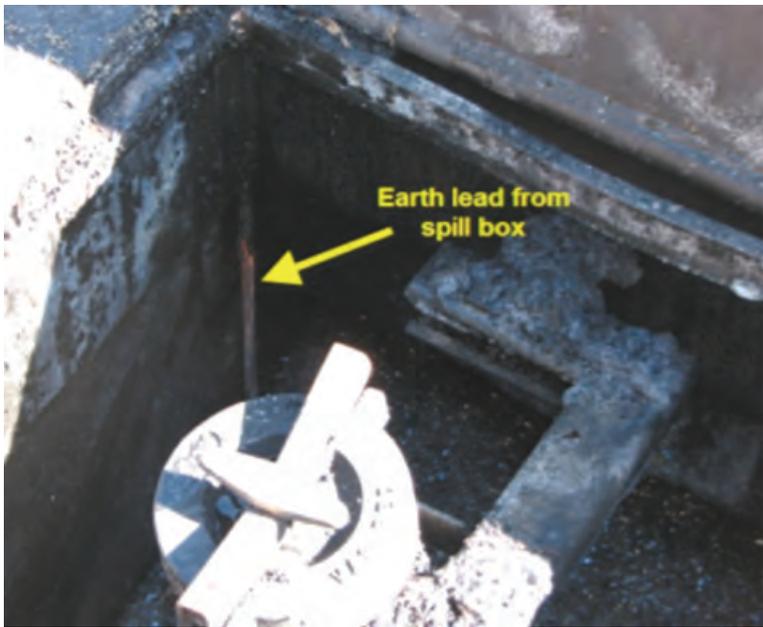
Figure 23 Vapour recovery connection point

Figures 23 and 24 show that, at the time of the fire, an earth lead was connected to the spill box and a bonding strip was connected from the spill box to the vapour recovery point.

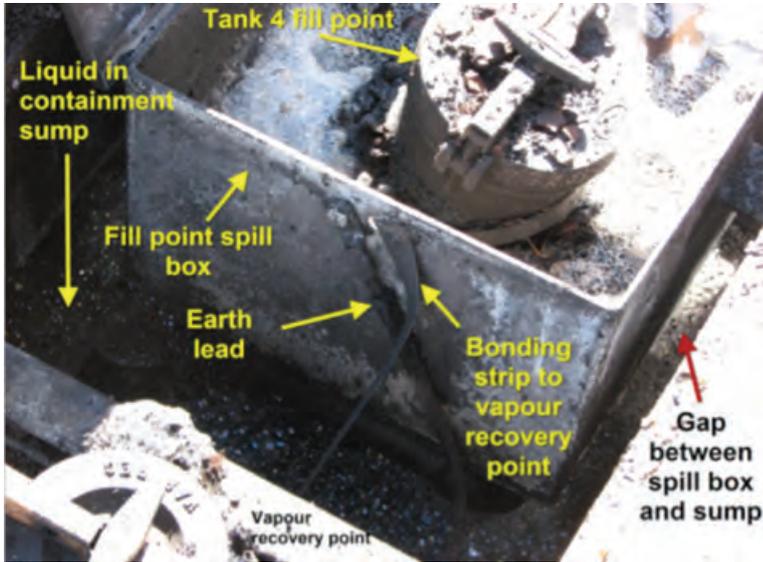
Figure 24 Vapour recovery connection point and fill point spill box

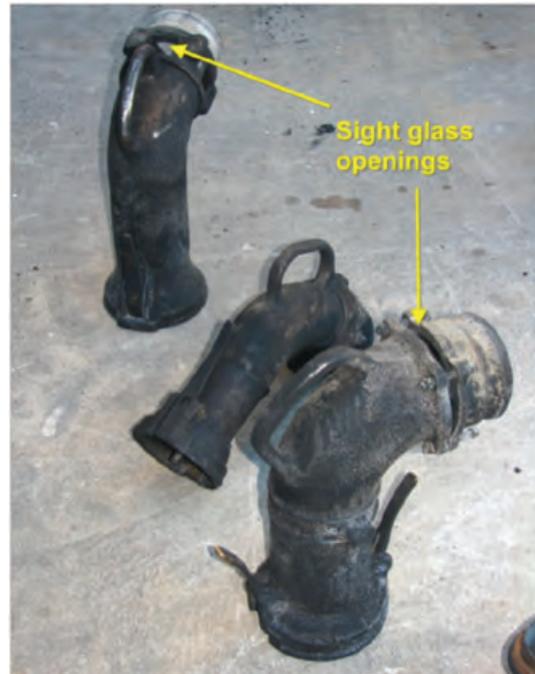
- Three of the tanker product outlet valves had become detached from the product pipe work when it melted (Figure 32).
- All of the outlet valves were in the closed position.
- Sight glasses on the fill elbows for the underground tank fill points had melted (Figure 33).
- The three tanker hoses (two product hoses and one vapour hose) in use at the time of the fire were destroyed. The only remnants were the metal wire coils that surrounded the original hoses and the hose couplings (Figure 34).

**Figure 33** Underground tank fill elbows. Central unit is the vapour recovery elbow

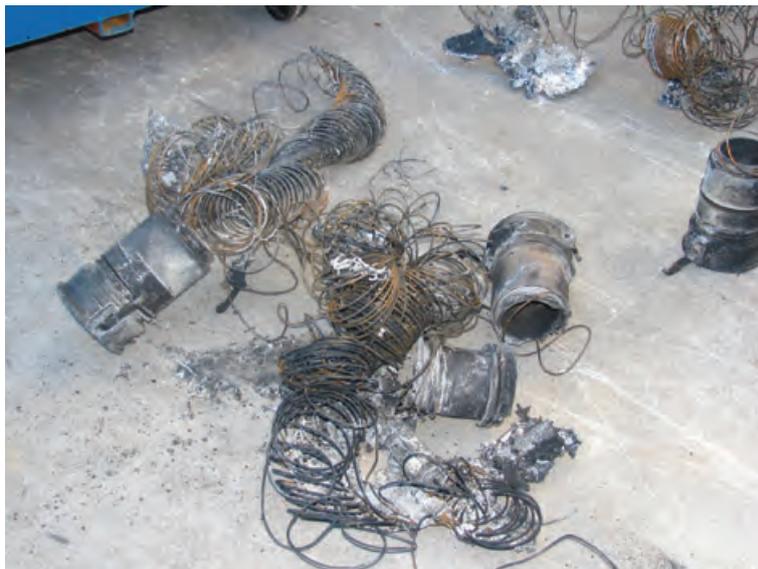
**Figure 34** Remnants of the tanker hoses

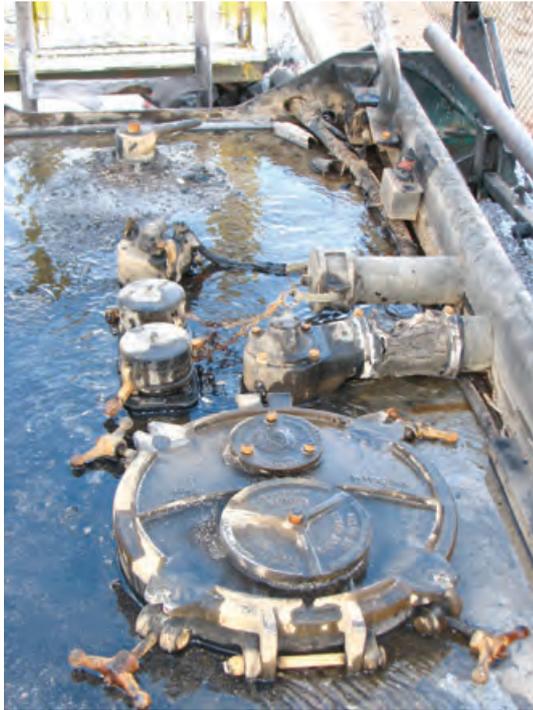
- The top of each of the six tanker compartments was fitted with a manhole cover assembly. This assembly included an emergency vent and a pressure-vacuum vent. A vapour recovery vent and dip and fill points were also fitted to each compartment.
- The manhole cover assemblies were intact and showed no signs of failure (Figures 35 and 36).

**Figure 35** Manhole cover assembly for compartment 6

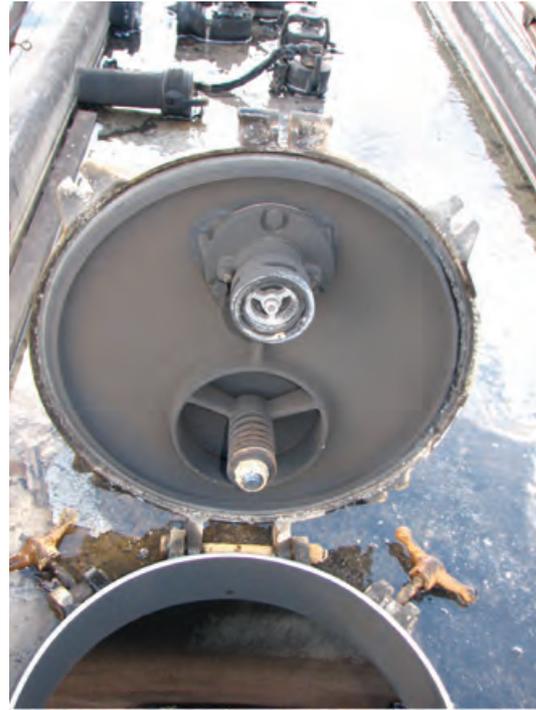
**Figure 36** Inside surface of manhole cover with pressure-vacuum vent (top) and emergency vent (bottom)

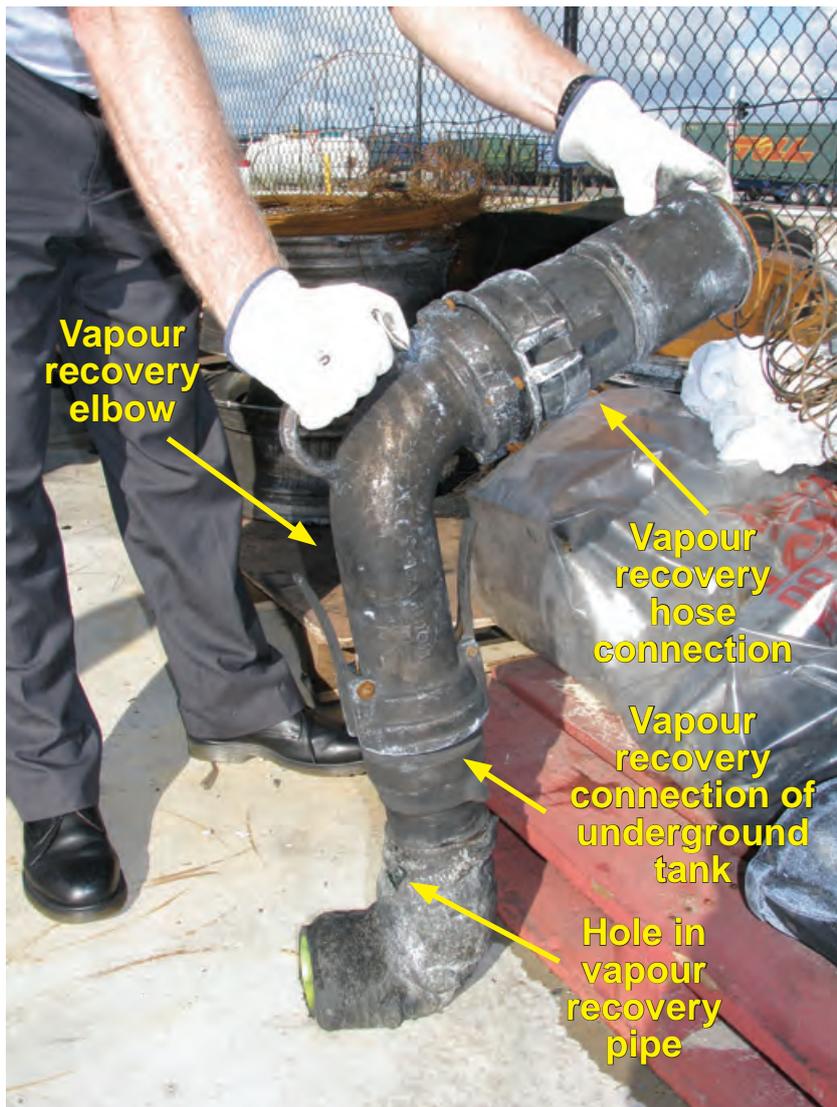
- The connection between the tanker vapour recovery hose coupling and the top of the vapour recovery elbow appeared to be a normal flush fit.
- The connection from the bottom of the vapour recovery elbow to the top of the vapour recovery point from the underground tank appeared to be a normal flush fit.
- Apart from major fire damage (Figure 38), which included a hole (Figures 39 and 40), the vapour recovery connection appeared normal.

**Figure 37** Tanker vapour hose connected via the vapour recovery elbow to the underground tank vapour recovery point

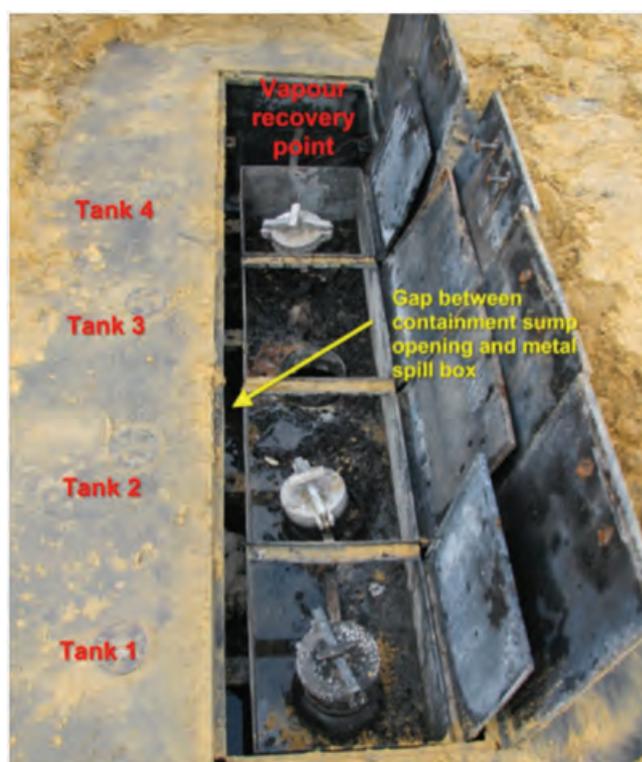
With the fire damaging the pipe elbows, a significant amount of fuel may have entered the containment sump after the fire started. The fuel is likely to have come from discharge hoses that melted in the fire. Burning liquid would have entered the containment sump through the small gap between the edge of the fill point assembly and the metal spill box (Figure 41).

**Figure 41** *In situ layout of underground tank fill box*

The fill point and vapour recovery elbow joints have been examined for signs of fire damage (see Section 3.6). The fire caused significant damage to pipe elbows, and a significant amount of fuel may have entered the containment sump after the fire started until the tanker outlet valves were shut off by the tanker driver. The fuel is likely to have come from discharge hoses that had melted in the fire. Thus, burning liquid would have entered the containment sump through a small gap between the edge of the fill point assembly and the metal spill box (see Figure 41).

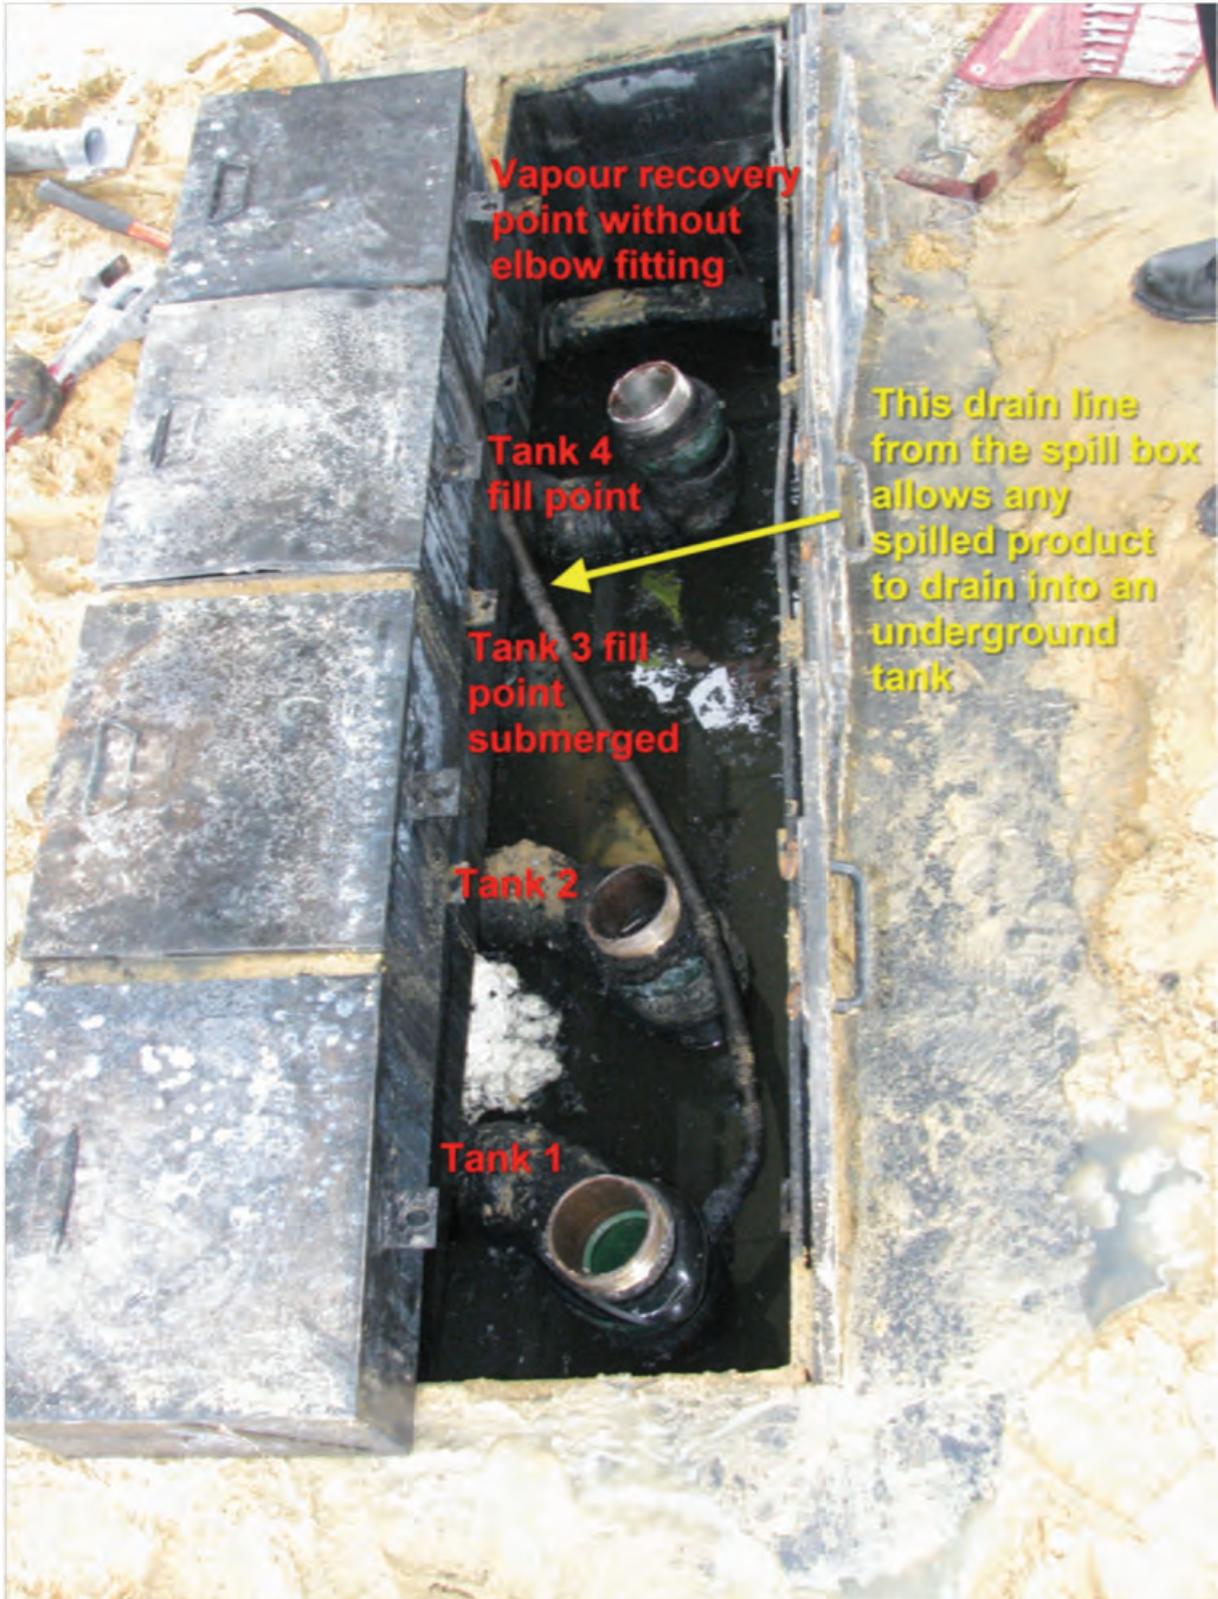
- There was very little fire damage to the fill point elbow for tank 1 (Figures 43 to 45). No holes were visible on the elbow.
- There was moderate fire damage to the fill point elbow for tank 2 (Figure 46 to 48). No holes were visible on the elbow.
- There was major fire damage to the fill point elbow for tank 3 (Figures 49 to 51). The fire was so intense that the plastic fill line (to the underground tank) that attached to this elbow had softened and elongated. A hole was initially identified on a section of the fill point elbow but when this section was cut off for further examination, it was clear that the hole did not penetrate the inner wall of the fill line.
- The fill point elbow for tank 4 sustained major damage, with the elbow point softened and deformed by the fire (Figures 52 to 55).
- The vapour recovery elbow sustained major fire damage (Figure 40).

Figure 42 Fill point elbows for the underground tanks after the metal spill box was removed

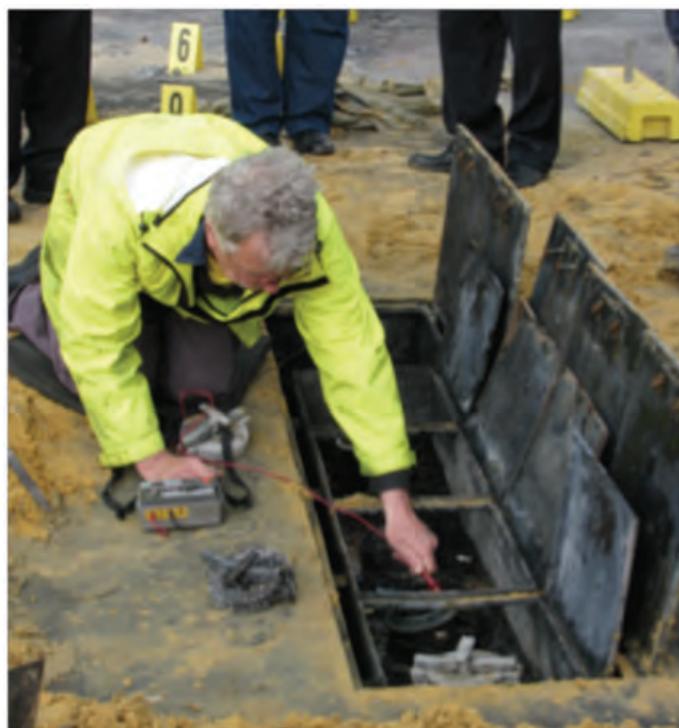
The electrical continuity of the components of the fill box assembly was assessed at the service station (Figure 56).

The tank system had passed the required electrical continuity tests when it was commissioned.

**Figure 56** *Measuring electrical conductivity at the service station after the fire*

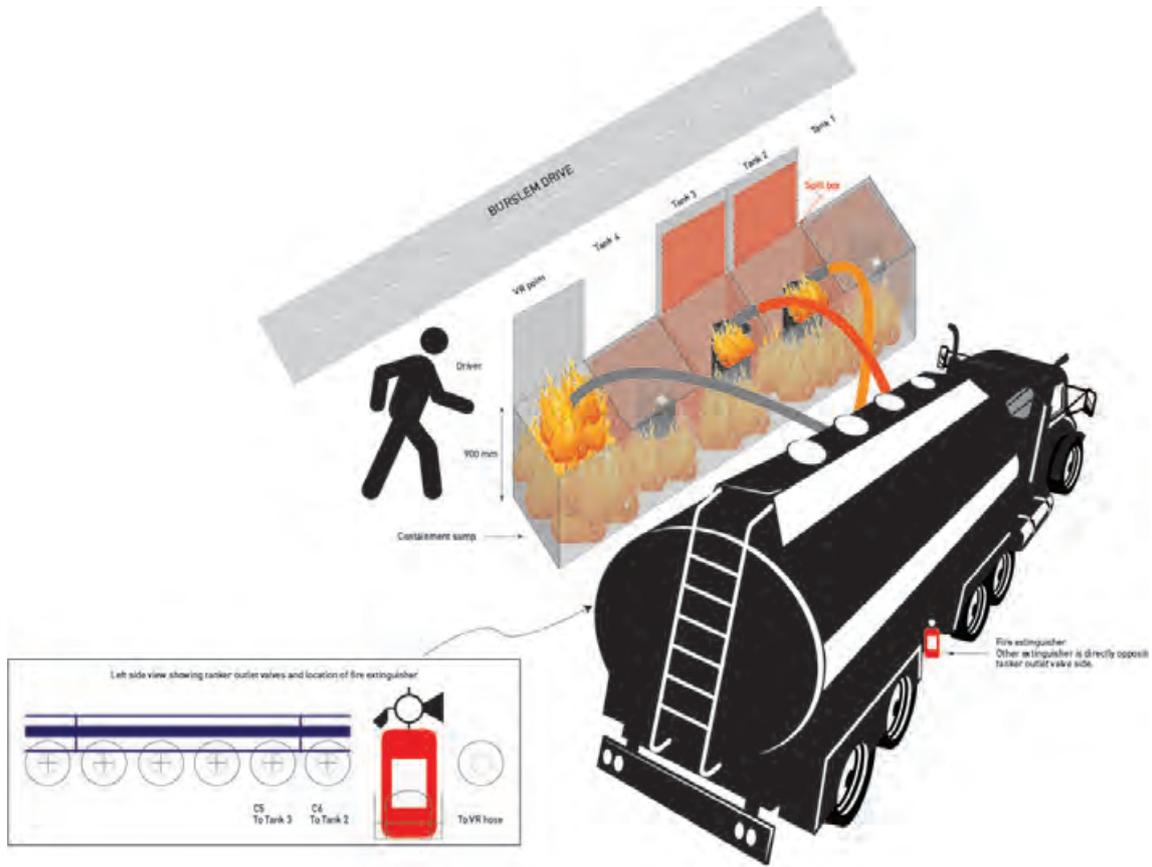
At this time, a man drove into the service station and either pointed or shouted to the driver about the fire. The driver turned around and saw that the sump was on fire. He observed that the flames at the sump were about knee high at that time (Figure 60). He went around the truck, grabbed a bucket of water, returned and poured water into the sump. A customer had also thrown some water under the truck. Initially, these actions appeared to have extinguished the fire, but it reignited a second or two later.

**Figure 60** Sketch showing the fire around underground tank fill points. Note: Figure is diagrammatic and not to scale

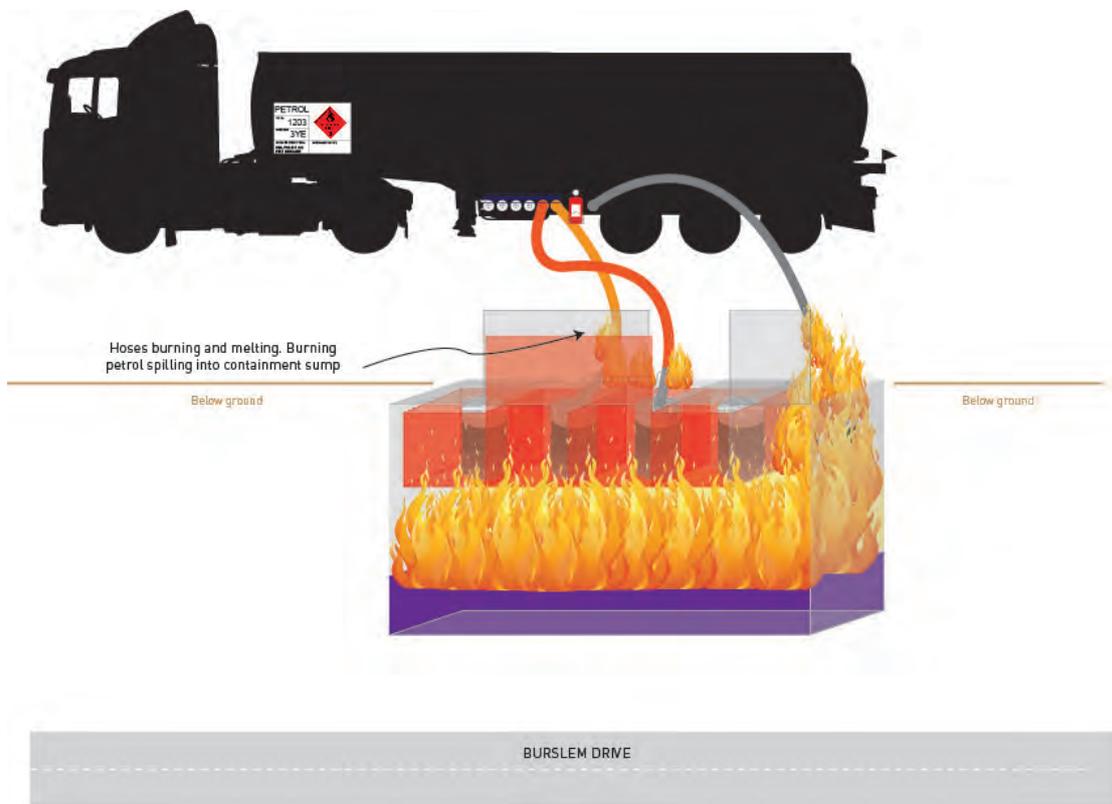
When the fire in the sump reignited, the vapour recovery hose and the discharge hoses were all on fire (Figure 61). The driver then shut off the outlet valves on the tanker by operating the levers manually. He removed the vapour hose coupling from the vapour recovery elbow with the intention of moving the truck. He planned to remove the hose couplings from the two tank fill points, but was not able to because of the heat of the fire. At this stage, the driver's gloves and one boot were on fire.

**Figure 61** Sketch showing fire spreading to vapour recovery and tanker discharge hoses. Note: Figure is diagrammatic and not to scale

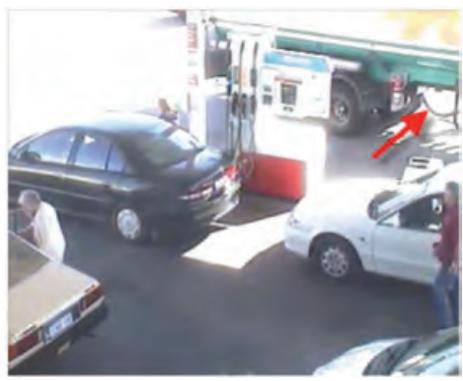
Event	CCTV time	Comments	Camera location	Image
Driver connects vapour recovery hose from tanker	13:39:16	Red arrow points to vapour recovery hose	Pump 5/6

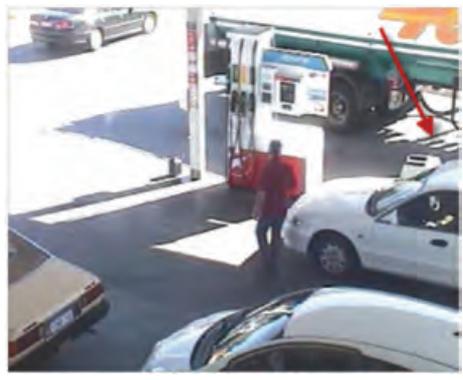
Driver connects hose to compartment 6 of tanker	13:39:59	Arrow points to shadow of transfer hose connected to compartment 6	Pump 5/6

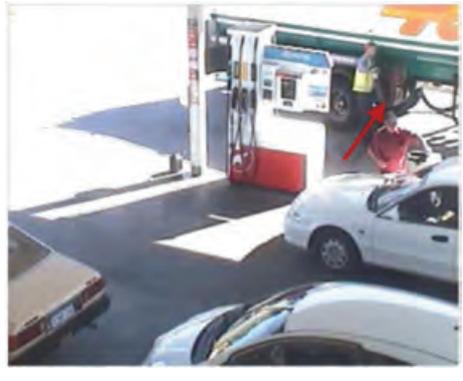
Driver gets second hose from rear of trailer (driver side)	13:40:15	Driver standing next to one of the dry powder extinguishers mounted on the truck	Pump 5/6

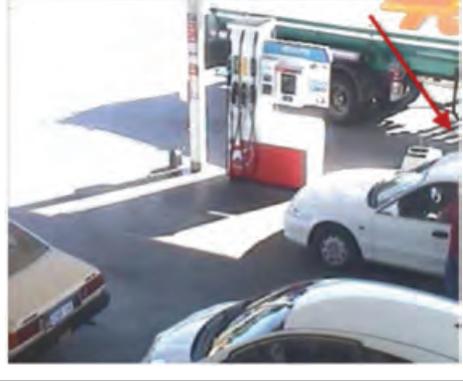
Driver connects hose to compartment 5 of tanker	13:40:37	After connecting the hoses, driver opened the valves on the tanker to commence transfer  There was no smell of fuel around the spill box area  Red arrow points to shadow of transfer hose connected to compartment 5	Pump 5/6

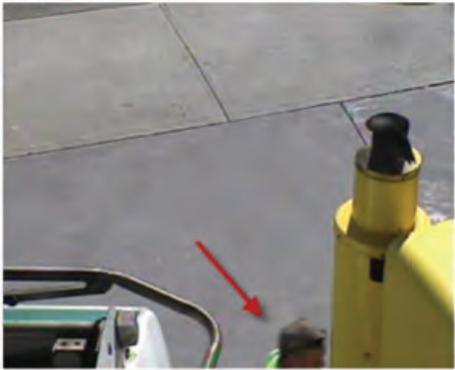
Event	CCTV time	Comments	Camera location	Image
Driver walks to the front of the vehicle, just behind passenger door of prime mover	13:40:57	Driver was standing towards the front of the trailer	Driveway entry 2

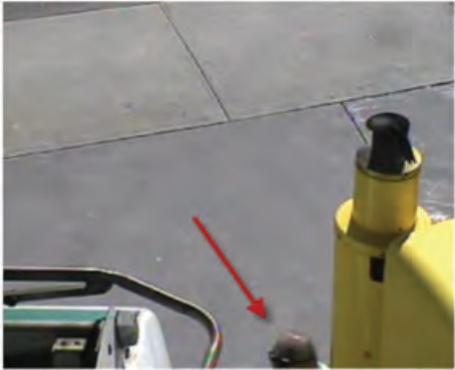
Driver standing by passenger door of prime mover	13:42:04		Driveway entry 2

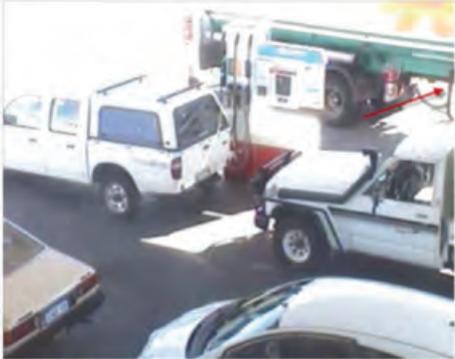
Flash recorded on CCTV footage in the vicinity of the fill point	13:43:15	<p>Driver heard a “bang” and a “whoof”, which sounded like two cars colliding</p> <p>Driver was unsure of how much time had passed between start of fuel transfer and hearing the “bang”</p> <p>A witness in a vehicle pulled into the service station next to the prime mover and recalled seeing the tanker driver sitting inside the prime mover cab</p> <p>Witness alerted the tanker driver to the fire near the fill point</p>	Pump 5/6

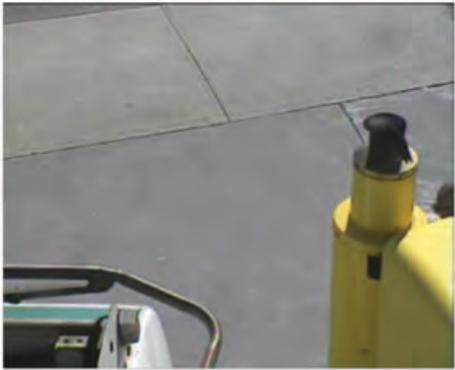
Event	CCTV time	Comments	Camera location	Image
Driver's head appears near passenger door of prime mover	13:43:28		Driveway entry 2

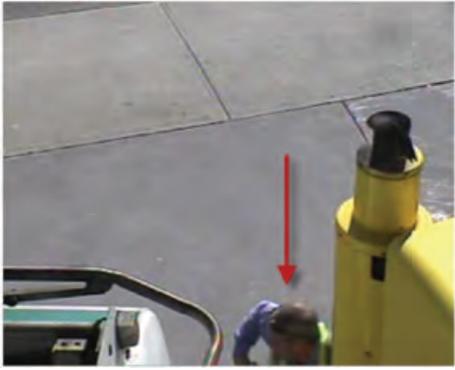
Driver reacts to "bang"	13:43:30		Driveway entry 2

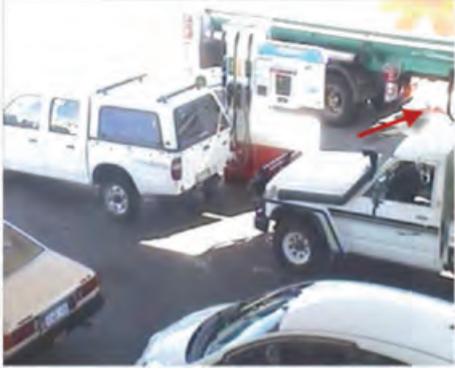
Flames visible beneath tanker	13:43:37	Driver saw knee-high flames in the area of the vapour recovery connection and sump and low-level flames around two fill points  Witness recalled seeing flames in the area of the vapour recovery hose connection	Pump 5/6

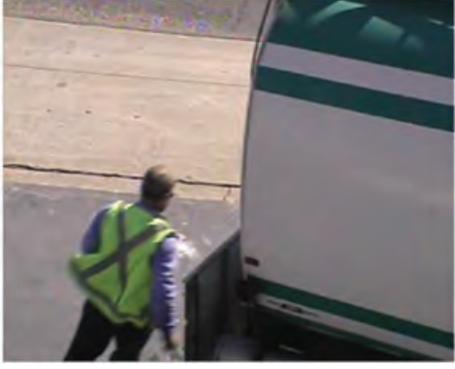
Driver grabs a bucket of water and returns to tanker	13:43:59	Driver recalled grabbing bucket of water and pouring water into the sump	Driveway exit 1

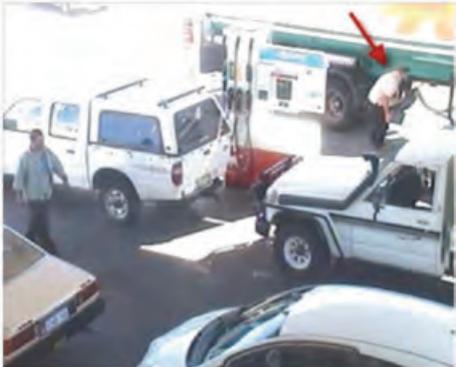
Event	CCTV time	Comments	Camera location	Image
Fire appears to have been extinguished, but reignites a second or two later	13:44:05	Bystander threw a bucket of water under tanker	Pump 5/6

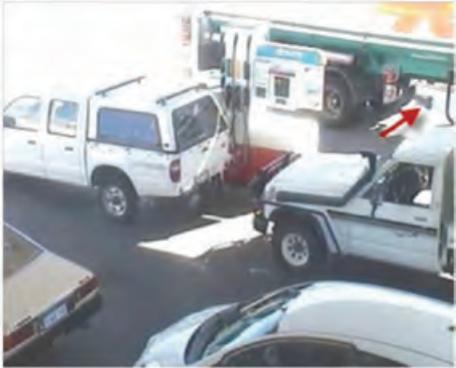
Driver disconnects vapour recovery hose from vapour recovery connection	13:44:16	<p>When fire reignited, vapour recovery and delivery hoses were on fire</p> <p>Tanker valves were shut off manually and vapour hose was removed from vapour recovery elbow</p> <p>Driver tried to remove the fuel transfer hoses from fill point elbows but was unable to do so</p> <p>Driver's gloves and boot on fire</p>	Pump 5/6

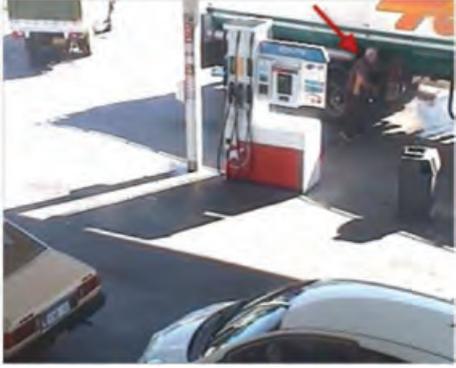
Witness One attempts to take a fire extinguisher from the driver side of the tanker, but heat and flames are too intense	13:44:29		Pump 5/6

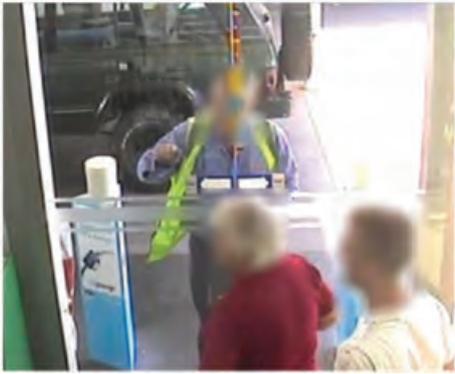
Event	CCTV time	Comments	Camera location	Image
Driver goes to service station building and asks people to phone 000 and evacuate the building	13:44:53		Store entry

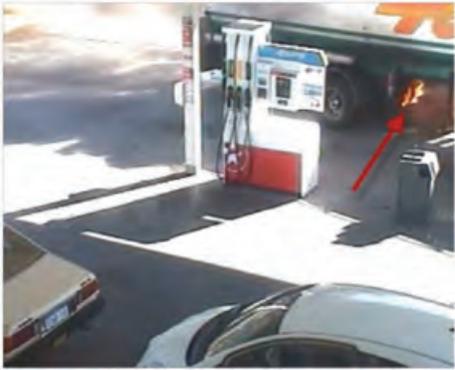
Tyres closest to the fill point, on passenger side of tanker, now on fire	13:45:08		Pump 5/6

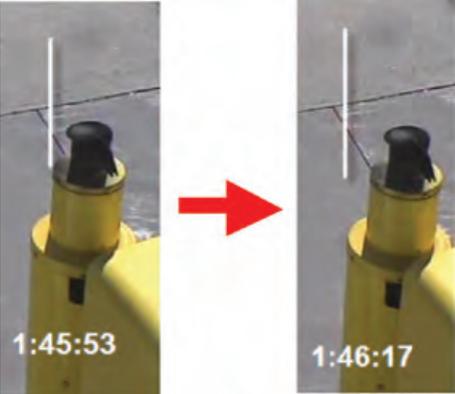
Vehicle has moved slightly forward, probably as a result of a tyre bursting	13:46:04	<p>FESA Communications Centre alerted at 13:46</p> <p>Maddington fire officers arrived at the scene at 13:48</p> <p>FESA officer observed vapour recovery hose not connected</p>	Drive entry 2

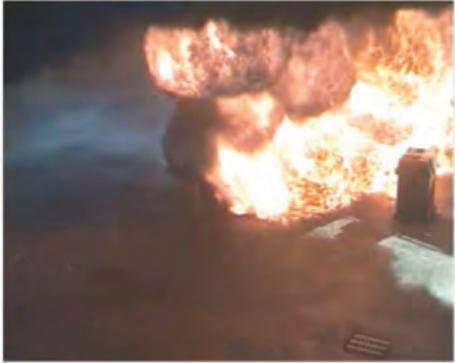
Large fireball forms and extends from tanker towards shop building	13:55:52	FESA crews later advised that tanker compartment 6 ruptured about 13:53	Pump 5/6

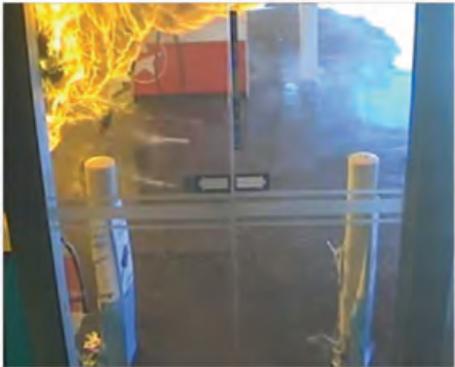
Event	CCTV time	Comments	Camera location	Image
Second fireball forms and extends from tanker towards shop building	14:04:31	FESA crews advised that compartment 5 ruptured about 14:00	Store entry
