Report on Shaft Condition Assessment

Donnybrook Shaft Remediation Goodwood Road, Upper Capel

Prepared for Department of Mines, Industry Regulation & Safety

> Project 96721.02 April 2022

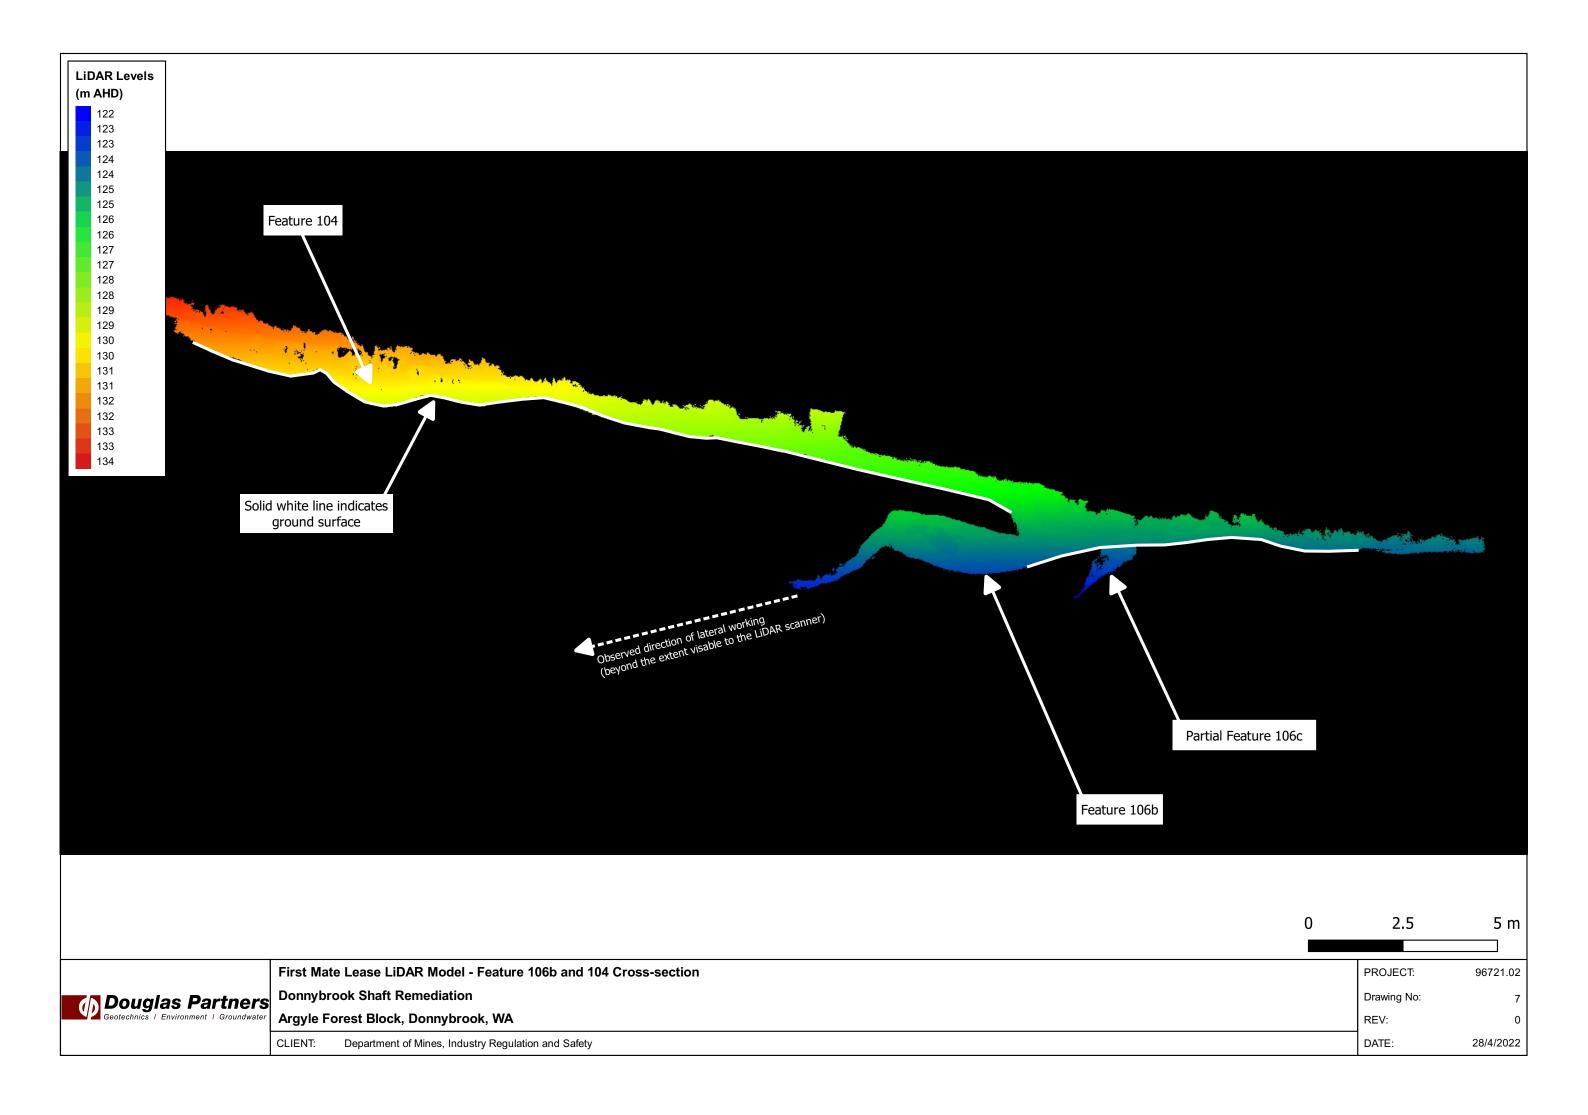
PROJECT:	96721.02
Drawing No:	6
REV:	0
DATE:	11/4/2022

106c	The northern-most feature of three closely grouped features. Approximately 2 m deep and 1.8 m by 1.1 m in plan. Probing the base of the feature indicates competent material at the base, approximately 0.4 m below the surface of the fallen vegetation. No evidence of lateral workings.
107	Approximately 1.3 m deep and 2.0 m by 1.5 m in plan. Probing the base of the feature indicates competent material at the base, approximately 1.0 m below the surface of the fallen vegetation. A small lateral working, observed at the base, on the northern side of the feature. Lateral working is approximately 0.3 m in height and video footage from the base of the feature suggests the lateral extent of the working not more than 0.5 m.
