Our Ref: 121085.01 L02

20 September 2021

**BULONG TAILINGS STORAGE FACILITY CONDITION ASSESSMENT
SITE INVESTIGATION**

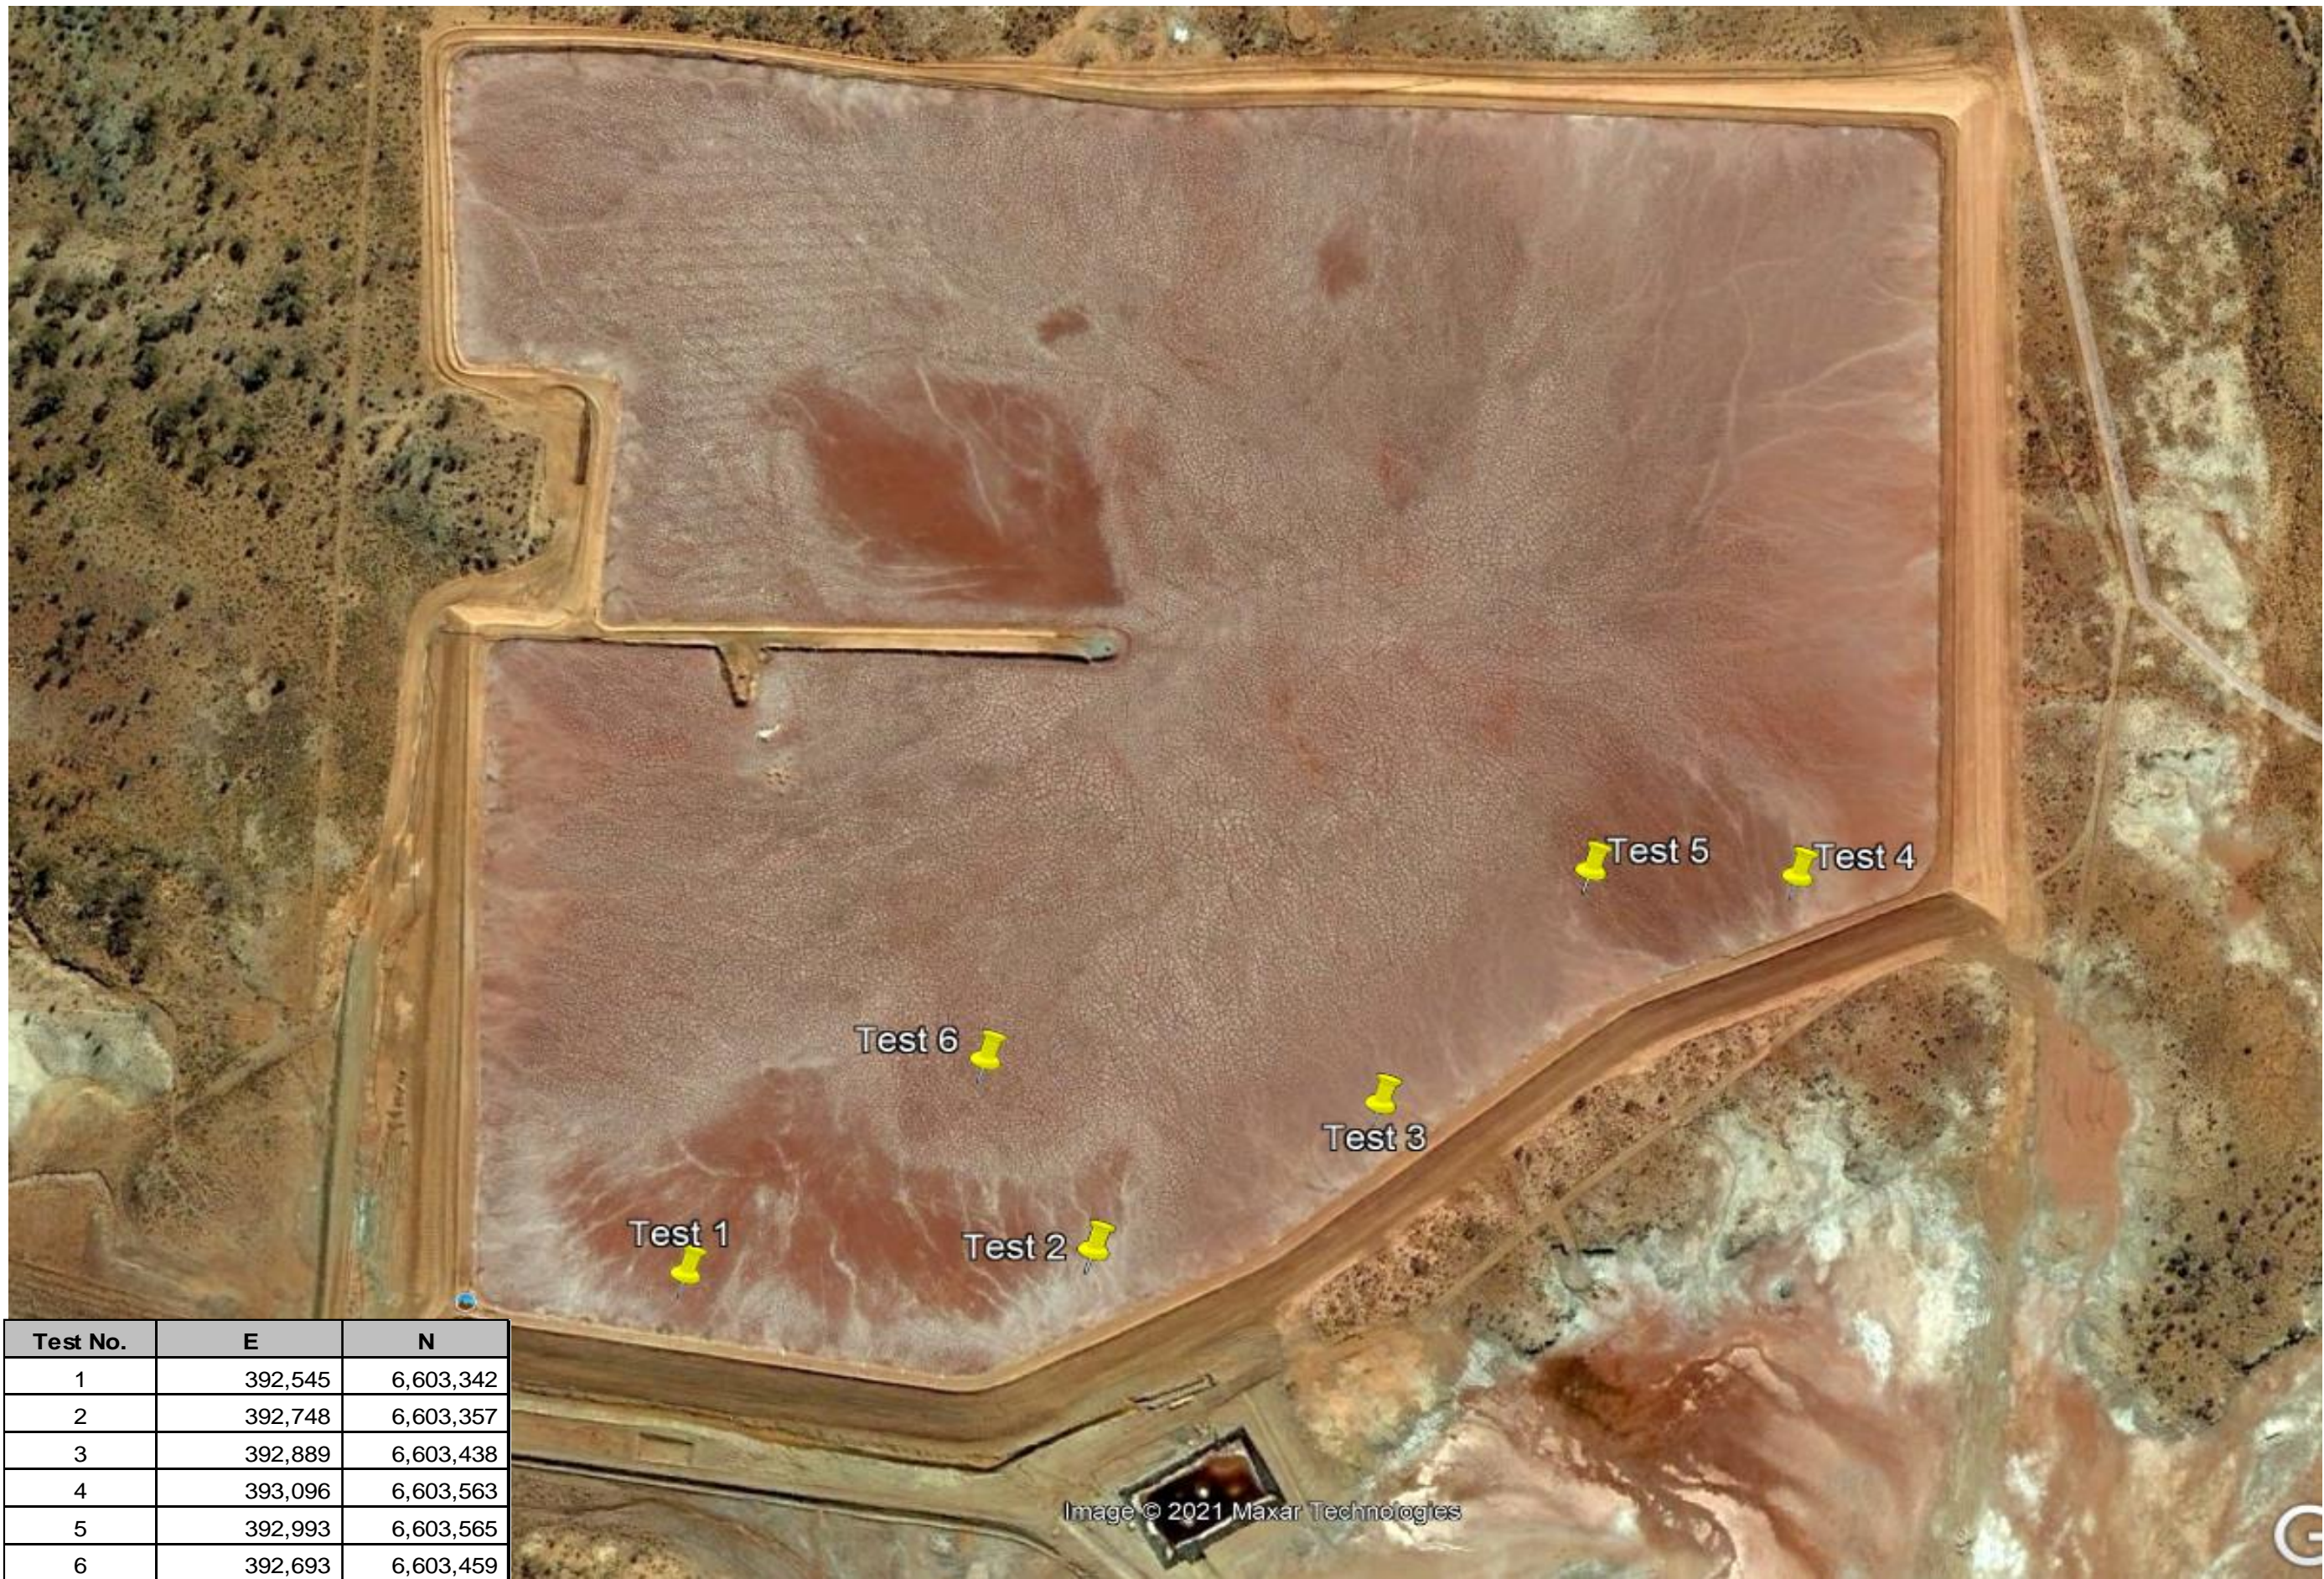
PANDA DCP testing was performed at six locations across the tailings beach to a maximum depth of 4.2 m. Test locations are presented in **Figure 1**. Testing was conducted by an ATCW engineer.

Test No.	E	N
1	392,545	6,603,342
2	392,748	6,603,357
3	392,889	6,603,438
4	393,096	6,603,563
5	392,993	6,603,565
6	392,693	6,603,459
