## Mines Safety Bulletin No. 176

**Subject:** Inspection and maintenance of accessway and platform gratings

**Date:** 10 August 2020

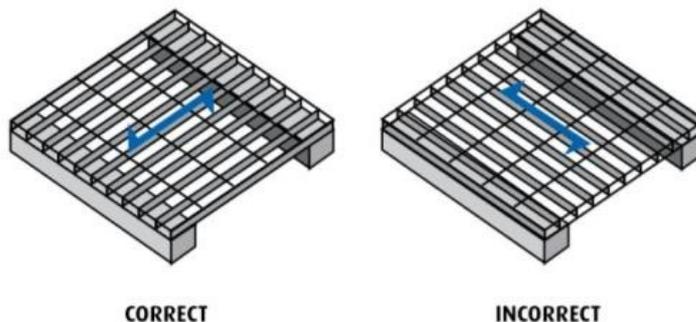
Example of load bar direction from OEM literature

- Competent persons inspecting accessways and platforms must be able to assess:
  1. If the grating is damaged or deformed. This includes identifying:
    - twisted or deformed load bars
    - penetrations that have been cut into the grating
