# SUMMARY OF ACCIDENT REPORTS

1993

**Explosives and Dangerous Goods Division**

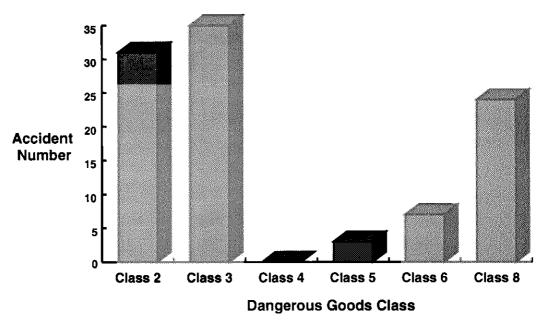
#### Storage Accidents by Dangerous Goods Class (1989-1993)

Expectedly, Class 2 (Gases) and Class 3 (Flammable Liquids) feature prominently in accident reports as they represent the dangerous goods most commonly handled in the State.
