# **Department of Mines, Industry Regulation and Safety**

## Wheal Ellen Mine Shafts and Open Pits Remediation Remediation Methodology Report

October 2020

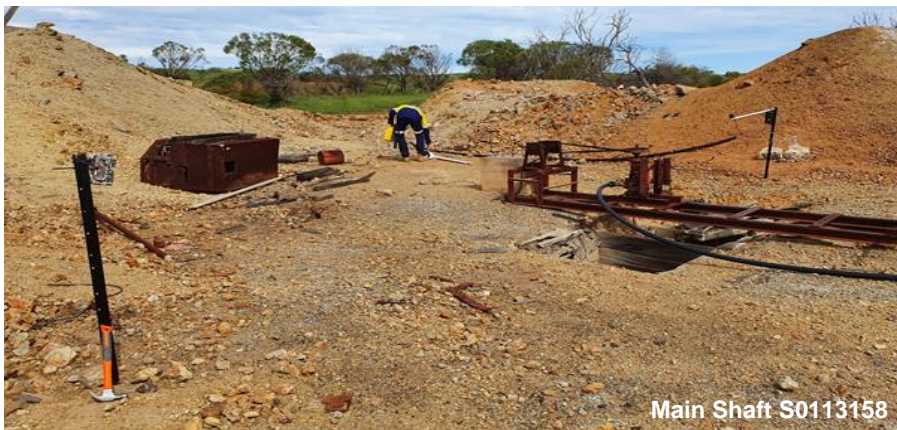
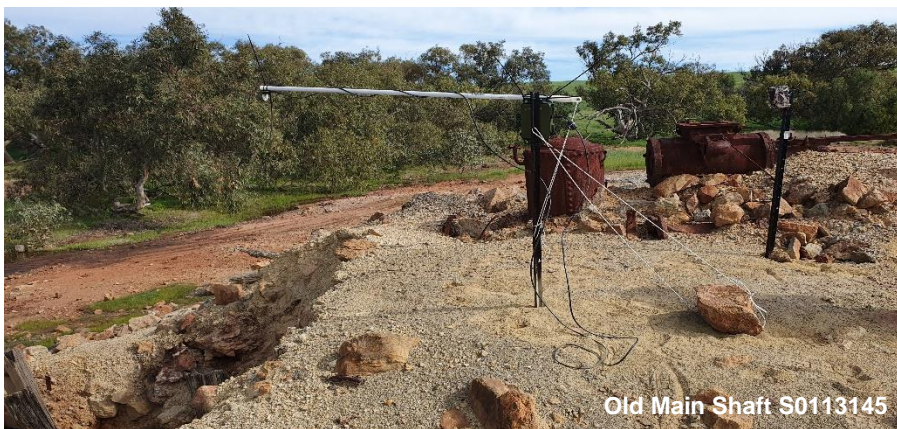
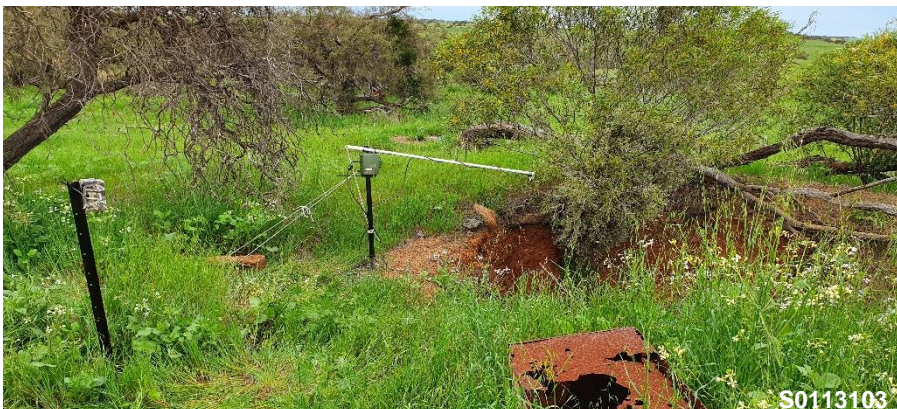
**Plate 1 Bat detector and camera set ups**

- Ultrasonic bat detector (Songmeter Full Spectrum (SM4 bat) Wildlife Acoustics) was placed at the entrance of features Main Shaft (S0113158) and Old Main Shaft (S0113145) with the microphone positioned to record the calls of bats during the night. On the second night the detector from S0113145 was repositioned to Pass No. 5 North (S0113103). Plate 1 displays the location of the detector at each mine shaft. The detectors were installed during the day and set to turn on at least 30 minutes before sunset and off 30 minutes after sunrise. The data recorded was downloaded to computer for analysis.

- An in situ passive infrared cameras (Reconyx Hyperfire models) was installed at feature S0113158 and S0113145 to record the movements of animals exiting or entering the mine shaft. On the second night the camera set at S0113145 was repositioned to S0113103. Plate 1 displays the location of the camera at each mine shaft. The cameras operated from late afternoon through early morning recording still pictures. The data recorded by the cameras was downloaded to computer for analysis.

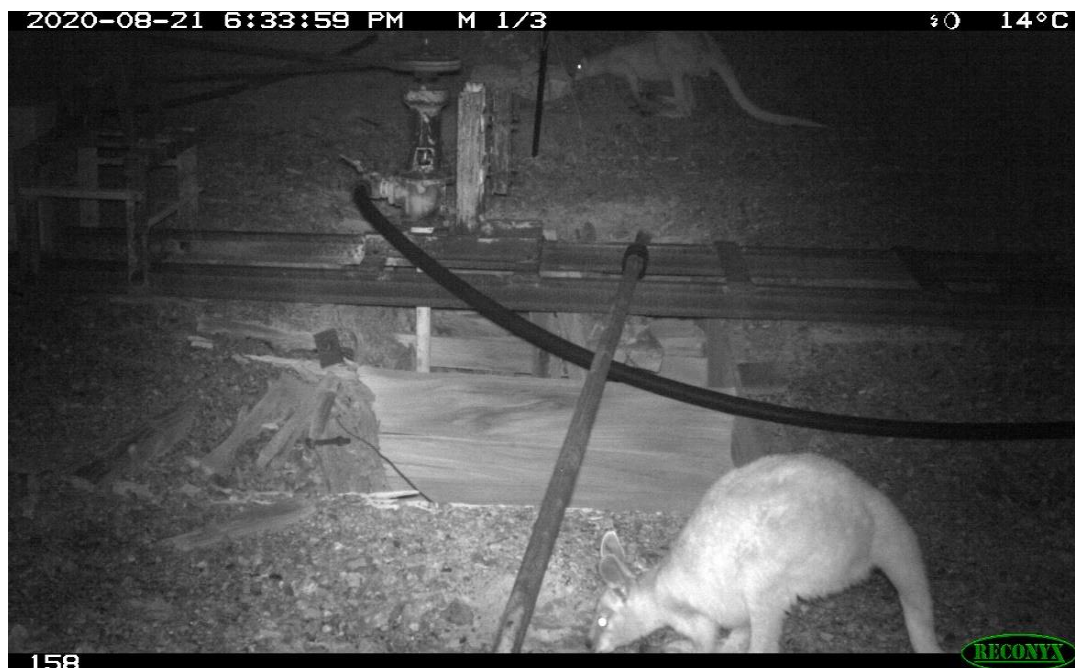
**Plate 2 Reconyx camera at S0113158 displaying two Western Grey Kangaroo**

Two species of fauna were recorded at S0113158 including Western Grey Kangaroo, *Macropus fuliginosus* and Common Brushtail Possum, *Trichosurus vulpecula* (see Plate 2 and 3). The Common Brushtail Possum is known to occupy artificial structures and it is possible that the mother and young use ledges / cross-braces in the shaft for daytime refuge.

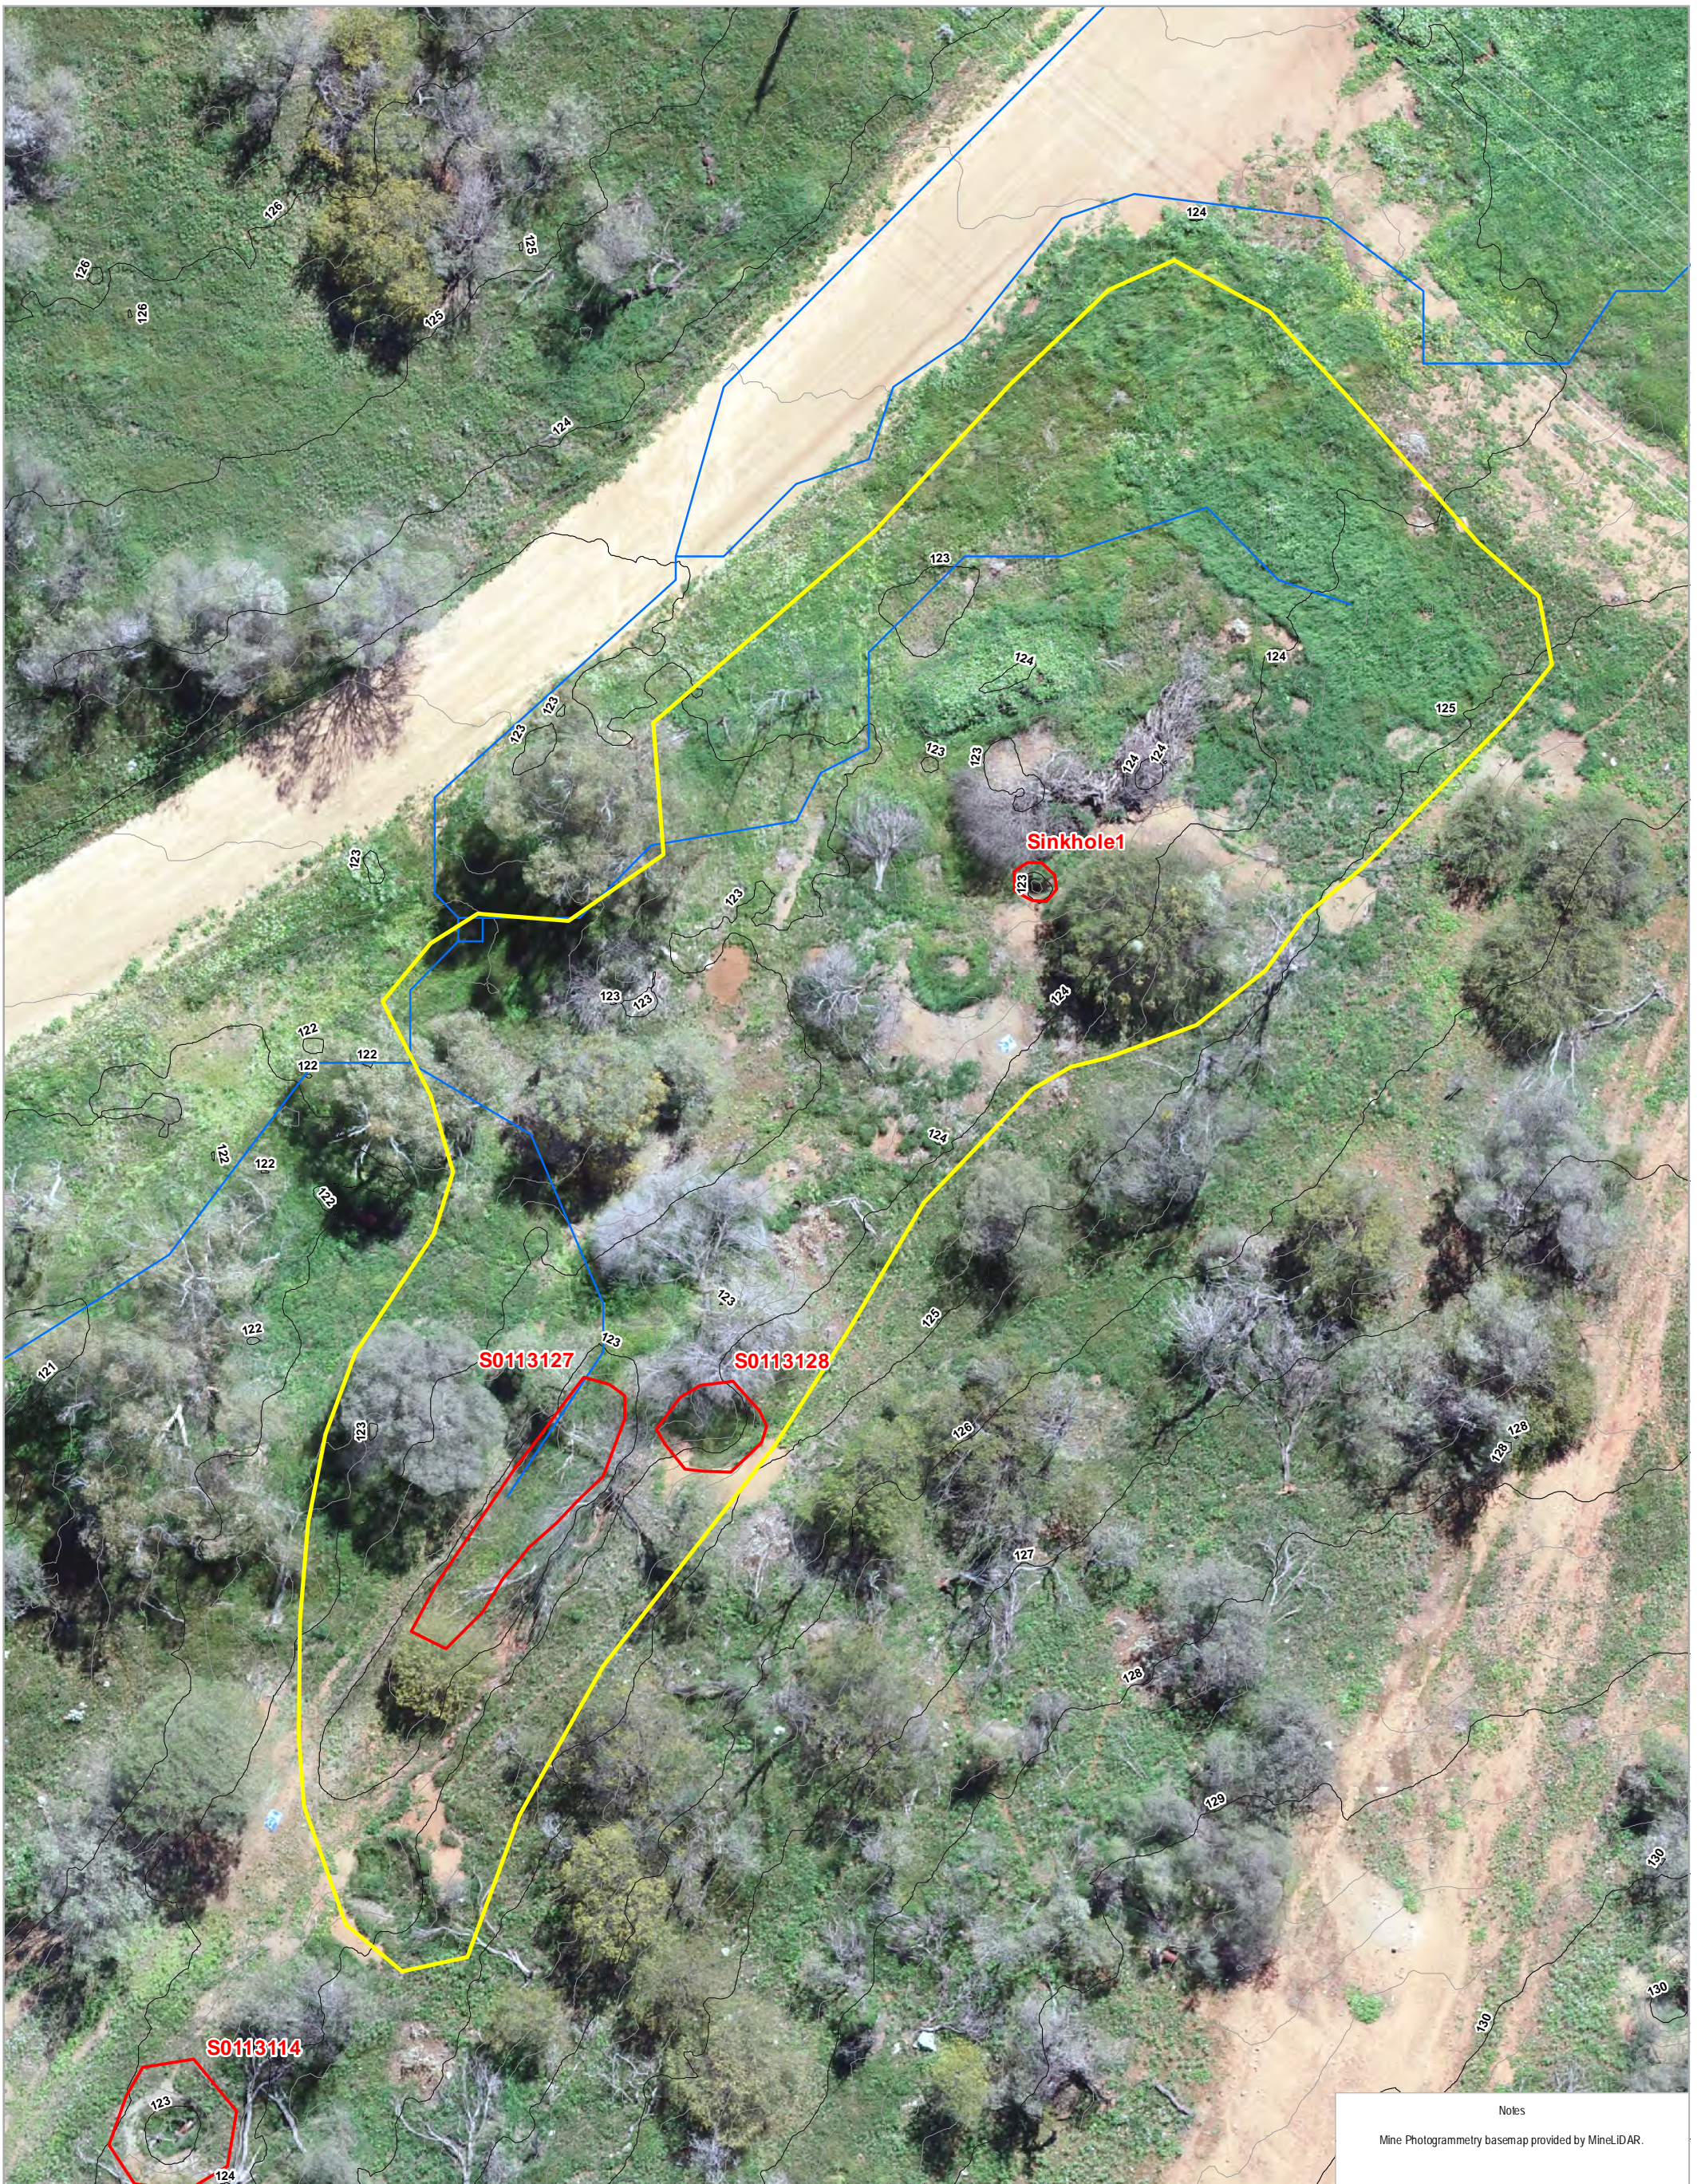
**FIGURE 3a**

- Legend**
- Regrade fill area
  - Surface extent
  - Contour - 1m interval
  - Contour - 0.25m interval
  - Watercourse

A hydrological assessment of site drainage has not been undertaken to allow sizing of open drains and culverts for design flows. Furthermore, site topography and drainage patterns are likely to change significantly as the site is rehabilitated for non-mine subsidence objectives. However, an assessment of what drainage improvement works are needed for mine subsidence remediation purposes has been made using the August 2020 survey and observations. These remediation measures are shown on Figure 3 and 3a in Appendix A and comprise the following.
