DEPARTMENT OF  
MINERALS AND ENERGY  
WESTERN AUSTRALIA

# MINESAFE

MINING OPERATIONS DIVISION

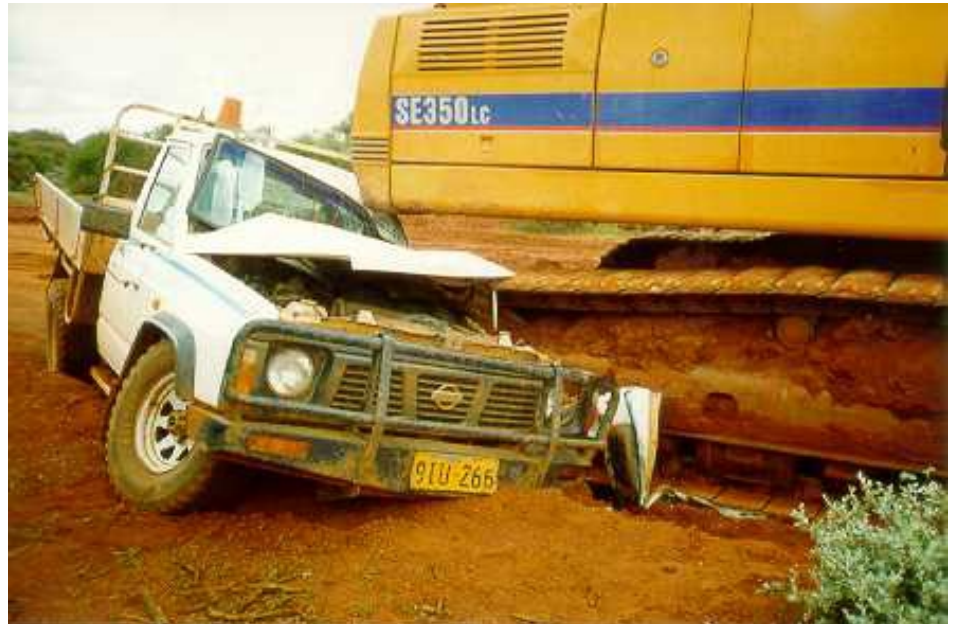
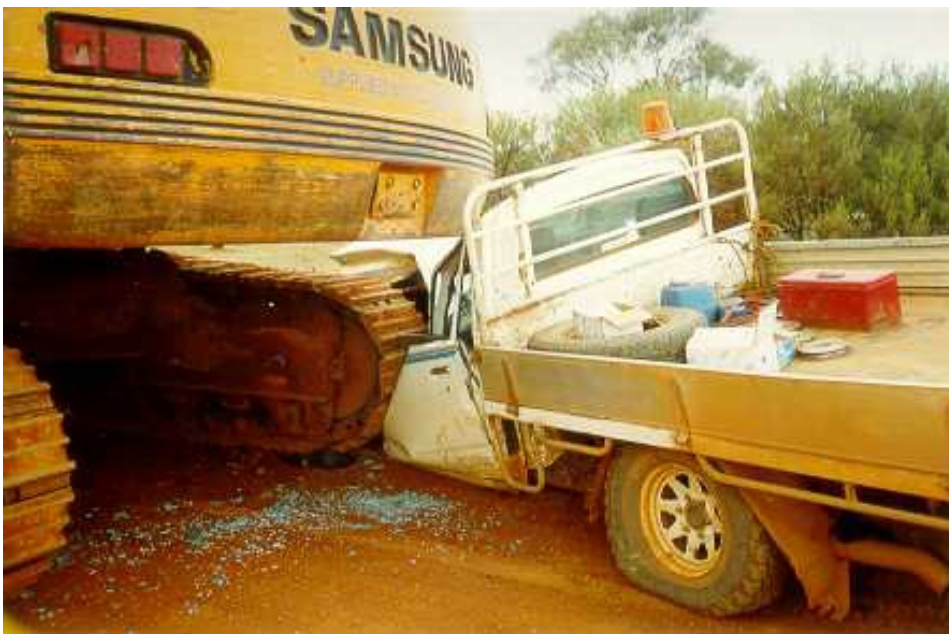
**View  
from  
front**

**View  
from  
rear**

The only thing that is odd about this MINESAFE's front cover photographs is that the excavator driver ran over his own vehicle.

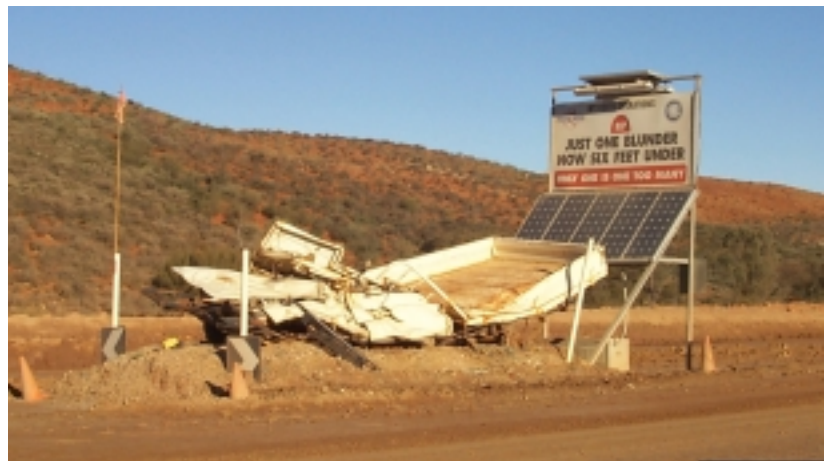
*The product of a simulated accident serves as a permanent reminder at Mt Keith*

Anyone doubting how extensive the damage can be, should take a look at the photograph provided by WMC - Mt Keith, showing a tray-top that was purposely driven over by a haultruck and then placed in the middle of a haulroad as a constant reminder.

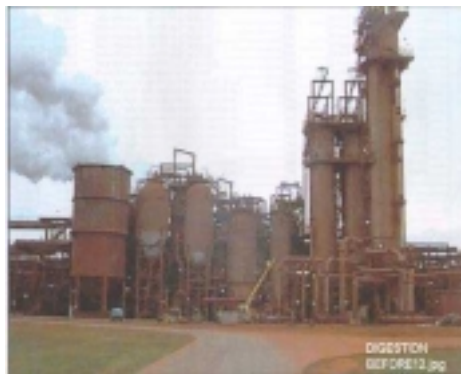
Gramercy Digestion plant - before explosion

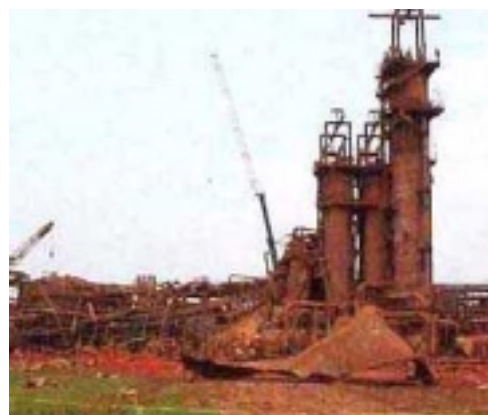
Gramercy Digestion plant - after explosion

As shown in the photographs, the explosion totally demolished the whole digestion section and surrounding plant areas. Large portions of blow-off tanks, flash tanks, pipes, valves and structural supports were blasted hundreds of feet in all directions. The dome of flash tank No6 weighed 7600 pounds and was found 3000 feet away.

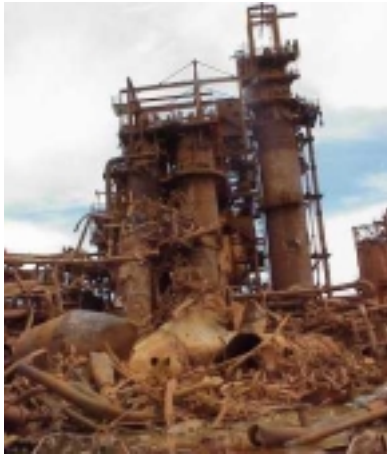
Total destruction of digestion plant area

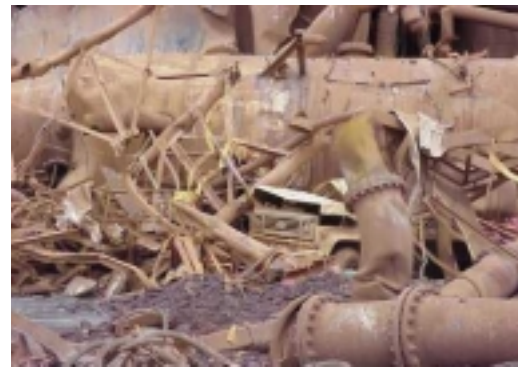
4WD vehicle buried amidst debris

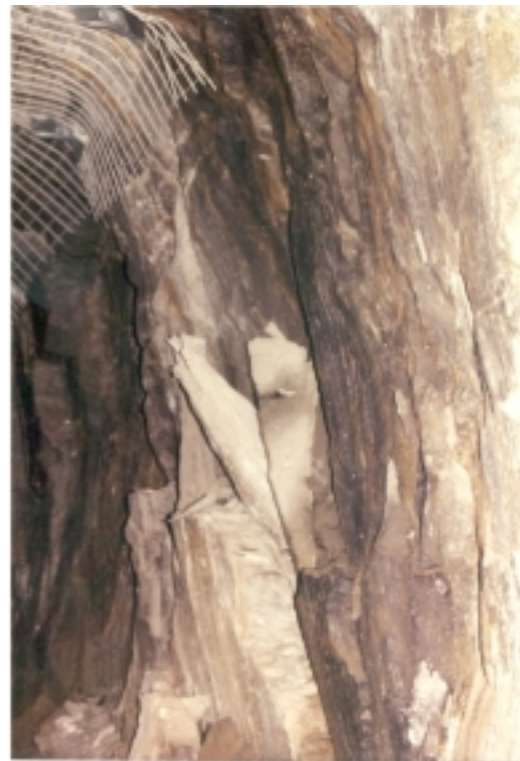
*An experienced miner would know the importance of scaling loose rocks on sidewalls and be better able to assess whether scaling is necessary*

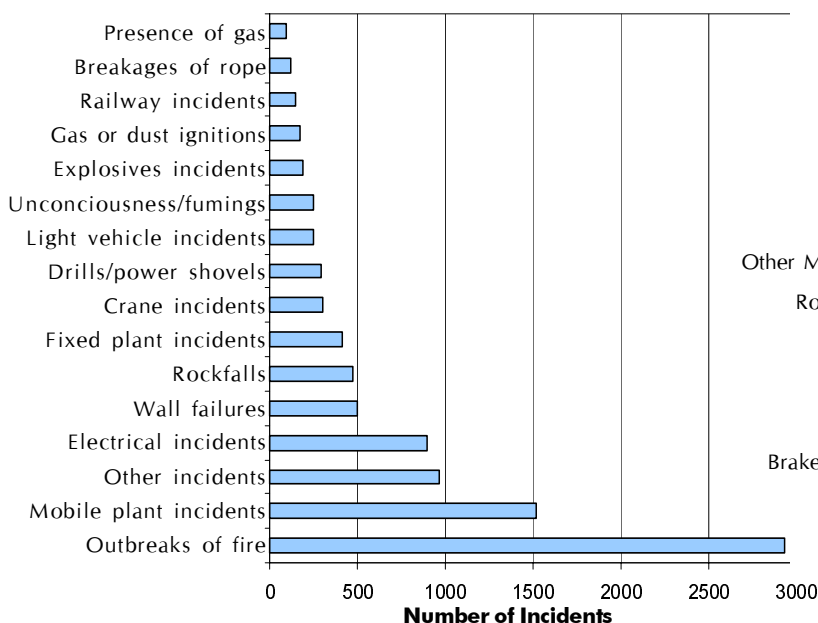
Number of incidents reported since 1994

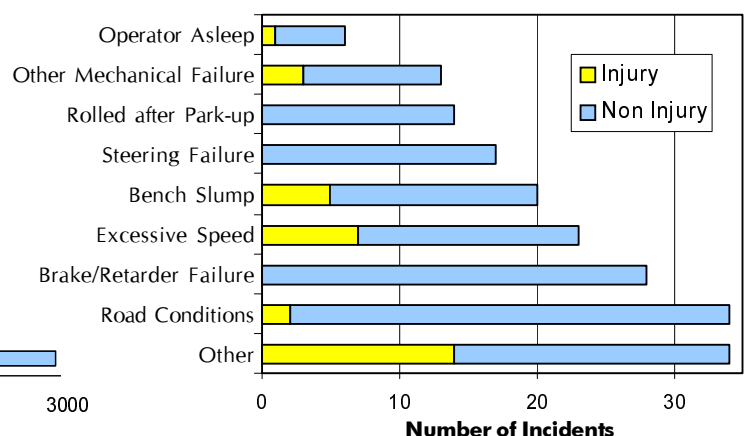
Mobile Equipment Loss of Control 1999
