DEPARTMENT OF
MINERALS AND ENERGY
WESTERN AUSTRALIA

Explosives and Dangerous Goods Act 1961
SUMMARY OF ACCIDENT REPORTS
1997

EXPLOSIVES AND DANGEROUS GOODS DIVISION
MINERAL HOUSE, 100 PLAIN STREET, EAST PERTH, WESTERN AUSTRALIA

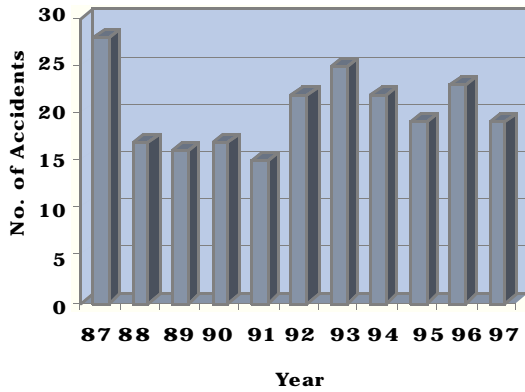
Transport Accidents

The number of dangerous goods transport accidents recorded in 1997 was less than the number recorded in 1996. However, this number is in line with the ten year average of approximately 20.

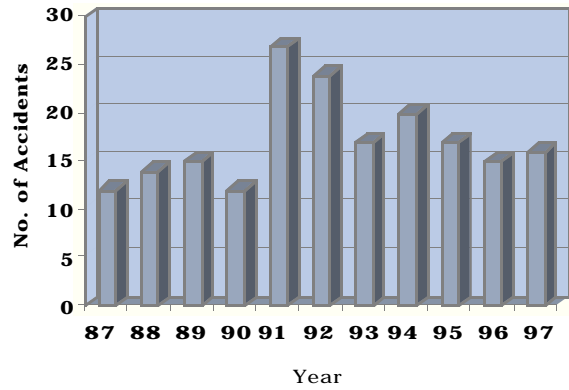
Storage Accidents

The number of storage accidents recorded in 1997 was one more than recorded in the previous year and consistent with a general healthy trend of a decreasing number of accidents over the past 6 years.

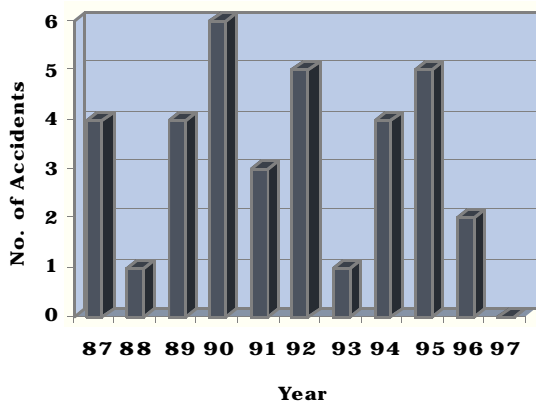
Explosives Accidents

No accidents were recorded in 1997; this indicates that the use of explosives is handled in a safe manner in Western Australia.

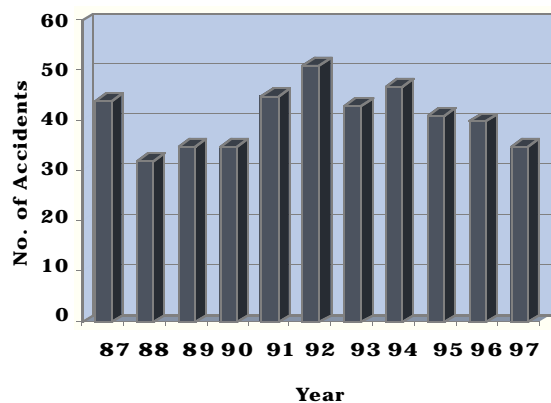
Total Accidents

The total number of accidents recorded in 1997 is less than the number recorded in the previous years.

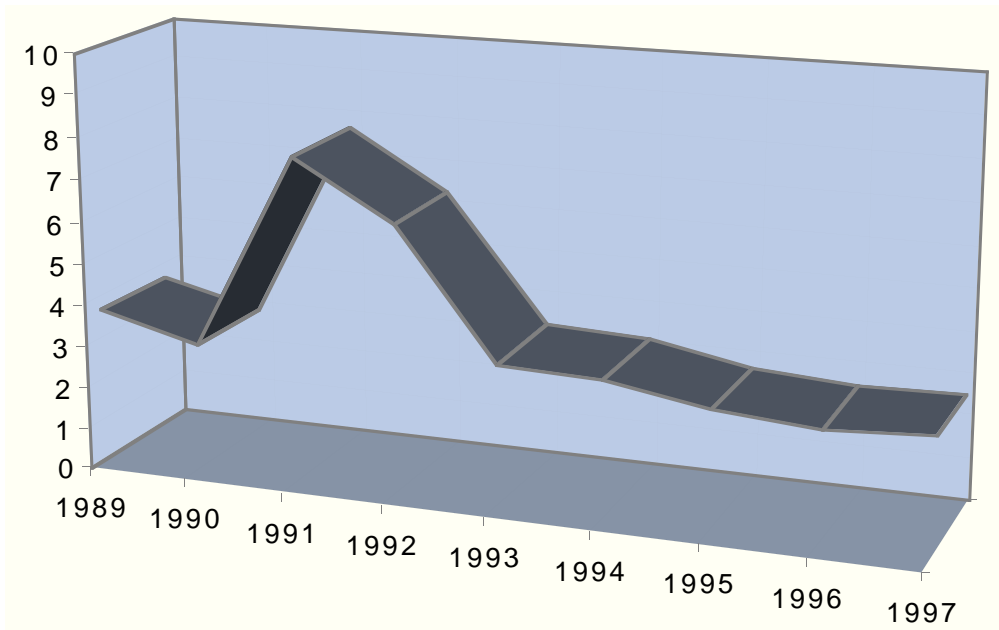
Number of Accidents per 1000 licensed Premises

The 1997 figure is similar to that recorded for the last 2 years, suggesting a trend of just under 3 accidents per 1000 licensed premises. There are almost 6000 premises licensed to store dangerous goods in Western Australia.

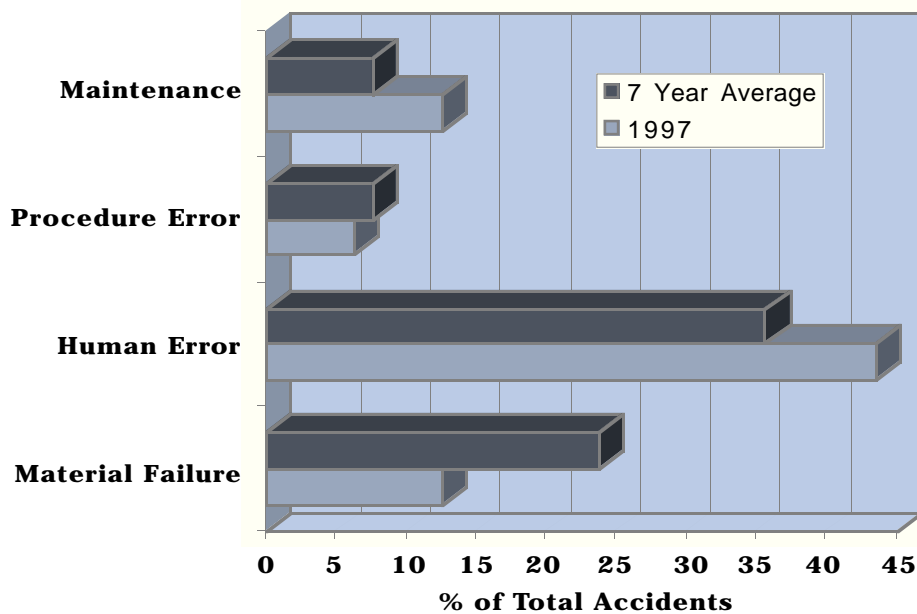
Causes of Storage Accidents - (1997 vs 7 Year Average)

In line with previous years, the major casual group of storage accidents is the failure of people to follow standard operating procedures (reported as human error).

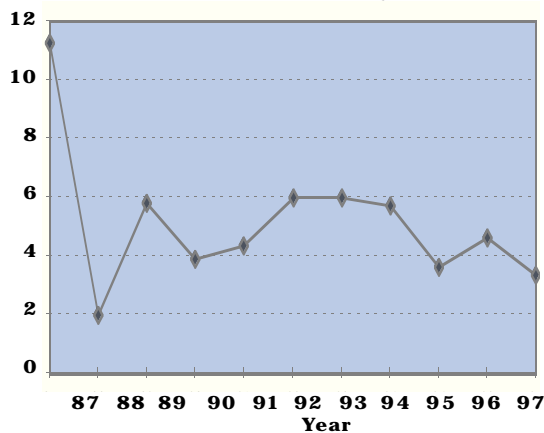
Number of Accidents per 1000 licensed Vehicles (Bulk Only)

The 1997 value is slightly lower than in 1996 due to a lower number of bulk vehicle incidents. In the last 9 years, the accident rate has been between 3 and 6.

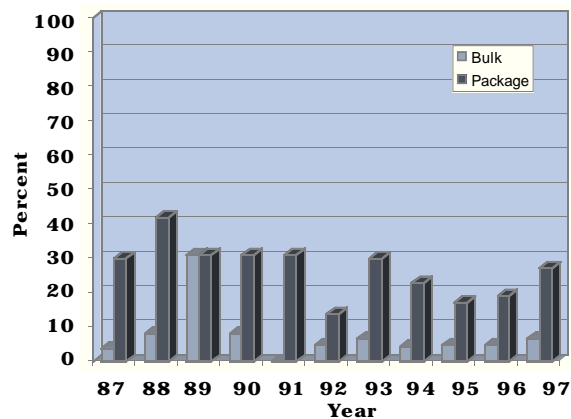
Non Complying Vehicles in Accidents (Bulk/Package)

The 1997 value is similar to previous years. While bulk vehicles have very good compliance with the ADG Code, there is room for improvement for packaged vehicles; substandard stowage is the main problem.

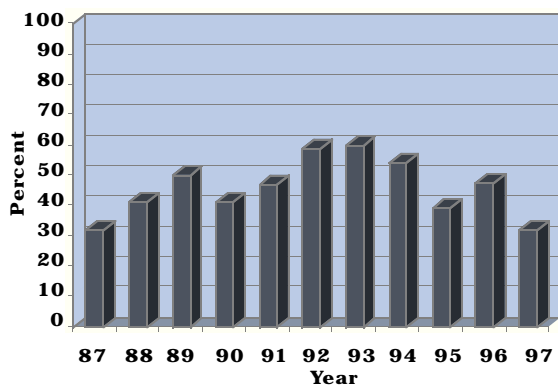
Percentage of Accidents Caused By Operator Deviation From Standard Procedures

The above figure includes only deviation from dangerous goods legislation: it does not include deviation from other road safety legislation or company rules. Not following standard procedure was still a major problem in 1997 and no significant improvement can be seen over the last ten years.

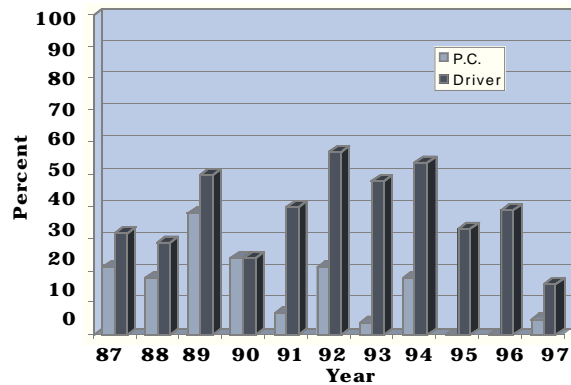
Driver and Prime Contractor Contribution to Operator Deviation Caused Accidents

In 1997, the driver value is substantially lower than in the previous 6 years. As was predicted in the 1996 Report, the introduction of compulsory refresher driving course in January 1997 did improve the situation.
