**Explosives and Dangerous Goods Act 1961**

**SUMMARY OF ACCIDENT REPORTS**

**1998**

**EXPLOSIVES AND DANGEROUS GOODS DIVISION**  
**MINERAL HOUSE, 100 PLAIN STREET, EAST PERTH, WESTERN AUSTRALIA**

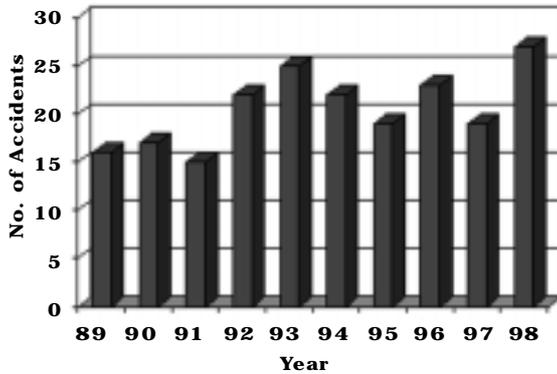
## Transport Accidents

The number of dangerous goods transport accidents recorded in 1998 was more than the number recorded in 1997.

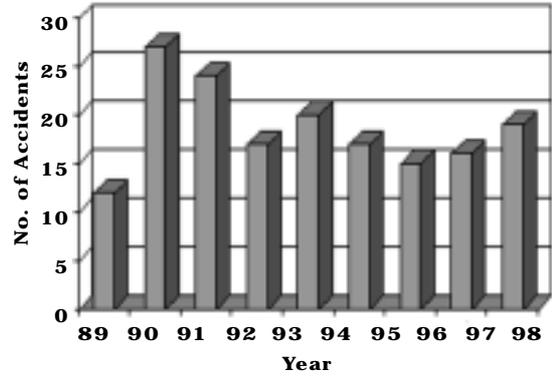
## Storage Accidents

The number of storage accidents recorded in 1998 was three more than recorded in the previous year. However, 19 accidents is in line with the ten-year average of approximately 20.

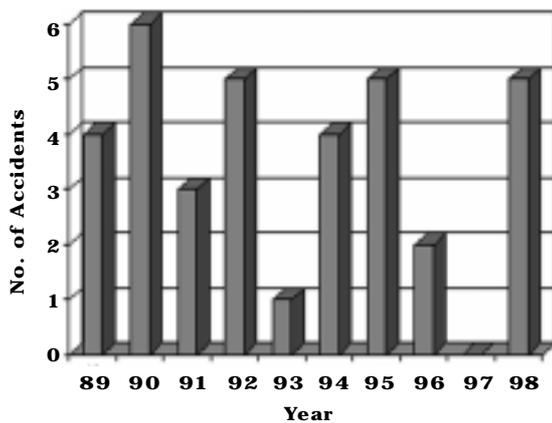
## Explosives Accidents

Five accidents were recorded in 1998, the same number of accidents as 1995 and 1992.

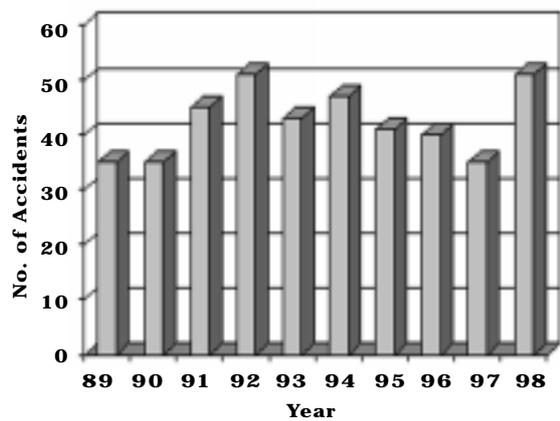
## Total Accidents

The total number of accidents recorded in 1998 is more than the number recorded in the previous years.

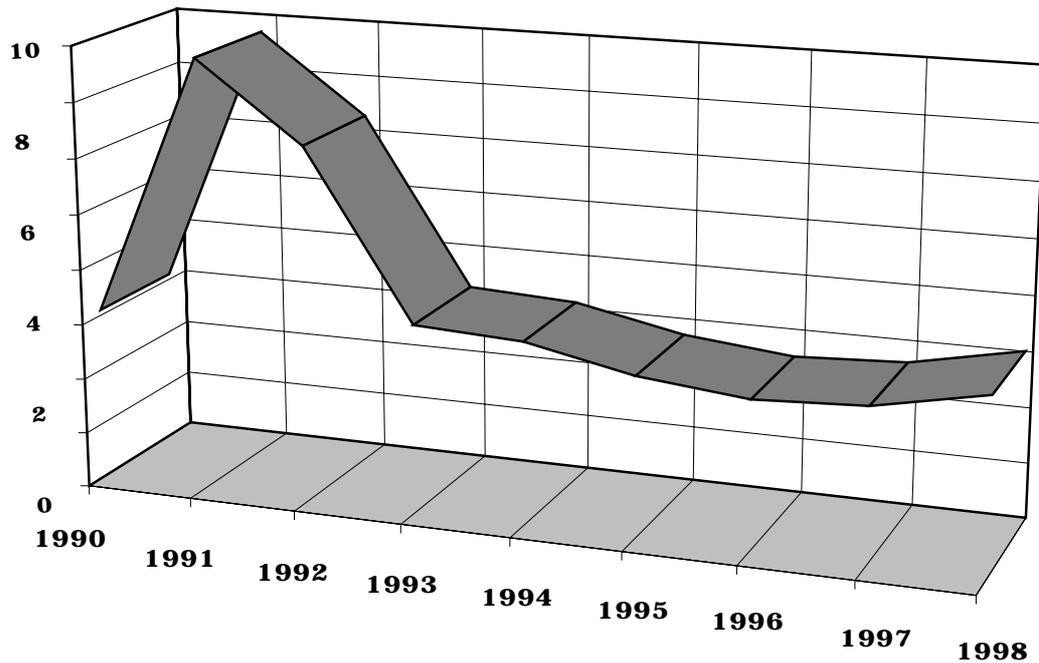
### Number of Accidents per 1 000 licensed Premises

The 1998 figure is similar to that recorded in recent years, confirming the trend of about three accidents per 1 000 licensed premises. There are almost 6 000 premises licensed to store dangerous goods in Western Australia.

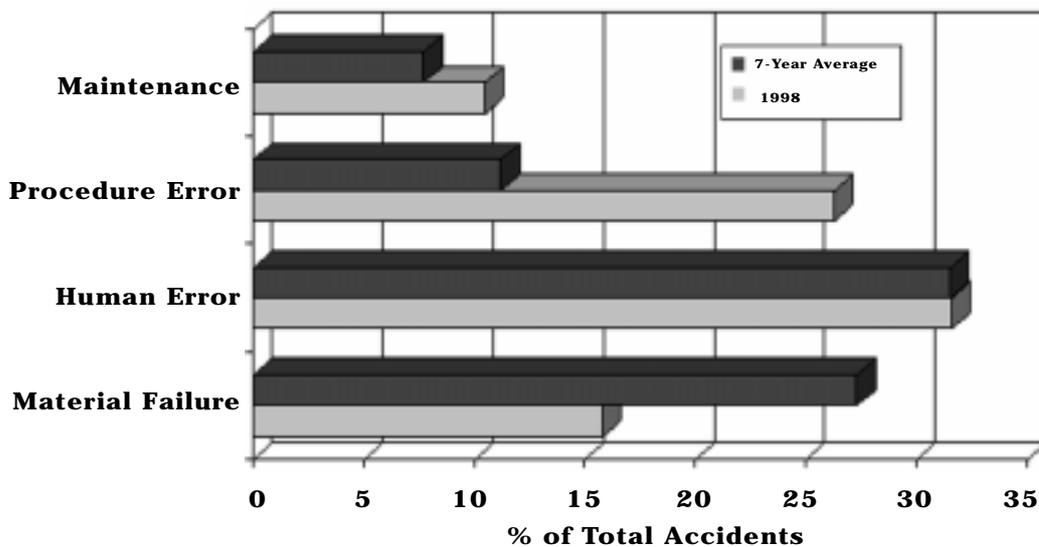
### Causes of Storage Accidents - (1998 vs 7-Year Average)

In line with previous years, the major causal group of storage accidents is the failure of people to follow standard operating procedures (reported as human error).

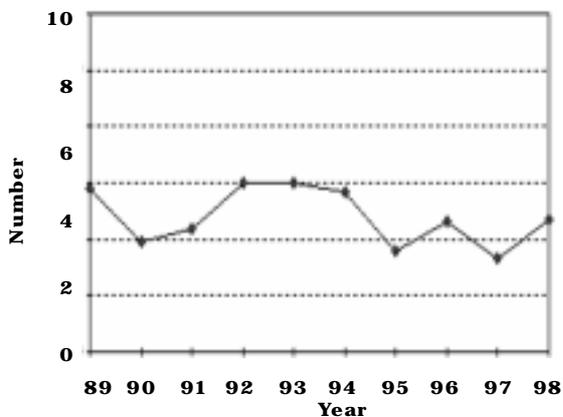
**Number of Accidents per 1000 licensed Vehicles (Bulk Only)**

The 1998 value is higher than in 1997 due to a higher number of bulk vehicle incidents. In the last ten years, the accident rate has been between three and six.

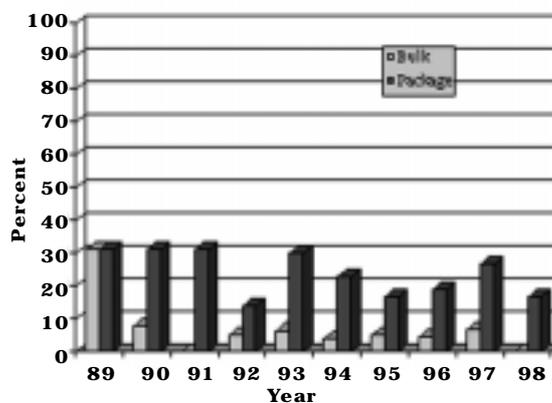
**Non Complying Vehicles in Accidents (Bulk/Package)**

While bulk vehicles have very good compliance with the ADG Code, there is room for improvement for packaged vehicles; substandard stowage is the main problem.

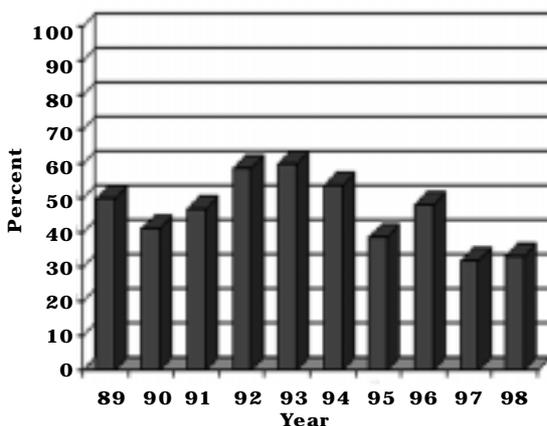
**Percentage of Accidents Caused By Operator Deviation From Standard Procedures**

The above figure includes only deviation from dangerous goods legislation: it does not include deviation from other road safety legislation or company rules. Not following standard procedure, as a causal group for accidents has decreased from the high levels experienced in 1992, 1993 and 1994.

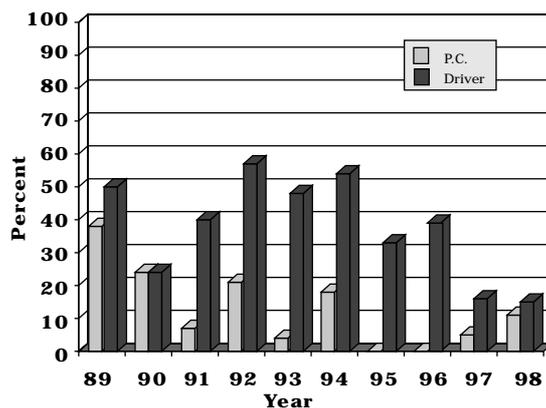
**Driver and Prime Contractor Contribution to Operator Deviation Caused Accidents**

In 1998, the driver value is substantially lower than in the 1989 to 1996 period. As was predicted in the 1996 Report, the introduction of a compulsory refresher driving course in January 1997 has improved the situation.
