Report on  
Geotechnical Investigation

Donnybrook Mine Shaft Remediation Methodology  
Lot F27 Goodwood Road, Upper Capel

Prepared for  
Department of Mines, Industry Regulation & Safety

Project 96721.00  
May 2021

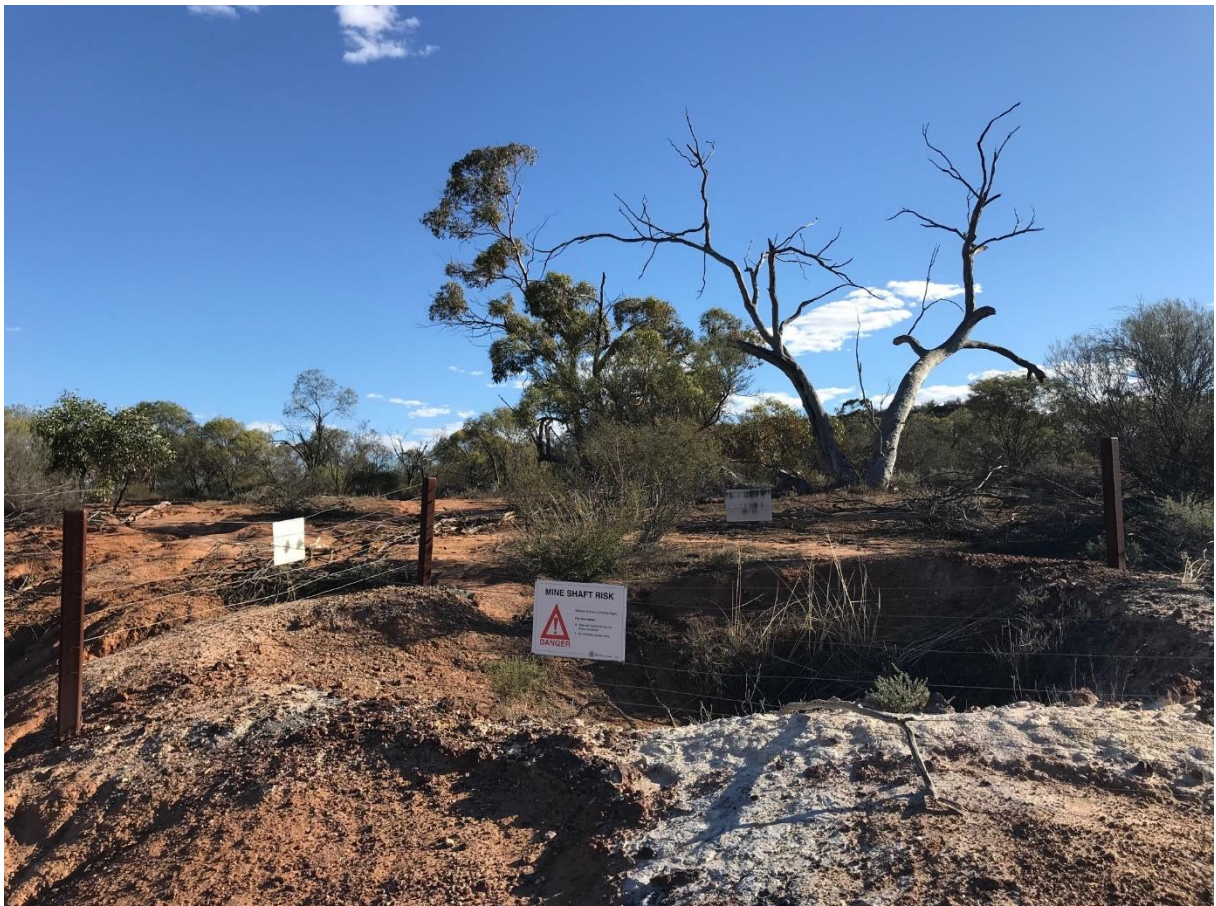
**Figure 2: Example of fencing around an abandoned mine shaft (coal mine shafts in Coalseam Conservation Park, Mingenew, WA)**

An example where this solution was implemented is shown in Figure 2 below.

- Feature 3 – due to the small volume required and the proximity to the track; and
- Feature 6 – if the PACM is left in place, to ‘cap’ the contaminated material.
