SAFETY BULLETIN NO: 67

OPEN PIT SCALING

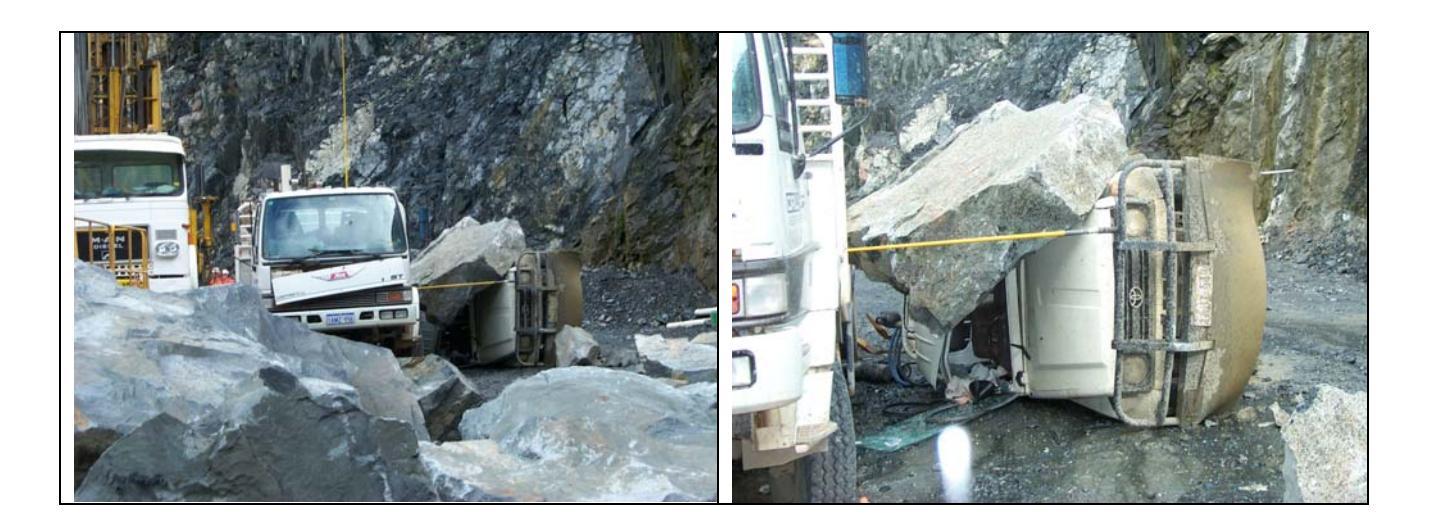
On hearing a cracking noise the geologist looked up to see rock falling towards him and dived under the drill rig support truck. A large rock then struck the utility he had just parked-up, pushing it 4m into a windrow on the side of the haul road.

Additional rock struck a second Landcruiser utility, tipping the vehicle (and the driver) onto its side. A large rock weighing approximately 5t came to rest on top of the utility's passenger-side door. The remaining crew, on seeing the rock fall, ran to safety behind the drill rig. Once the dust settled the driver disembarked hurriedly from the utility through the windscreen.

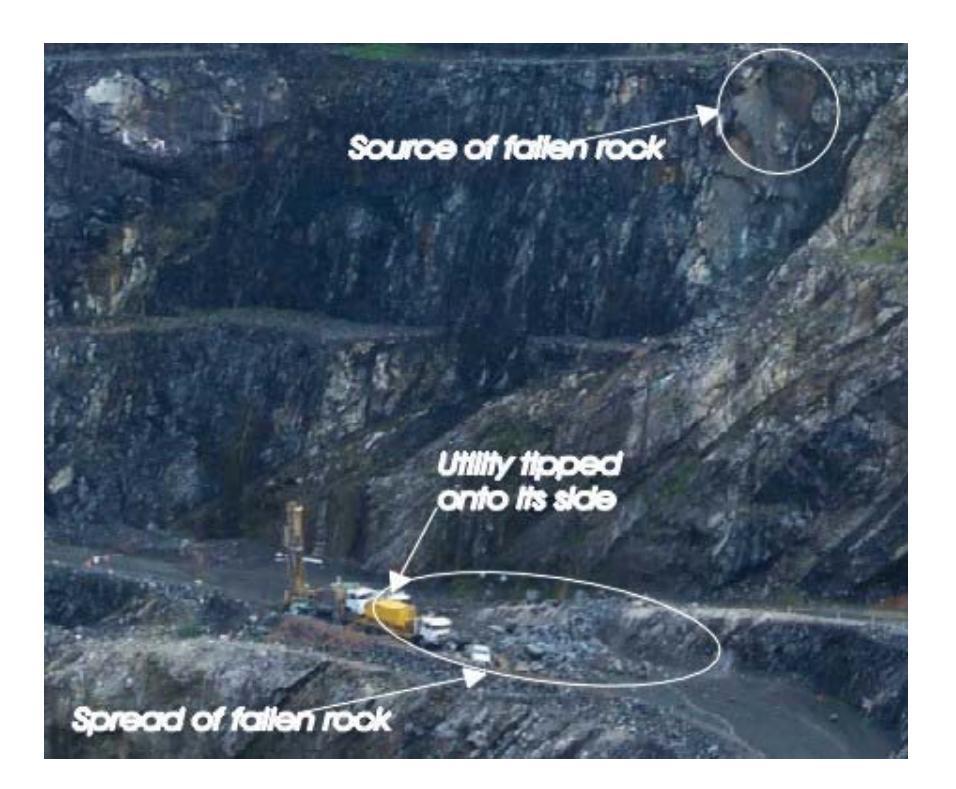
The fall was caused by a "wedge failure" along two intersecting joints in the rockmass at the crest of a batter slope. Rain prior to the incident potentially contributed to the failure - possibly by providing a lubricating mechanism or removing some "bonding" materials from the joints defining the wedge boundaries. Nonetheless, the wedge must have had a tenuous hold in its original location, and could be expected to have fallen at any time. The rock wedge (some 50m above the incident site) had been exposed for approximately 6 years; it was not readily accessible for visual inspection and had not shown any obvious signs for concern from general observation points.
