Mines Safety Bulletin No. 81

Subject: Unattended vehicles rolling away

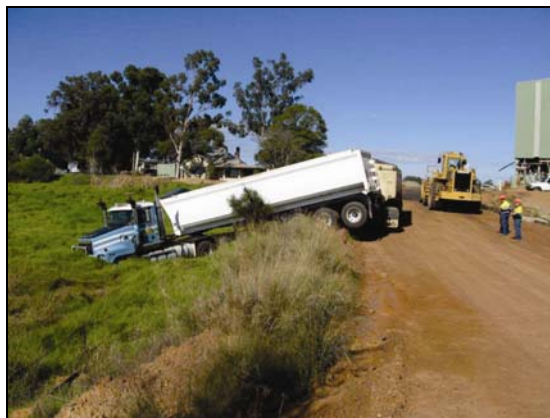
- An operator was loading the rear trailer of a road train and, while returning with the third bucket, noticed the truck and trailer rolling downhill. The operator placed the bucket of material between the front and rear trailer but this failed to stop the truck. The truck came to rest with the prime mover and front trailer in a creek about 120 metres from the loading area. On inspection after the incident, the truck park brake was disengaged. The slope on which the truck was parked was very slight and barely noticeable.

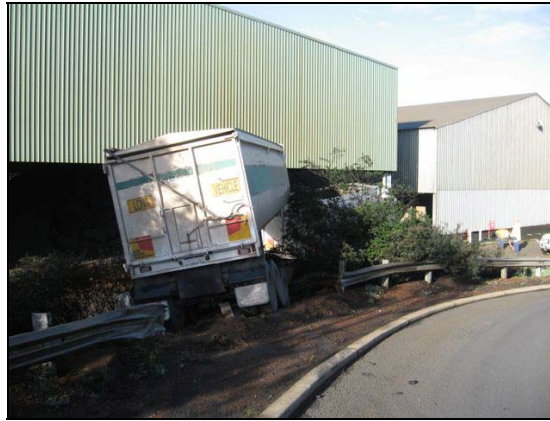
- An operator had just finished tipping the lead and dog trailers into a hopper and had pulled the truck and trailer forward to clean the wheels and rear of the dog trailer. The operator thought the maxi-brakes were on and neglected to engage the handbrake. As he walked alongside the truck it started rolling forward off the ramp. The truck went down the ramp and crashed through an Armco barrier at the base of the hill, continued through a garden bed and across a road. The operator had run after the truck and, after it had crossed the road, decided to enter the truck and apply the foot brake. He successfully stopped the truck centimetres from an upright metal beam on the side of a large shed.
