## Mines Safety Significant Incident Report No. 185

### Serious entanglement injury sustained during calibration of conveyor belt weightometer

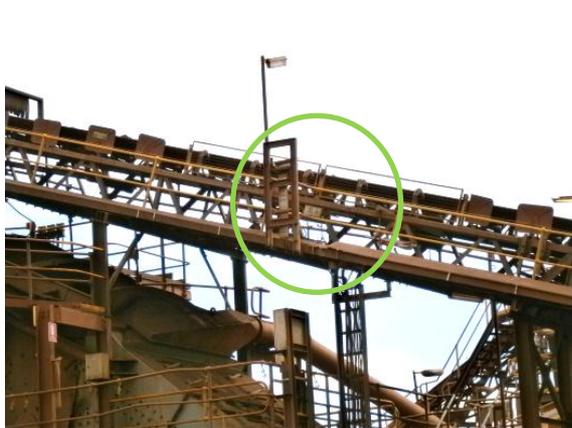
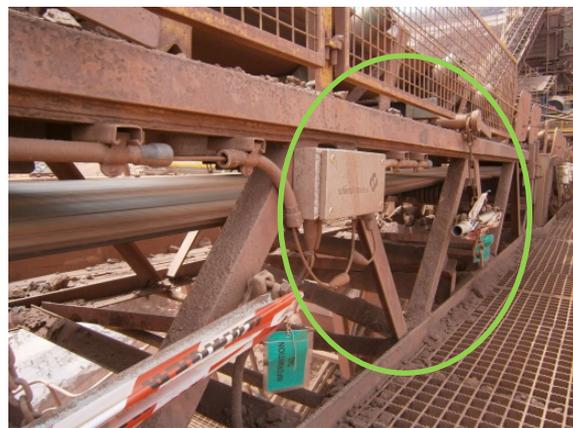
A worker was cleaning a calibration weight, a routine task completed before calibrating the conveyor belt weightometer, a task that required the conveyor to be running. The broom being used to clean the weight, which was located about 30 cm beneath the conveyor, touched the running conveyor, causing the handle to “flick” the worker’s hand into the return roller, trapping his arm.

Photographs showing location of weightometer under conveyor belt

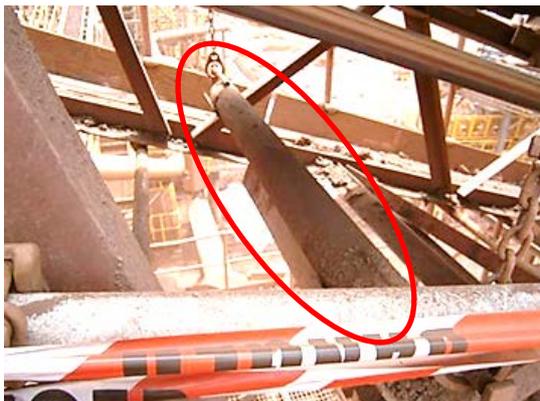
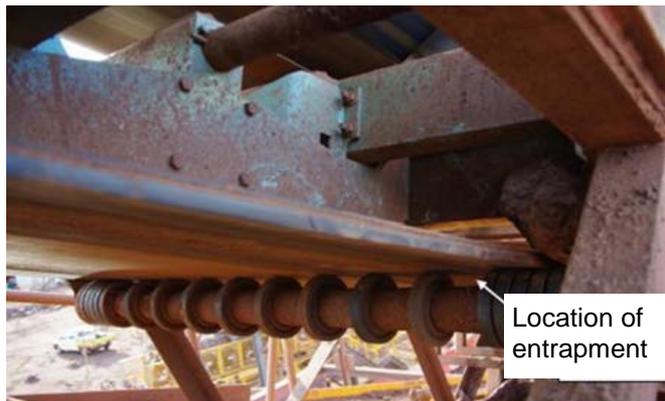
Photographs showing calibration weight requiring cleaning (left) and nearby return roller (right)

- The conveyor was not isolated during cleaning of the calibration weight.

- There was no separation of the weight cleaning task from the weightometer calibration task.
- The guarding of moving and rotating parts near the conveyor weightometer was inadequate.
- There was no approved work instruction for this routine task.
- The site was overly reliant on "shop floor" low-level risk assessments.
- There was a lack of training and competency assessment for the task being performed.

Conduct a team-based risk assessment for tasks where there is the risk of exposure to rotating and moving parts, and develop an approved safe work instruction where all practical measures have been taken to eliminate or mitigate the hazard. For the cleaning of conveyor belt weightometers, such measures might include:

- isolation of the conveyor belt to allow the weights to be cleaned manually without risk of entanglement
- installation of a hose point to facilitate cleaning of the weights without the need to use tools
- an audit of the conveyor where this task is undertaken, and implementation of a plan to replace, modify or install guarding to control the risks associated with rotating and moving parts.

Develop a safe system of work to allow calibration of the weightometer while the conveyor is running.

Implement competency-based training for work done on conveyors where there is the risk of exposure to rotating and moving parts.
