Mines Safety Bulletin No. 113

Subject: Reducing the potential for fall-back arrester arms on tyre handlers to become projectiles

Date: 15 August 2014

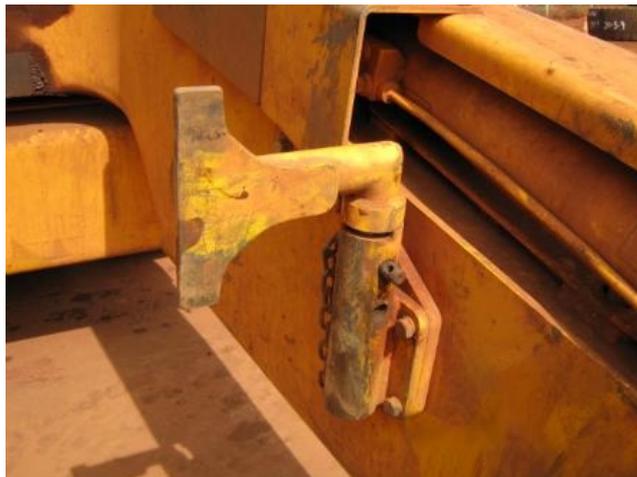
Tyre handlers are commonly used to assist with the repair and replacement of tyres on earth-moving equipment. Over the last three years, four tyre handler incidents have been reported that involved failed components on fall-back arrester arms. Stored energy is released when the arrester arm fails and components may become projectiles. The trajectories and distances travelled by the components are unpredictable, and workers can be harmed and plant damaged several hundred metres away.

Example of fall-back arrester arm showing components that can become projectiles

- Ensure tyre handlers are fit for purpose.
- Define load ratings that reflect the risk assessment and site requirements.
- Follow OEM guidance for the use, maintenance and inspection of tyre handlers.
- Establish an inspection regime that includes non-destructive tests of welded attachments.
- Review tyre handler operating procedures and training requirements to ensure workers:
 - can recognise the hazard of stored energy
 - are competent to undertake assigned tasks safely.
