Mines Safety Significant Incident Report No. 184

Shiploader rail clamps fail after original parts modified in unsuccessful attempt to overcome problem of rail misalignment

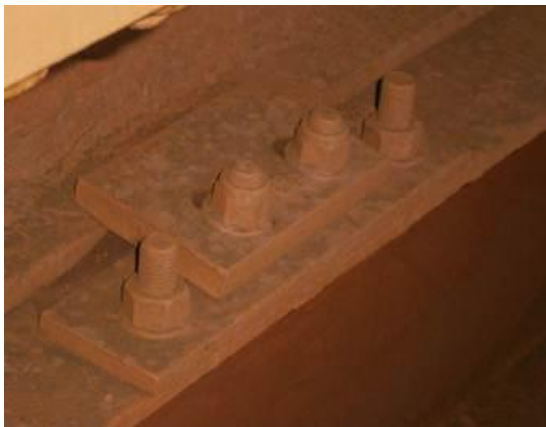
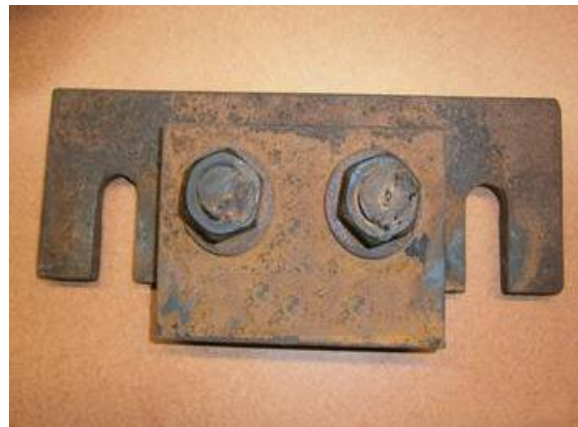
A 4.5kg rail clamp fell about 10 metres to the ground from a shiploader rail system after the nut-and-bolt assembly had loosened, allowing the clamp to vibrate free. Fortunately, no-one was injured. Rail clamps had fallen previously.

Many of the clamps had been modified from the original equipment manufacturer (OEM) design by cutting open-ended slots to the bolt holes to overcome what was believed to be a rail misalignment issue.

Photographs showing rail clamp as designed by OEM (left) and modified rail clamp (right) with open-ended slots and welded nuts and bolts.

- The rails were misaligned.

- No remedial action was taken to address the underlying issue of misaligned rails, although the misalignment had been identified in reports following previous incidents and during site structural audits.
- Modified rail clamps were used in repairs.
- The clashing of bolt heads with wheels is often an indicator of misaligned or worn rails — a potential underlying cause that the repairs did not address.
- To prevent bolt head clashing, some bolts had been shorted and beads of weld used to ensure the nuts did not come loose, making them susceptible to cracking.
- The structure showed signs of wear and corrosion.

Before making repairs, a competent person should determine the root cause of the failure and how to address the underlying problem. This may involve a review of past incidents and repairs.

A structural integrity audit may be required for large structures. For shiploader rail systems, such an audit should include:

- a survey of the alignment of rails and shape of the structure, and comparison with design parameters (see Australian Standard AS 1418:18 *Cranes, hoists and winches – Crane runways and monorails* for guidance on rail alignment criteria)
- an assessment of the condition of parts such as rails, wheels, guides, clamps, spacers, shims and bearing pads under rails
- an assessment of the adequacy of rail end stops and rail joints.

When installing, servicing or maintaining parts, particularly for safety critical systems on machinery, follow OEM maintenance guidance, fitting instructions, recommendations and specifications.

Do not use alternate or modified parts unless they have been assessed by a competent person as meeting the OEM's performance specifications.
