Significant Incident Report No. 242

Subject: Tyre fitter's fingers crushed while operating hydraulic bead breaker

Date: 14 June 2016

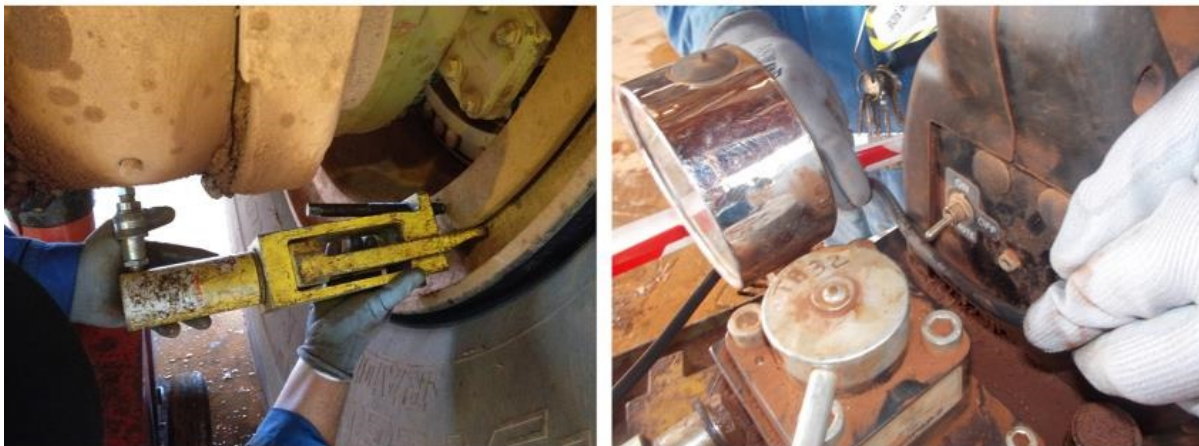
In April 2016, a tyre fitter was positioning a hydraulic bead breaker in preparation for breaking an inner tyre bead on a water cart. The worker was holding the bead breaker in his right hand and the remote control pendant for the hydraulic power pack in his left hand. He attempted to gain extra length in the pendant control cable by flicking it over the power pack. This action activated the hydraulic power pack, by either knocking the pump toggle switch to the 'on' position or depressing the pump 'on' button of the pendant. The sliding section of the bead breaker was set in motion and crushed three fingers on his right hand, resulting in partial amputations.

Re-enactments showing approximate hand grip on the bead breaker and position of power cable under the toggle switch

- The hydraulic power pack was energised with the control valve lever in the 'advance' position while the equipment was being positioned for operation.
- The tyre fitter inserted his fingers into the sliding section of the hydraulic bead breaker, exposing them to moving parts when it activated.

- The equipment design does not encourage the correct positioning of hands nor restrict access to moving parts.
- There is no guarding to prevent inadvertent contact with moving parts nor labelling on the equipment to warn of the nip or crush point.
- Work instructions did not outline the controls for all hazards associated with the task.

- Identify hazards associated with the operation of equipment in conjunction with the recommendations of the original equipment manufacturer (OEM). Assess the risk of workers being exposed to those hazards and implement appropriate controls.
- Document all practical measures to reduce the exposure to an acceptable level in a standard work procedure.
- Confirm that the OEM's instructions for the safe use of equipment are available and followed.
- Assess workers as competent for the task before they operate plant and equipment.
- Ensure hydraulic equipment is not energised while being positioned for the task.
- Identify if more than one person is required to carry out the task safely.
