Significant Incident Report No. 243

Subject: Drill fitter crushed between drill head and rod centraliser arm - fatal accident

Date: 14 July 2016

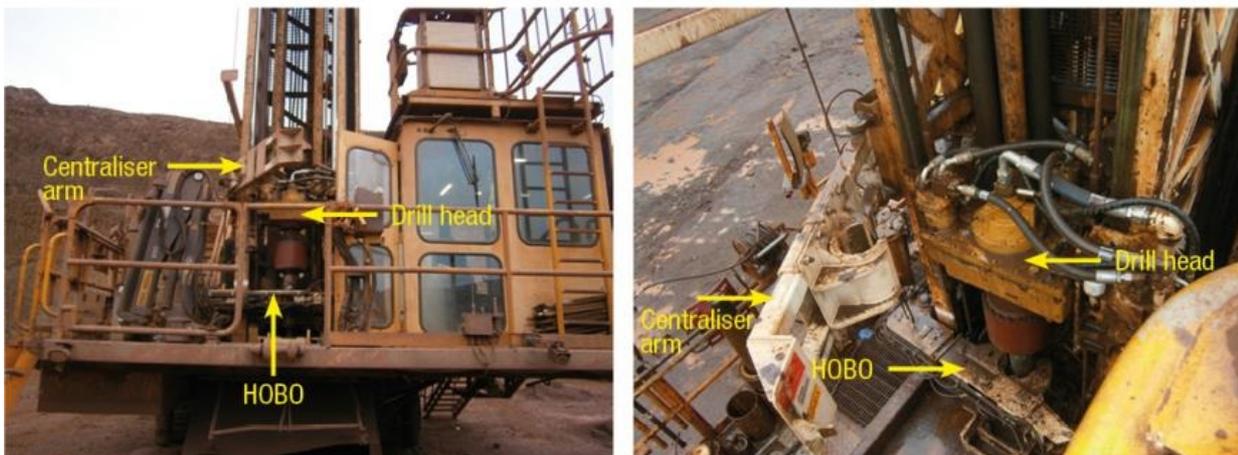
The fitter was accessing the drill head when the centraliser arm closed unexpectedly while he was standing on the hydraulically operated break-out tool (HOBO). He sustained fatal crush injuries to the chest and upper abdomen when caught between the drill rod centraliser arm and the drill head.

Blast-hole drill rig. Left. Front view showing position of HOBO, drill head, centraliser arm and drill cab. Right. Top view showing potential crush zone between the drill rod centraliser arm and drill head.

- The drill rod centraliser arm moved unexpectedly.
- The fitter was standing on the HOBO in a potential crush zone.

- An effective isolation had not been carried out prior to conducting the work.
- The uncontrolled movement of the rod centraliser arm had been identified on pre-start forms in the past but had not been actioned in the maintenance system.
- No task-based risk assessment (e.g. JHA) was performed for the task.

- Implement and enforce suitable isolation procedures.
- Confirm that workers conducting maintenance are adequately instructed, trained, assessed and supervised.
- Complete suitable task-based risk assessments, and assess and authorise prior to conducting work.
- Rectify defects or faults identified during equipment pre-start inspections within a suitable timeframe.
